WEEKLY REPORT – RED & BONITA BULKHEAD TEST

REPORT NO: 10

TEST PHASE: Phase 3, Filling to 200 ft Head

RED & BONITA BULKHEAD TEST
US EPA
BONITA PEAK MINING DISTRICT, COLORADO
PROJECT NO. 20C26021.00

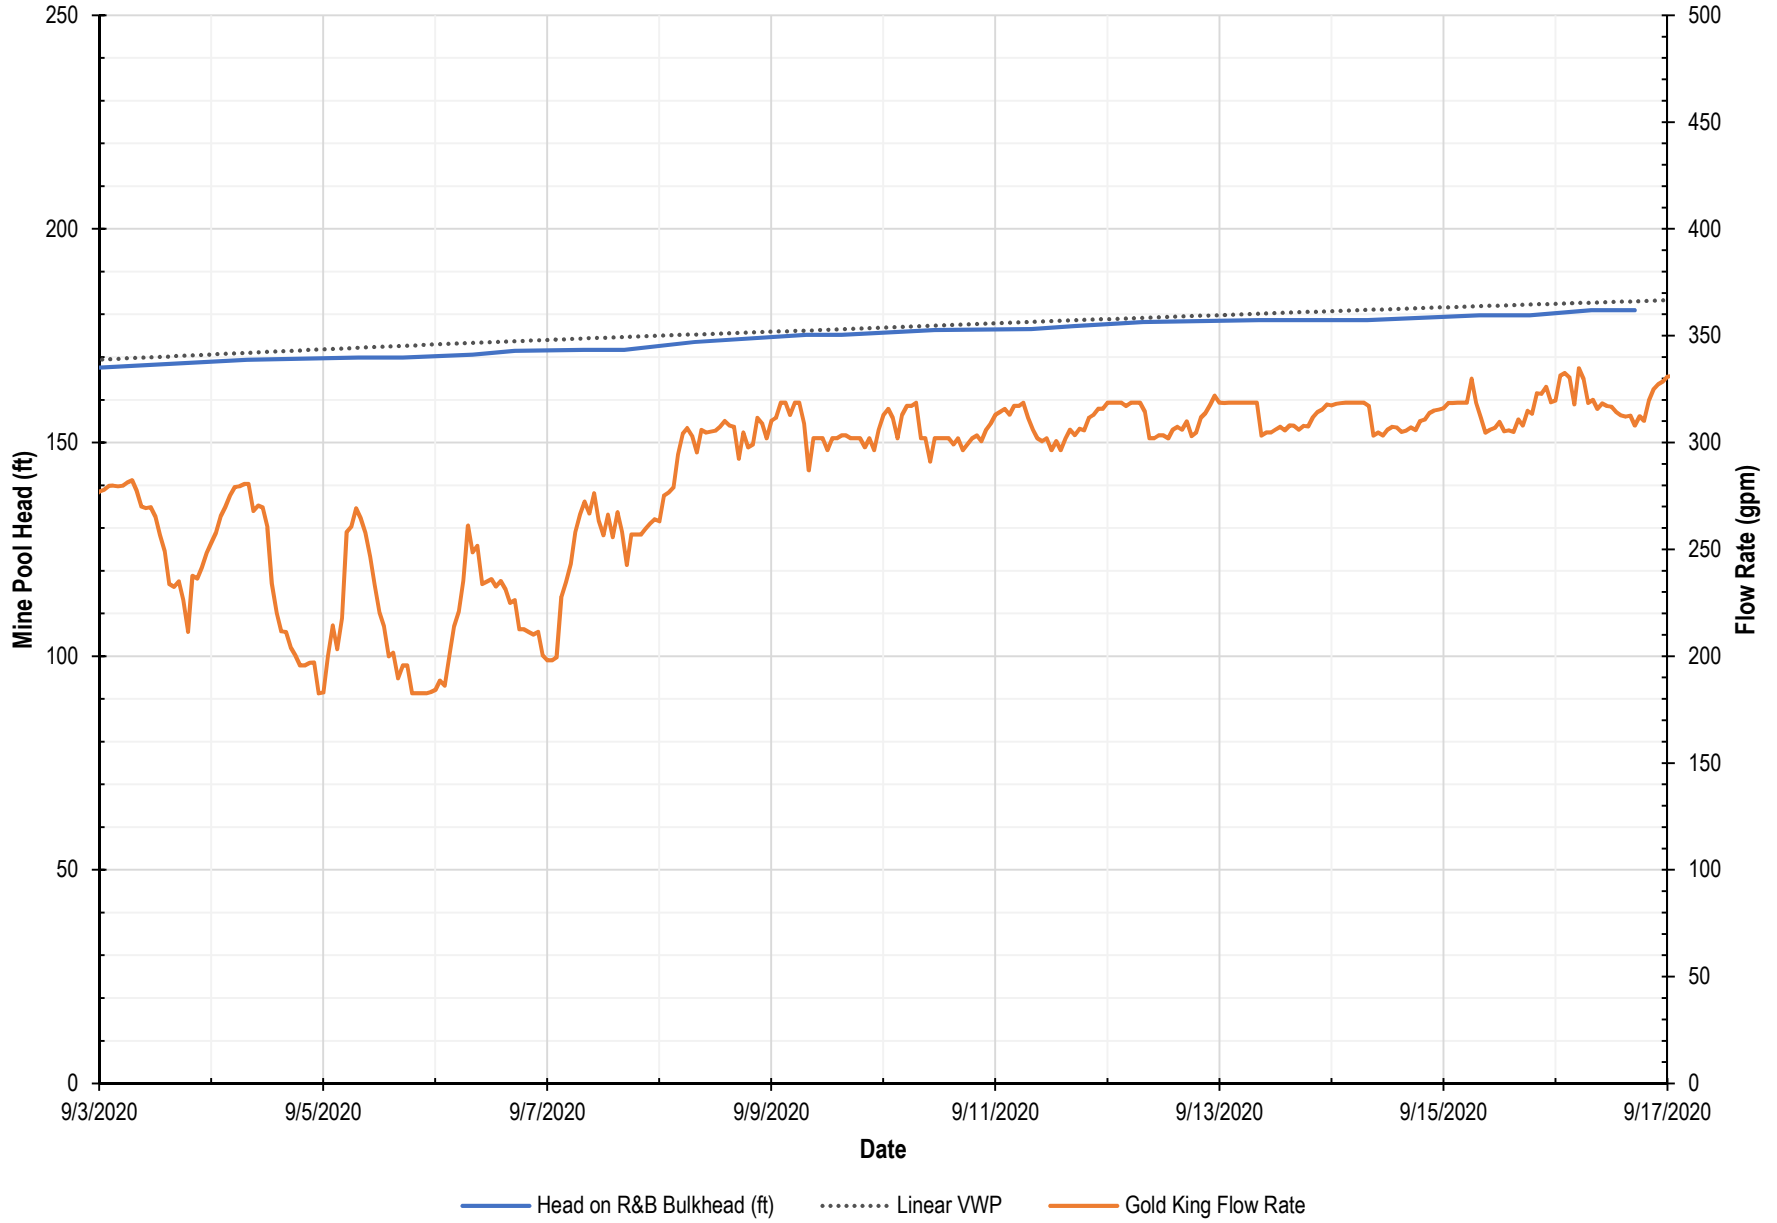
FIGURE 1: Head on Red & Bonita Bulkhead and Gold King Flow Rate

- The team decided to end Phase 3 (filling behind the bulkhead to 200') on September 21st, 2020, allowing approximately four weeks to drain down the level in Red & Bonita before the start of winter weather conditions.
- Pressure has been rising slowly and steadily behind the Red & Bonita bulkhead. The rate has slowed to approximately 0.9 feet per day (Figures 1 and 2). At this rate, it is estimated we will reach about 185-190 feet of head before the drawdown begins.

- Flow rates at Gold King continue with daily fluctuation cycles between approximately 290 to 330 gpm (Figure 1). Average daily flow rates increased from 305 to 330 gpm from 9/9 to 9/16 and daily fluctuations were less volatile than in previous weeks. Flow rates were similar to those in early to mid-August. The flow rates generally correspond with flow rates measured at the treatment plant.

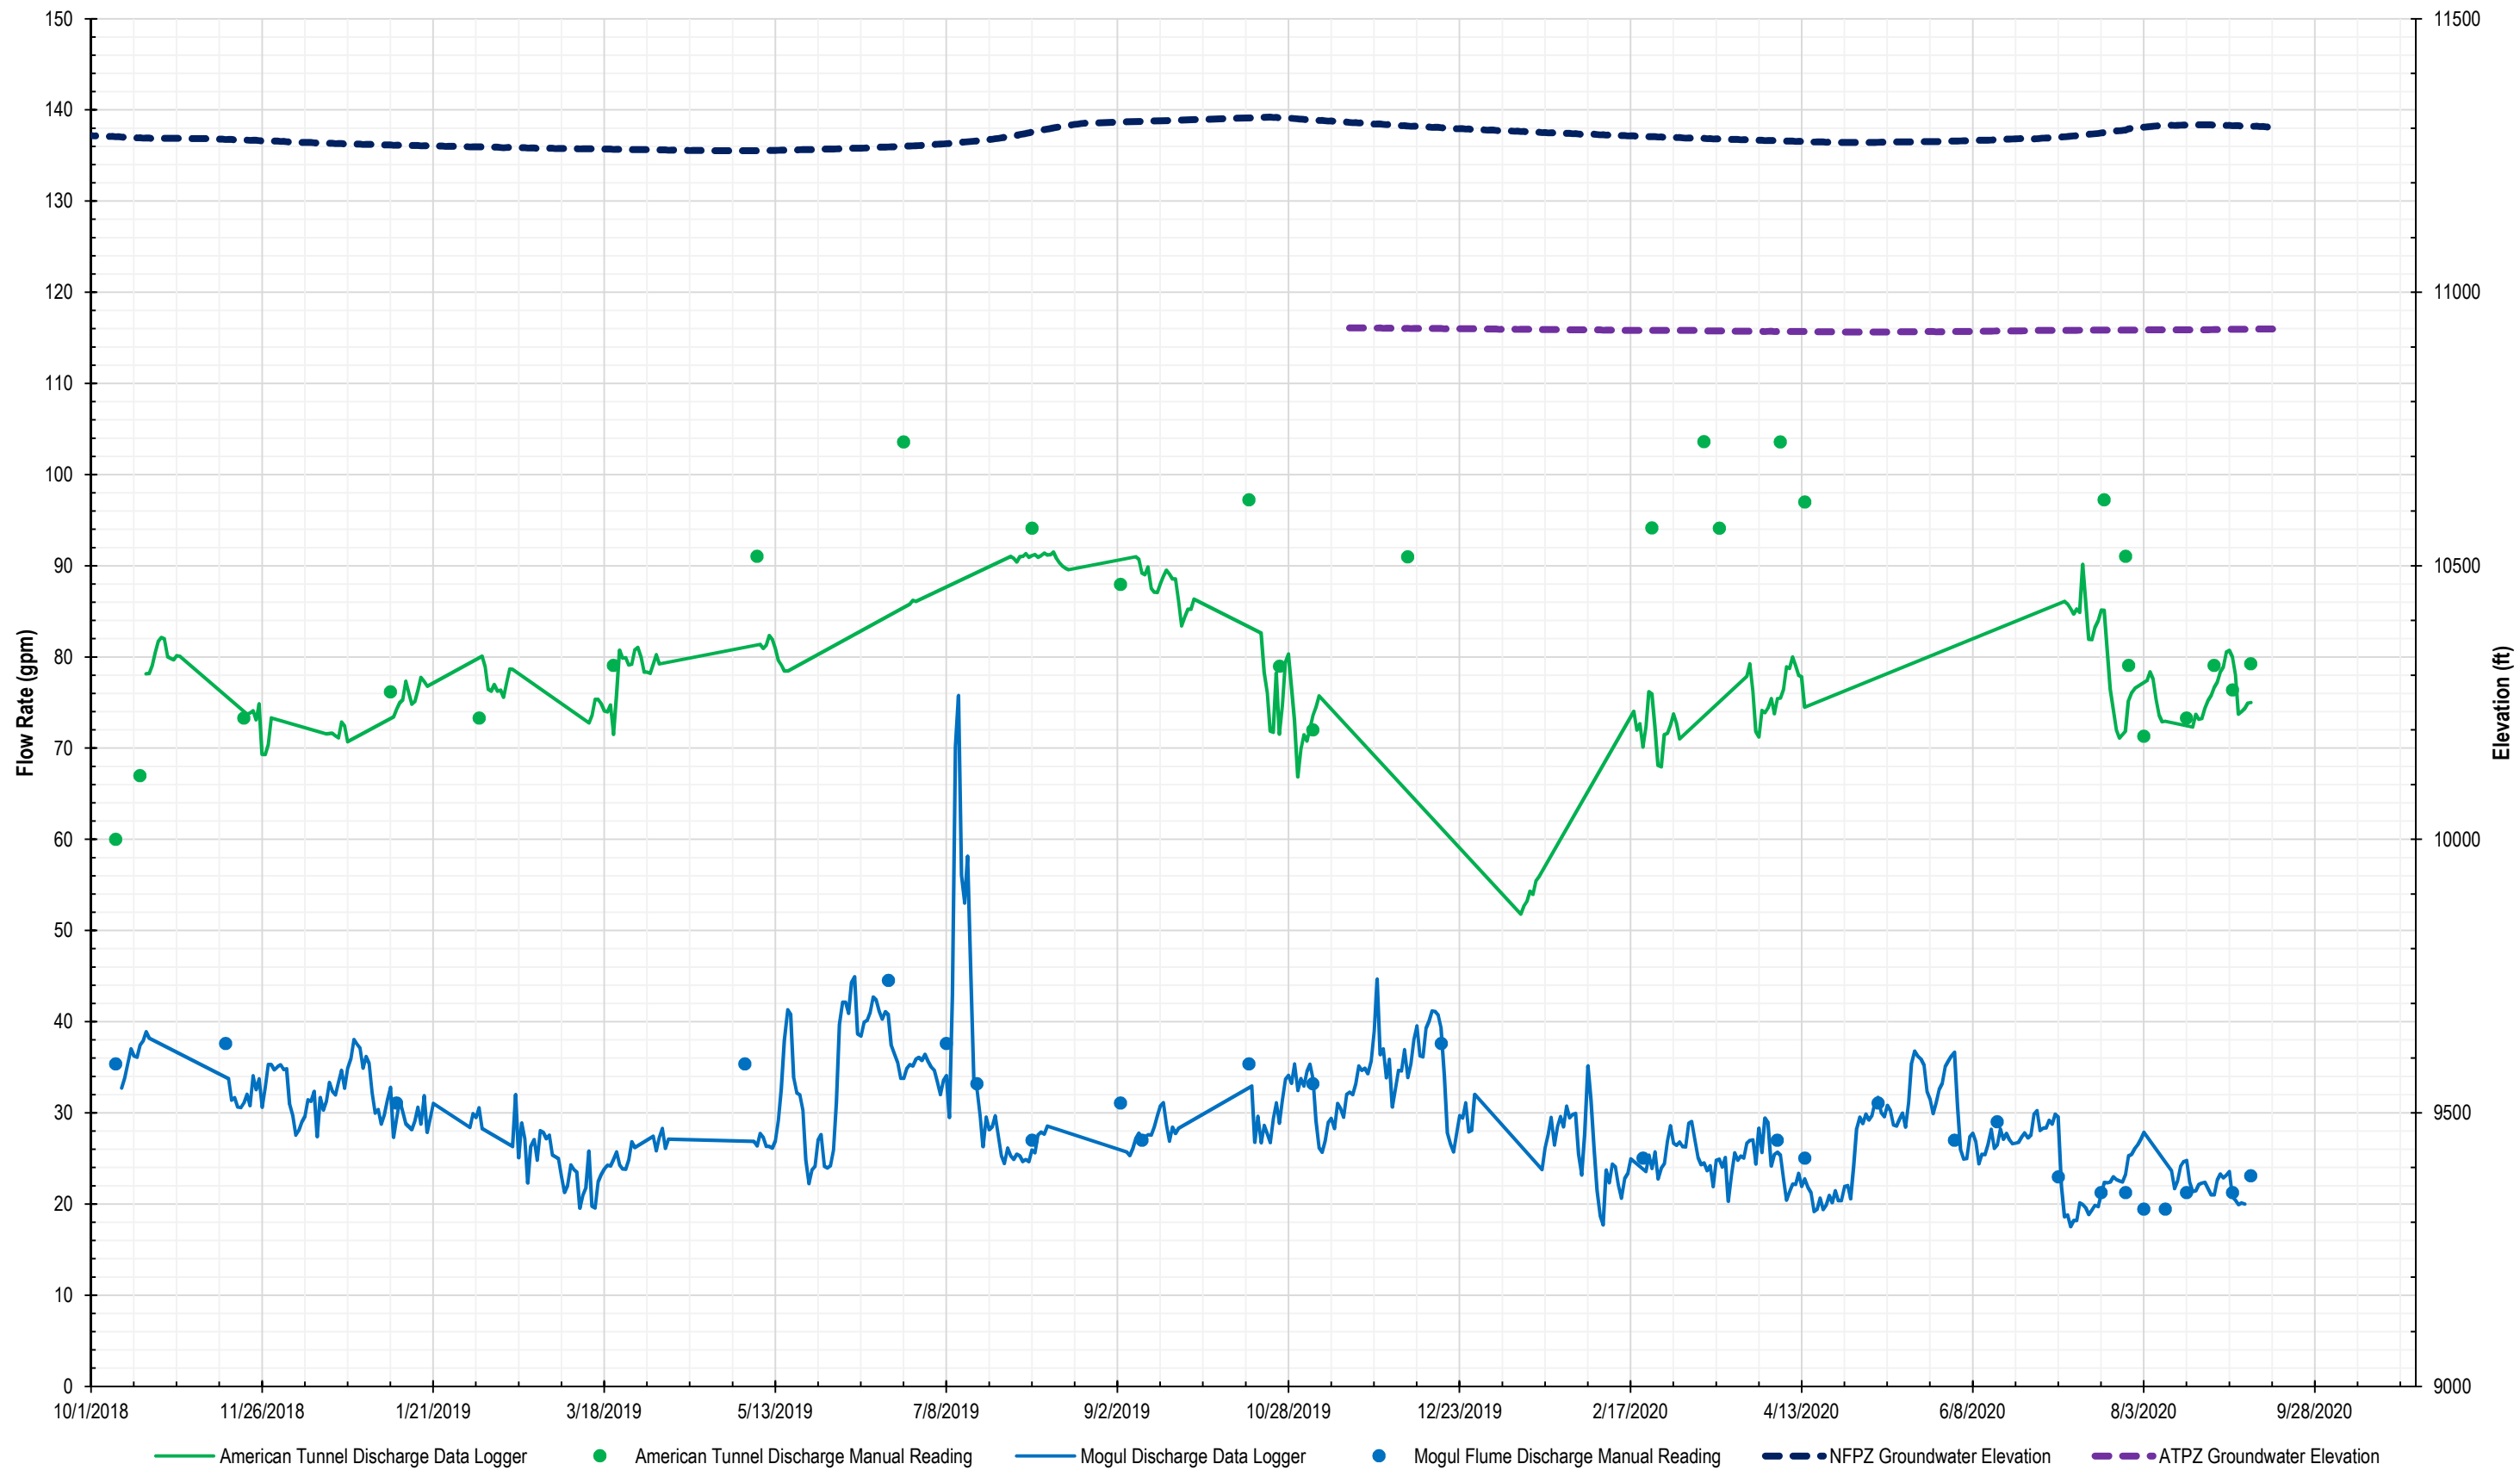
FIGURE 3: Adit Flows and Water Levels

- The data from American Tunnel and Mogul will not be updated this week. The data download will happen during the slug testing with the USGS on Sept. 19th, 2020. Additionally the barometer was stolen from Mogul, so there will be another gap in the data. Figure 3 is shown for reference.

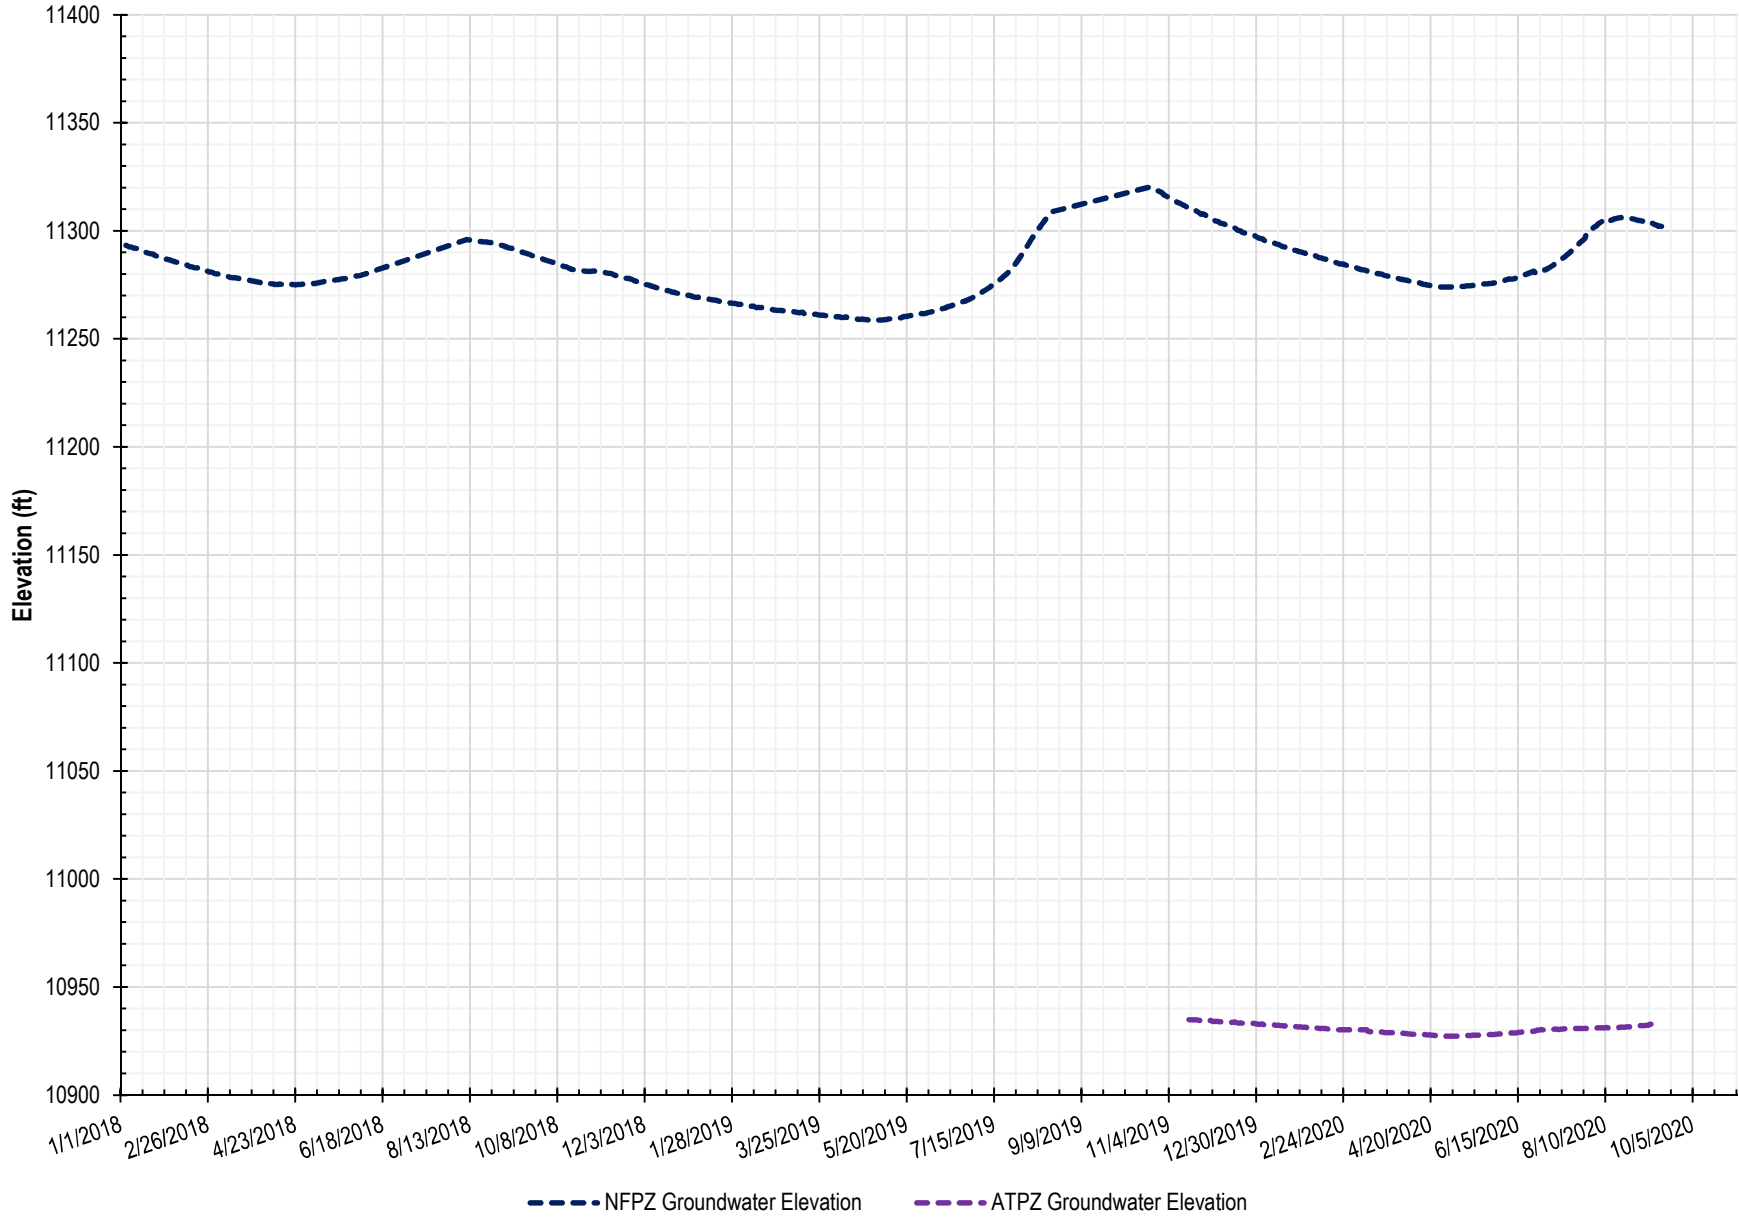
FIGURE 4: Groundwater Elevations

- Water levels in NFPZ-1 following typical seasonal cycle (Figure 4). Level in NFPZ-1 peaked in mid-August and is dropping as part of the typical cycle.

- ATPZ-2 (water level behind American Tunnel Bulkhead 3) remaining fairly steady (Figure 4). Slight increase in ATPZ-2 level in the past couple weeks – this will continue to be monitored in future weeks.

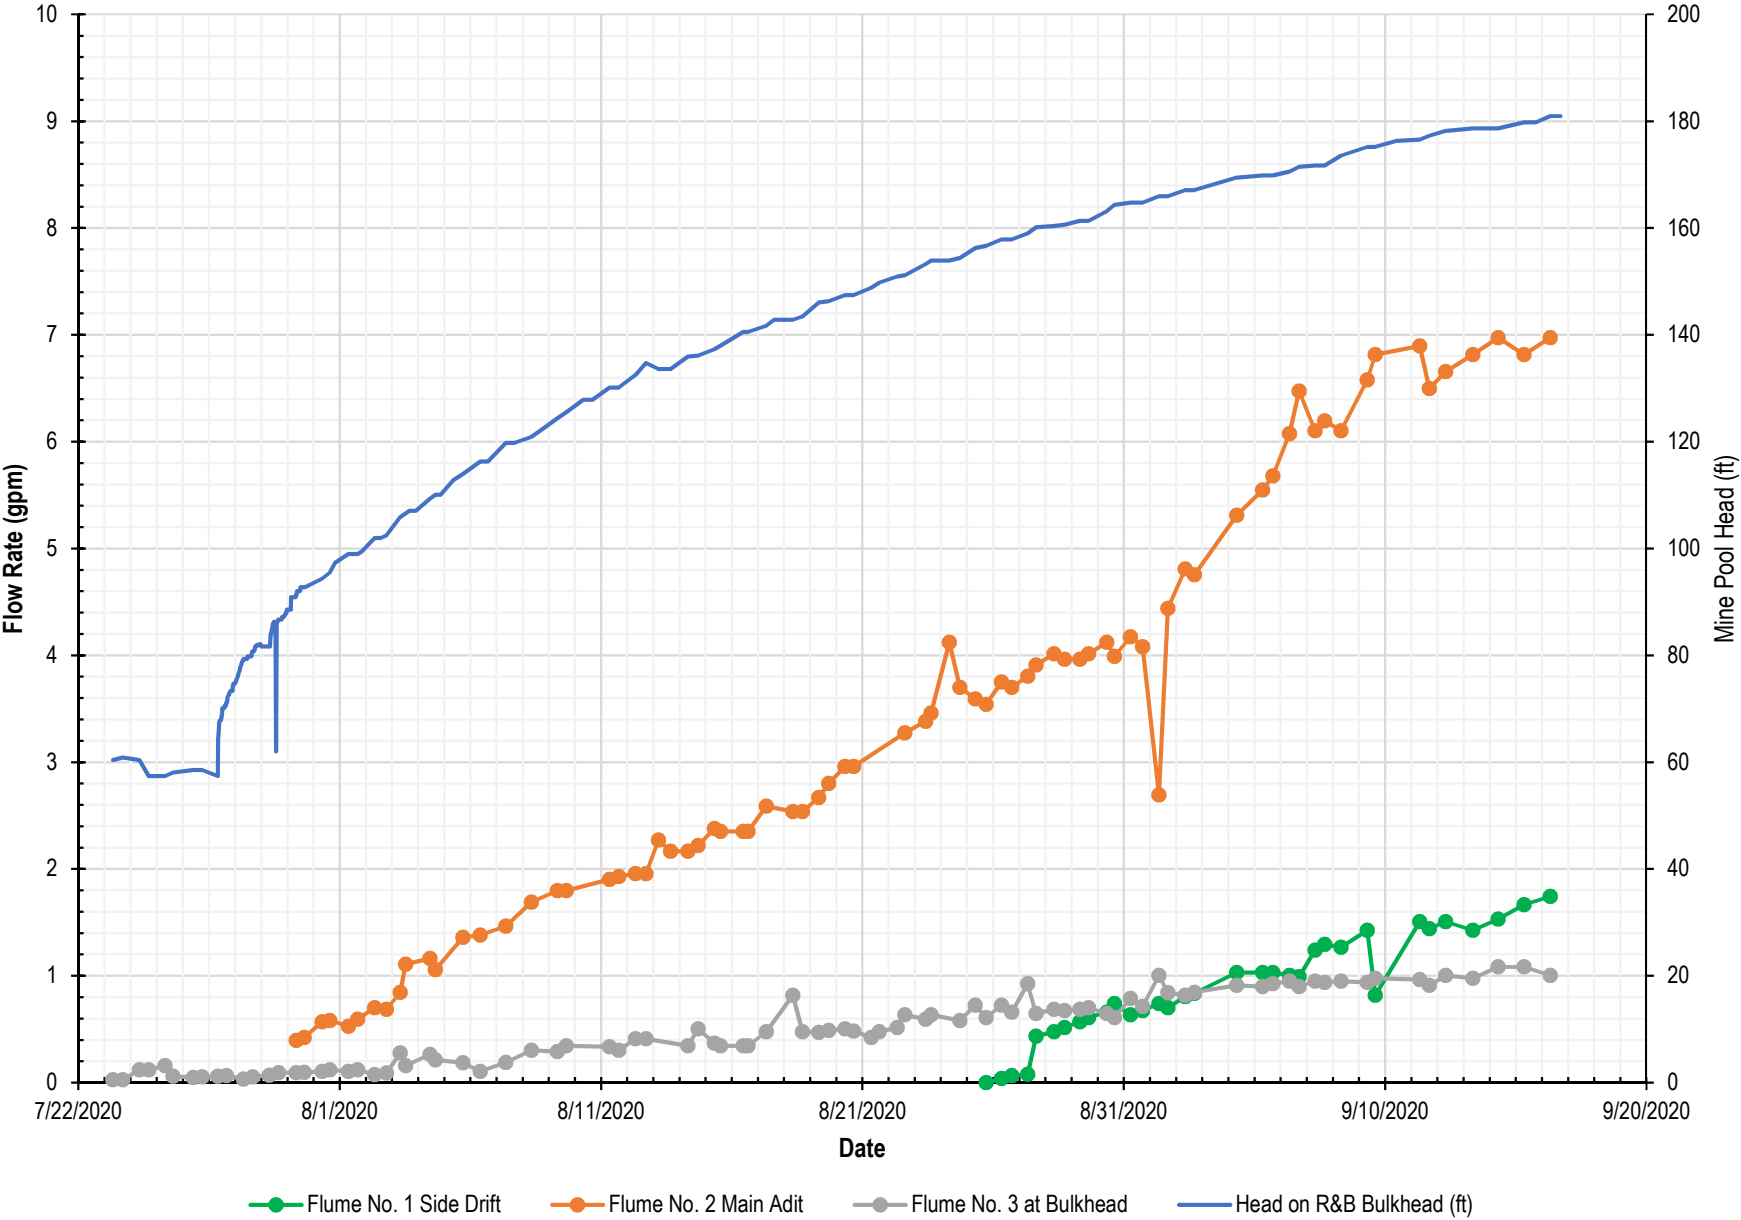
FIGURE 5: Red & Bonita Adit Flume Flow Rates

- 1 area of noticeable seepage but no major inflow
- Flows through Flume 1 side drift are measuring between 1.4 gpm and 1.7 gpm (Figure 5).
- Flows from Flume 2 in the main adit near station 2+30 stayed relatively stable around 6.8 gpm (Figure 5). This is within the expected range.

- Flows from Flume 3 at the bulkhead hovered around 1 gpm (Figure 5), relatively unchanged (up 0.1 gpm) from last week and still far from the 17 gpm threshold of concern.

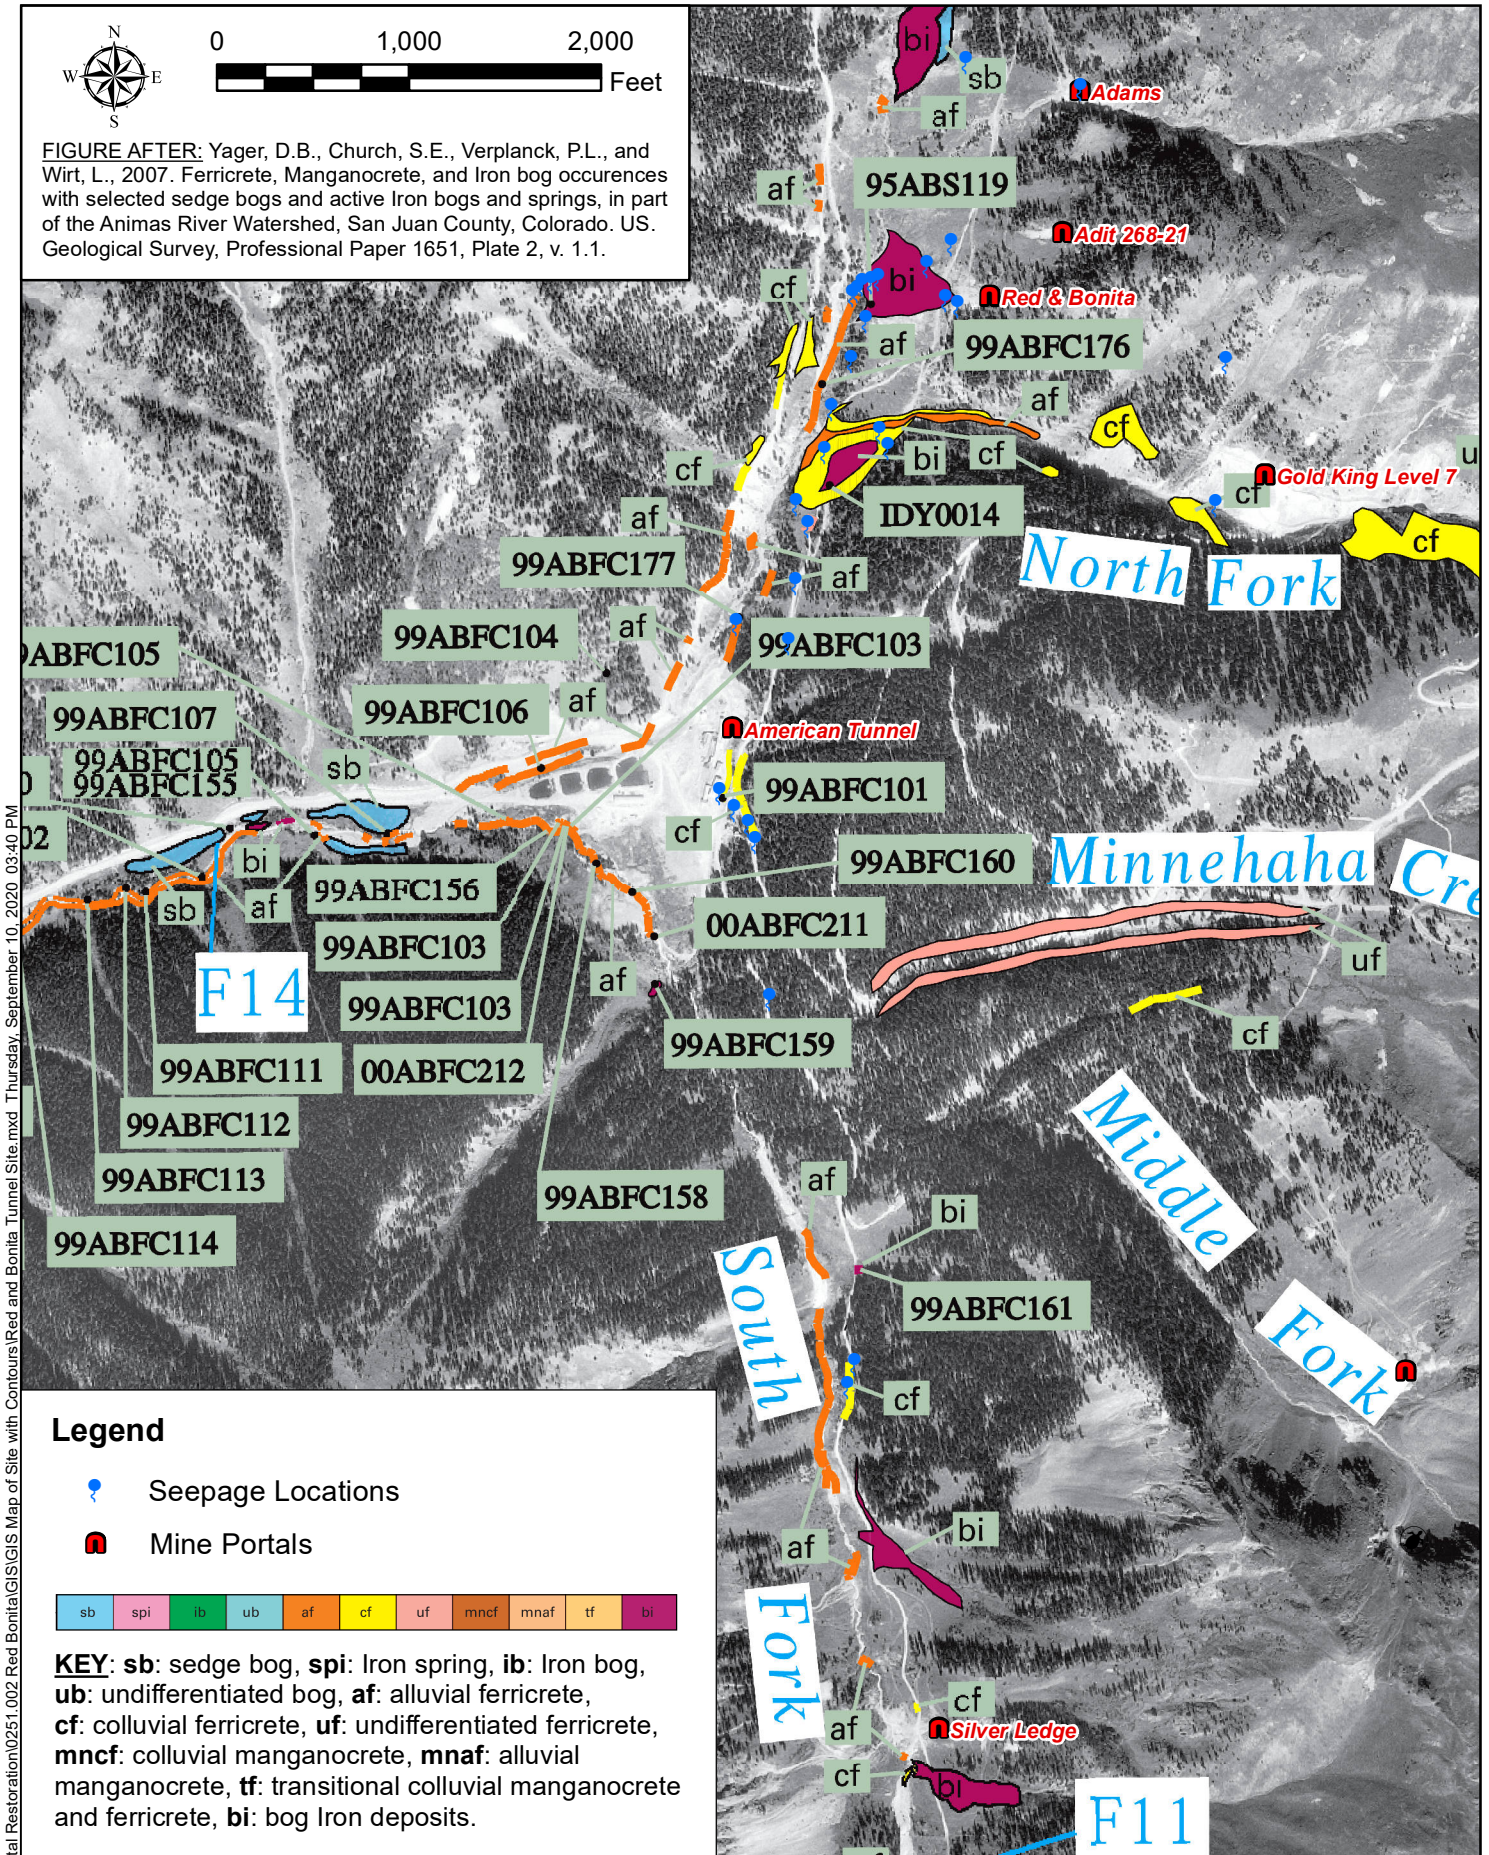
- Along the road to Natalie Occidental (CR-52) (SS414, SS016, SS017).
 These are described in Attachment B.
- Figure 8 overlays seepage observations locations with previously mapped areas of ferricrete, manganocrete and bog occurrences. Ferricrete is a natural phenomenon consisting of surficial deposits cemented in place by iron oxyhydroxide. The surficial deposits serve as flow paths and precipitation sites for iron-rich water derived from the oxidation of pyrite. Ferricrete deposits generally indicate areas of long-standing acidic groundwater expression at the ground surface. Ferricrete conditions have existed in the area before, during and after mining. The fact that seepage observations generally align with areas of ferricrete supports the theory that seepage is largely following pre-existing pathways, as groundwater returns to pre-mining levels during the bulkhead test.

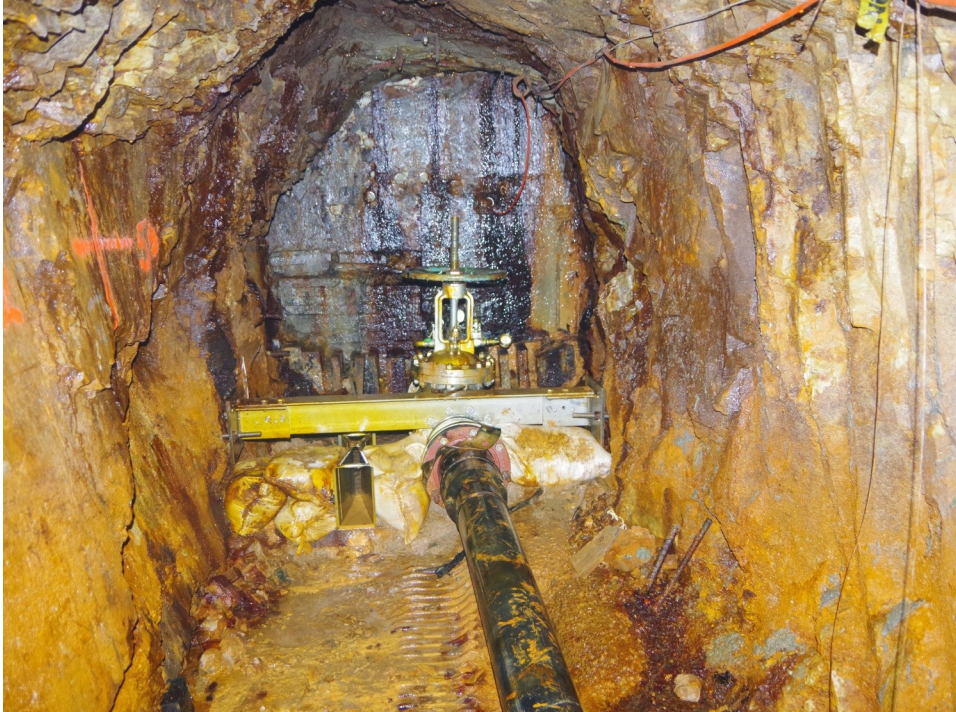
PHOTO 1

- Good agreement between pressure gauges at R&B portal and bulkhead.
- Weeping visible around R&B Bulkhead. This is normal and expected for this bulkhead test.

Looking at the Red & Bonita bulkhead with flume #3.

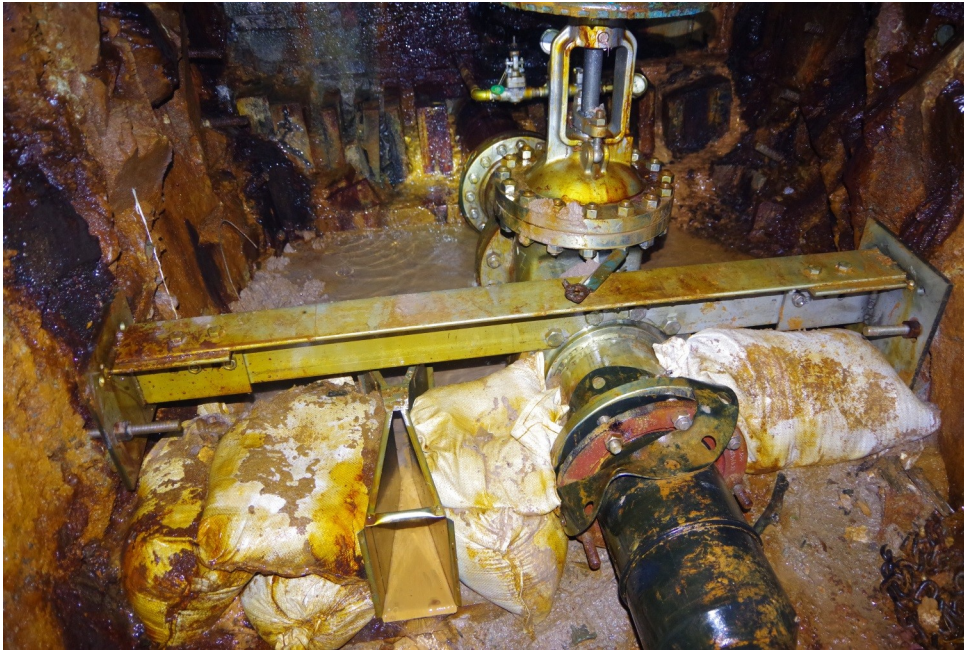
PHOTO 2

Looking behind the gate valve at the base of the Red & Bonita bulkhead with flume #3.

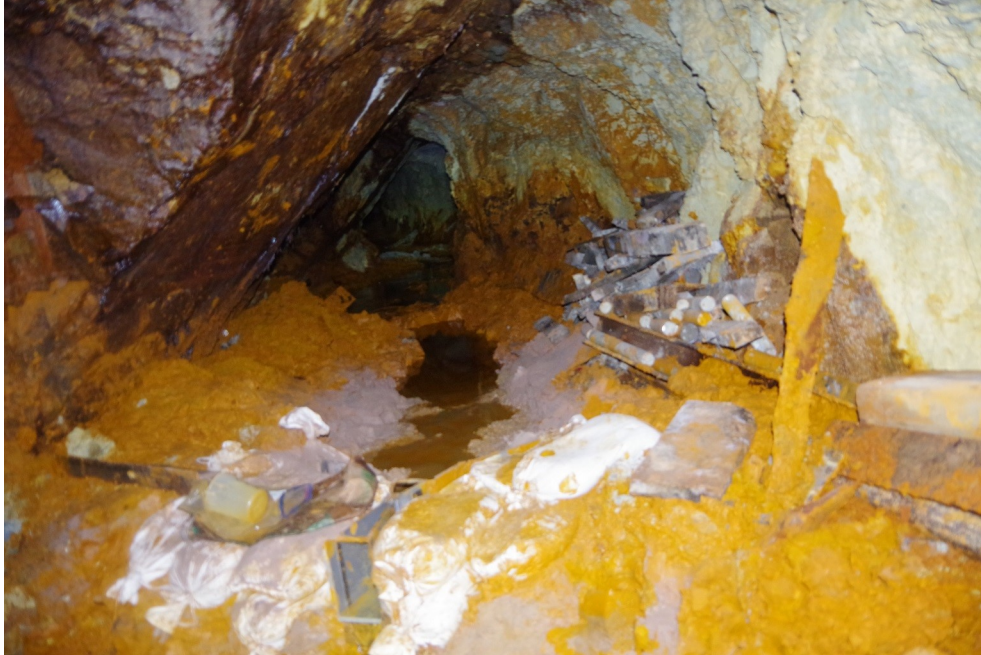
PHOTO 3

Side drift of R&B with flume #1.

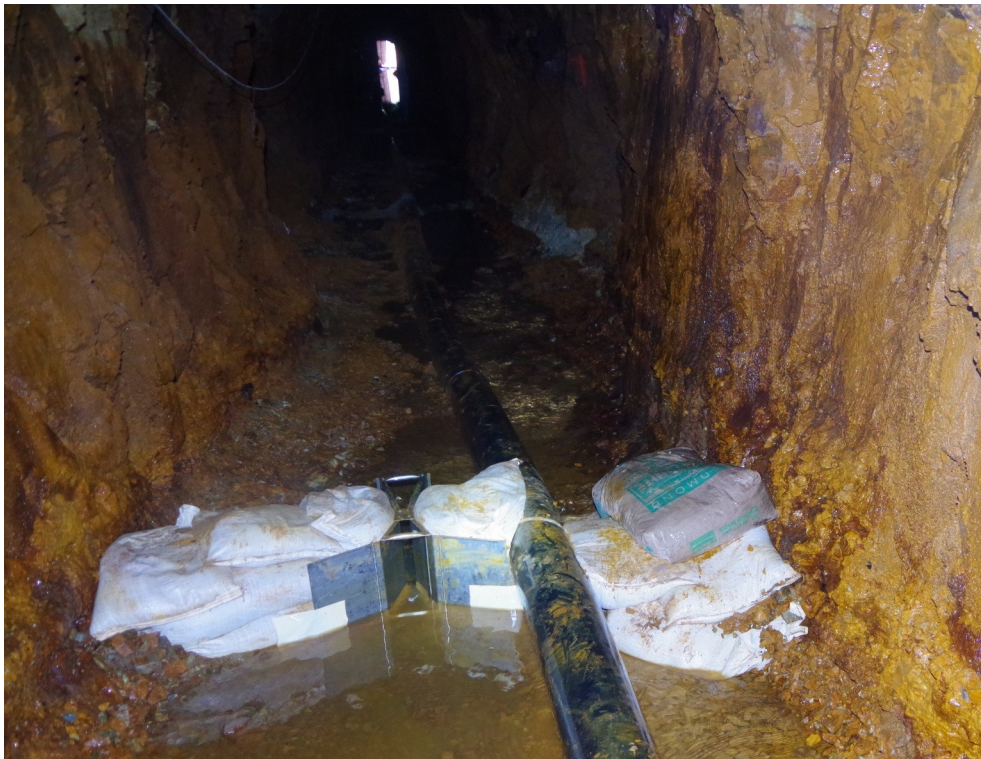
PHOTO 4

- Seepage on the left rib near 2+19 and 2+40. Overall less seepage on the left rib than the right. The seepage near 2+19 has increased since the previous site visit.

Ponding behind Flume #2 in Red & Bonita adit, looking towards the portal (outby). Note also seepage in left rib (right in photo) near station 2+19.

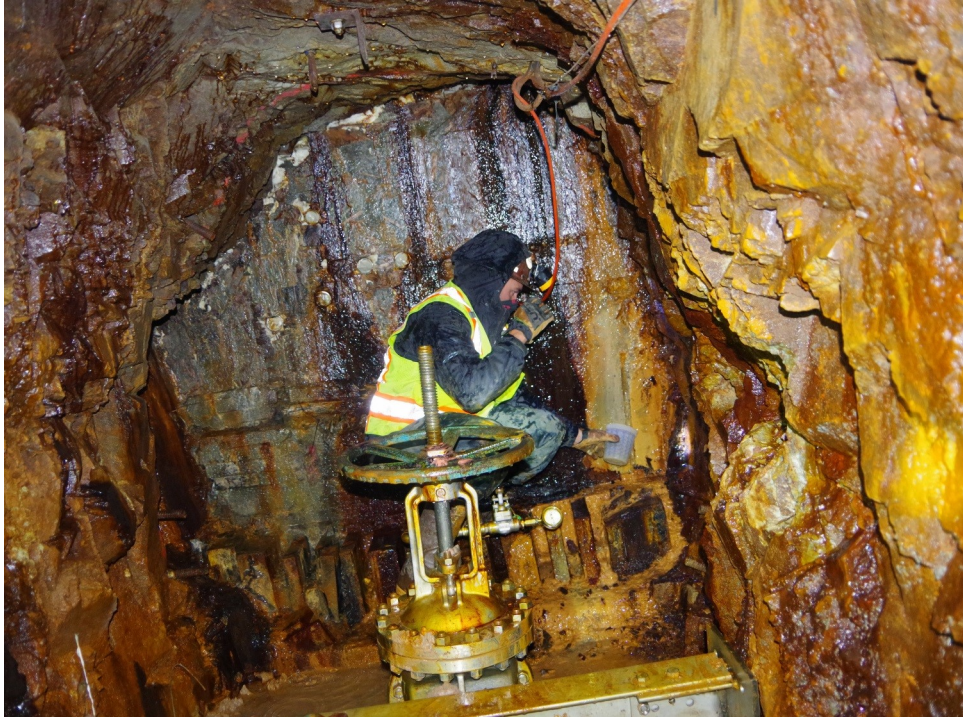
PHOTO 5

- Some weeps in joints 20-50 feet outby of bulkhead. This is normal and expected for this bulkhead test.
- Primary seepage path appears to be in right rib. This is visible at the bulkhead face, in the rib near 2+40, and in the right floor. Secondary seepage in the right rib near 2+18.

Seepage measurement and water quality sampling the right of the bulkhead.

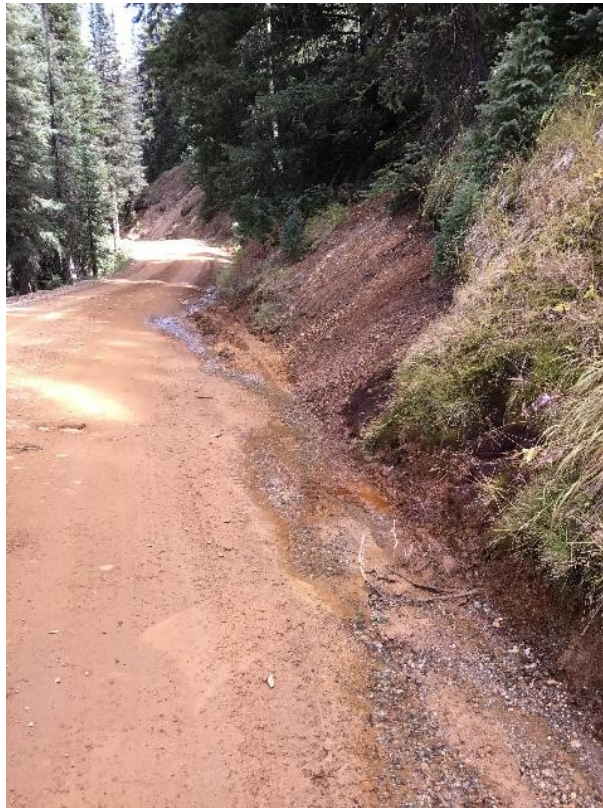
PHOTO 6

Seepage location SS016, along the road to Natalie Occidental (CR-52).

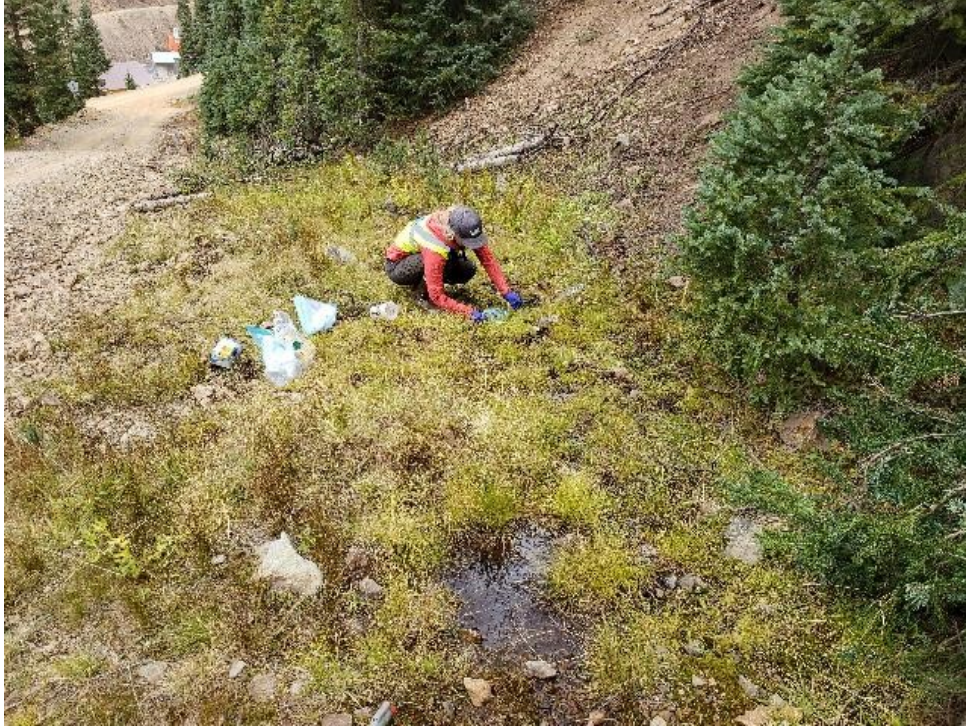
PHOTO 7

Seepage location at SS055, along CR51, towards ATPZ-2.

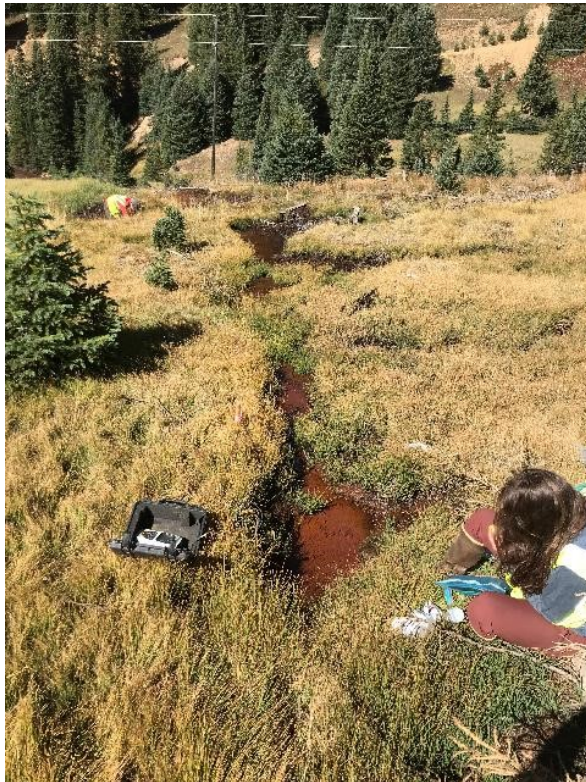
PHOTO 8

Seepage location in the fen below R&B.

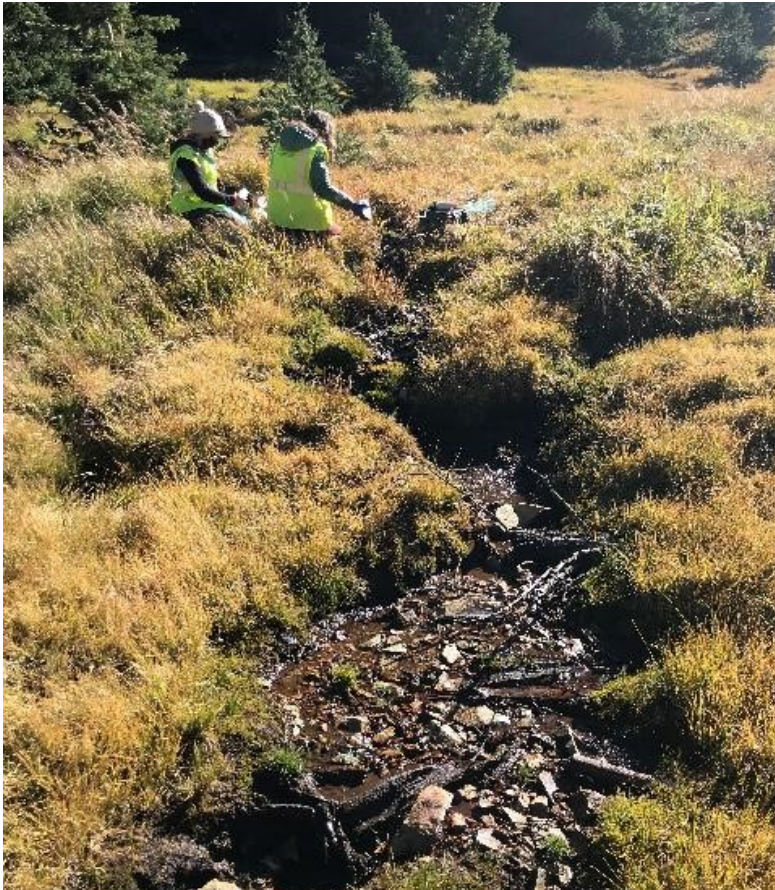
PHOTO 9

Seepage location at SS069, below the Adams mine, along Cement Creek above the North Fork.

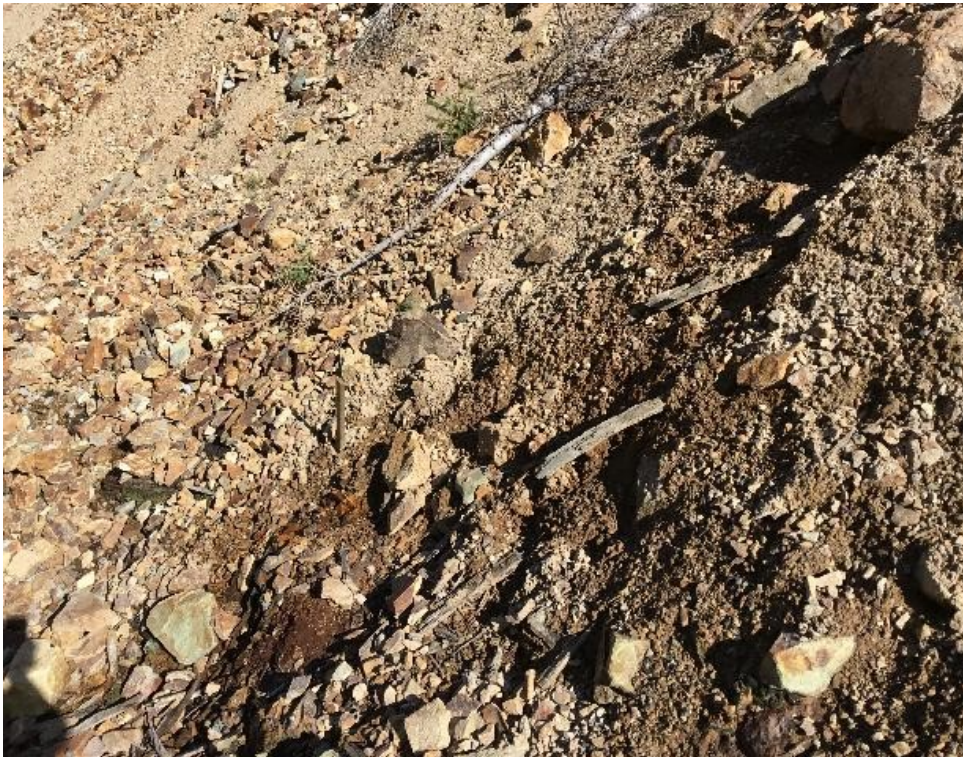
PHOTO 10

Seepage location SS084, below the Gold King Level 7 portal, along the North Fork.

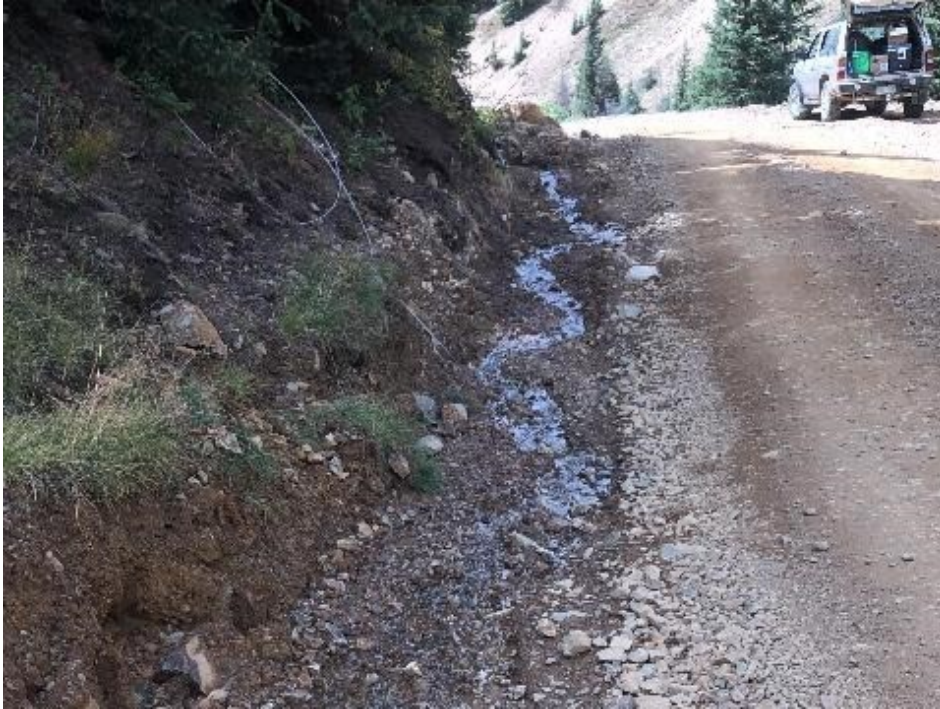
PHOTO 11

Seepage location SS404, along
the road to R&B (CR-53).

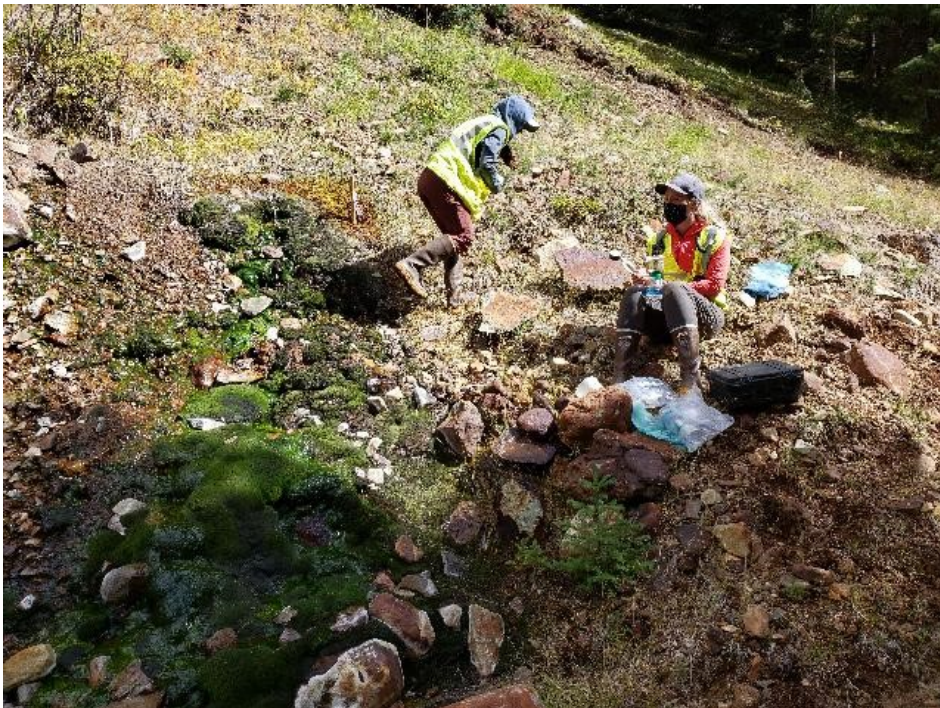
PHOTO 12

Seepage location SS301, along
Cement Creek up stream from
the American Tunnel Portal.

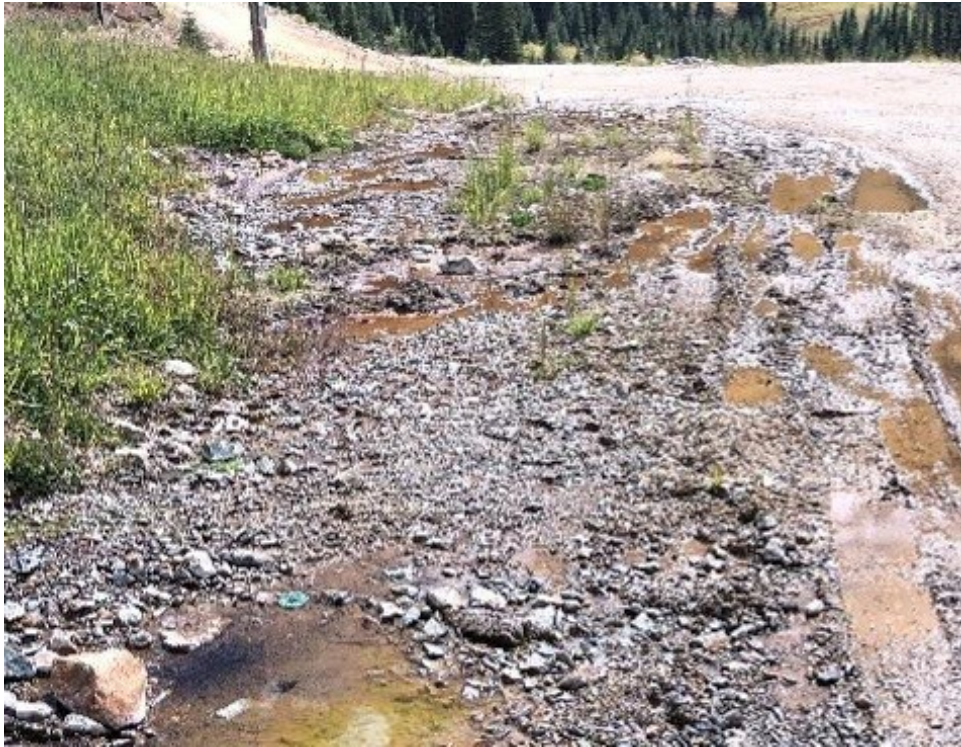
PHOTO 13

Seepage monitoring location
SS406. Near the intersection of
CR-51, CR-52 & CR-53. Likely
same water as AT or SS413,
flows have been inconsistent but
likely coming under road grade
from SS413
