WEEKLY REPORT – RED & BONITA BULKHEAD TEST

REPORT NO: 10

TEST PHASE: Phase 3, Filling to 200 ft Head

RED & BONITA BULKHEAD TEST
US EPA
BONITA PEAK MINING DISTRICT, COLORADO
PROJECT NO. 20C26021.00

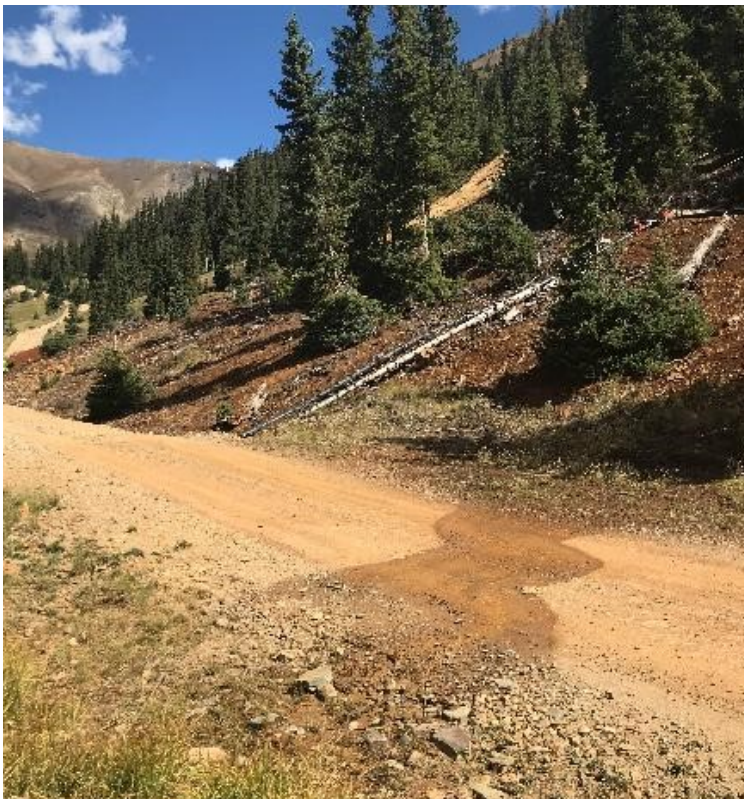
PHOTO 14

Newly identified seepage this
week at location SS420 on the
east side of CR-53 south of the
R&B culvert. Not flowing enough
to sample.

Event Date	Event Time	Location ID	Location Description	Temp (Celsius)	Specific Conductivity (µS/cm)	pH	Flow (CFS)	Flow (GPM)	Observations
9/14/2020	12:05	SS420	East side of road below R&B	NA	NA	NA	NA	NA	New seep observed on east side of road about 25' south of R&B culvert. Wet seep, not enough flow to be able to measure. No sample collected.

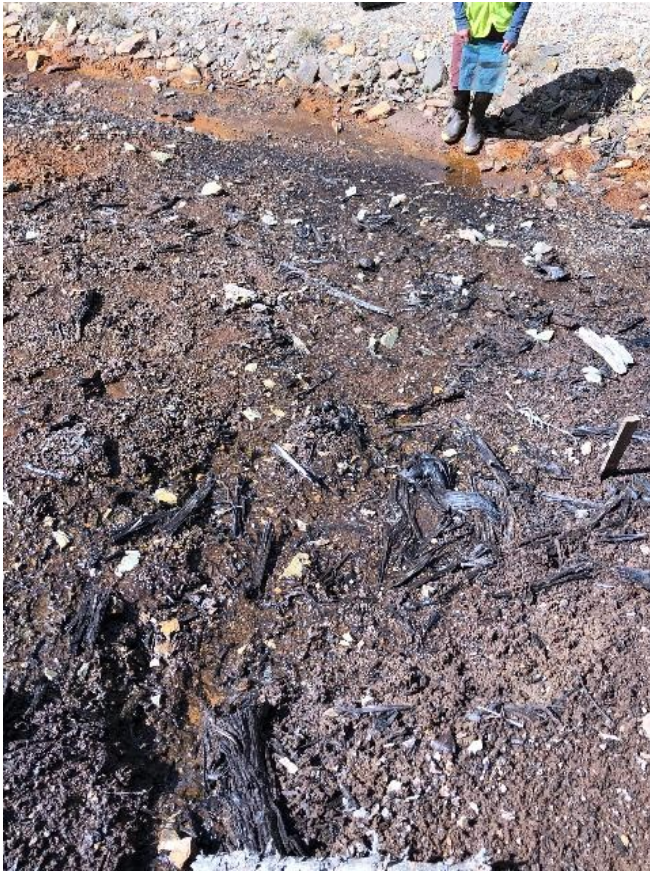
PHOTO 15

Seepage monitoring location SS407 showing increased flow at the base of the Red & Bonita waste pile.

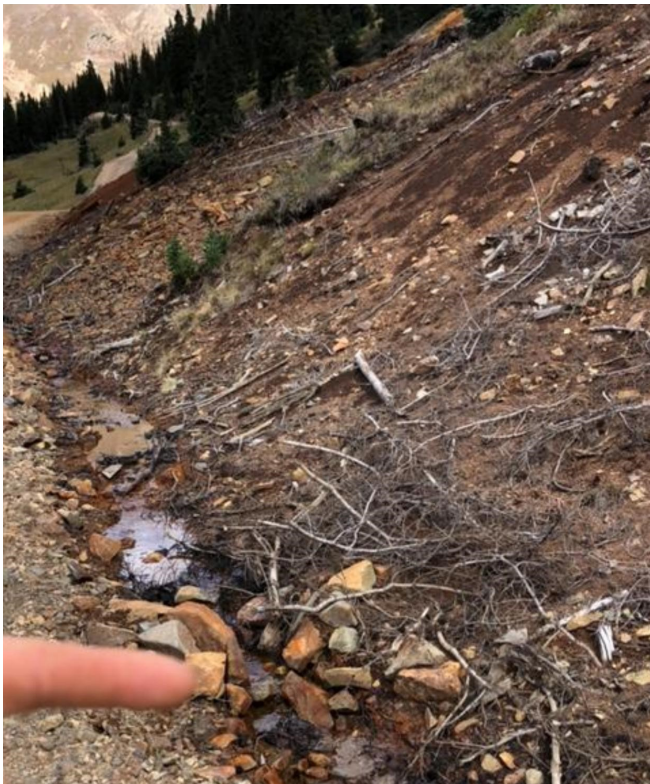
PHOTO 16

Seepage monitoring location SS408 showing increased flow at the base of the Red & Bonita waste pile.

9/14/2020	12:12	SS408	Below R&B Mine	6.7	3070	2.53	0.0003	0.1	Measured additional flow below confluence of SS407 and SS408 to capture additional seepage. 2.4 liters in 20 seconds 5% leakage (7.56 lpm). No sample collected.
9/14/2020	10:36	SS409	East side of CR53	NA	NA	NA	NA	NA	Not enough water to quantify.
9/14/2020	11:31	SS410	West Side of Cement Creek	8.7	1265	3.46	0.0037	1.6	No noticeable change since the last visit. No sample collected.

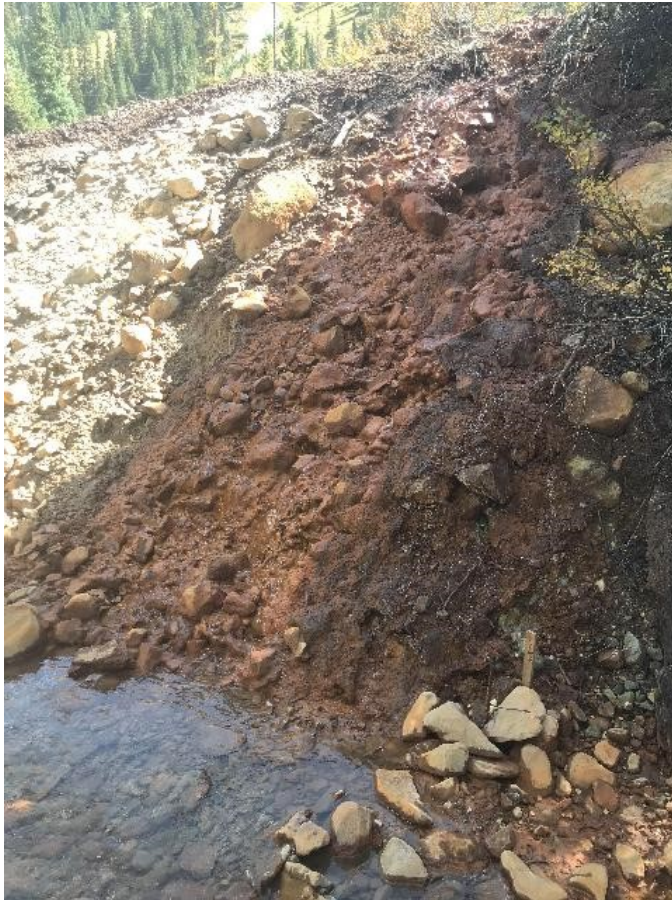
PHOTO 17

Minor outflow at SS416. Note this is not necessarily a change in condition or new flow, but an effort to document flows from the wetland area that may not have been discernible when R&B discharge was flowing through these channels.

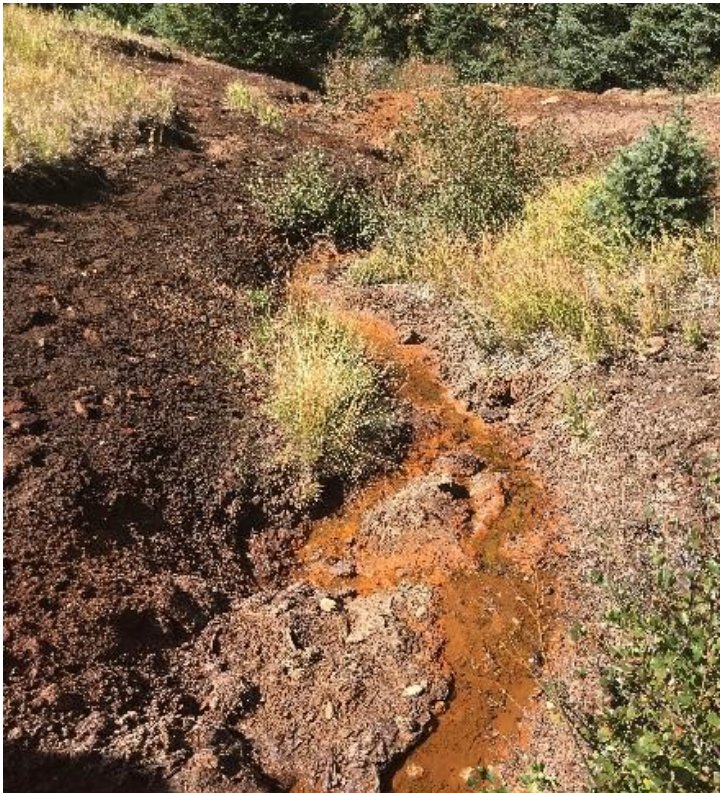
PHOTO 18

Outflow at SS417 location. Note this is not necessarily a change in condition or new flow, but an effort to document flows from the wetland area that may not have been discernible when R&B discharge was flowing through these channels.

9/14/2020	11:50	SS417	R&B Outflow Channel	NA	NA	NA	NA	NA	Dry. No noticeable change since the last visit. No sample collected.
9/14/2020	13:10	SS418	North tongue of North Fork	14.1	1755	2.50	0.0001	0.0	Seep on old road cut, now pipeline. Oily sheen on water surface. No sample collected.
9/14/2020	14:10	SS419	Culvert between SS055 and SS413	6.5	971	3.94	0.0059	2.6	No noticeable change since the last visit. No sample collected.

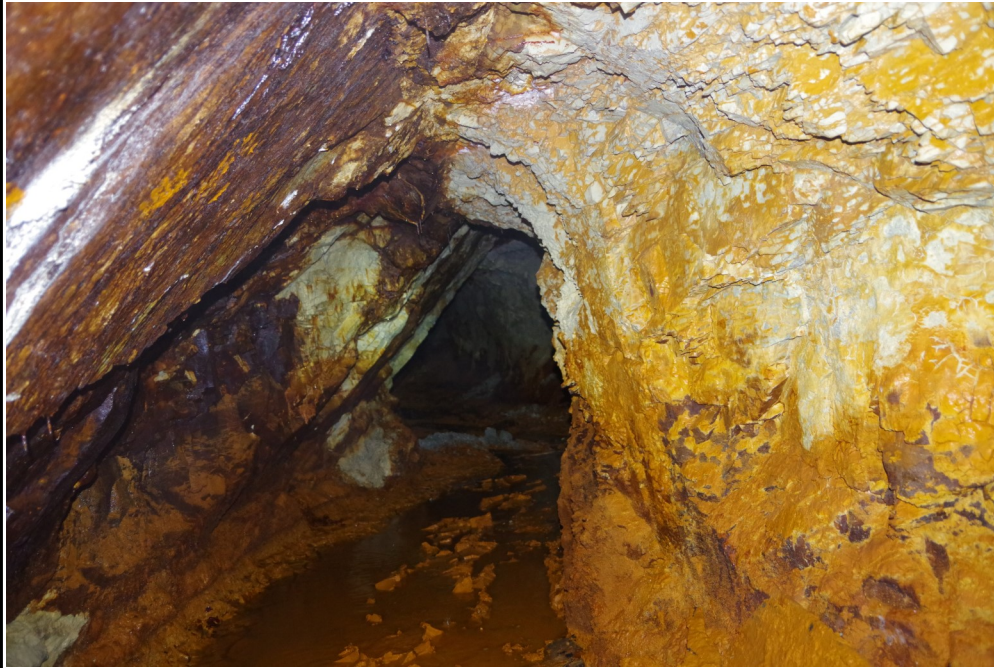
PHOTO 21

- Walked length of side drift
 - Follows small vein (wet joint) for 90'
 - Turn after 40' puts drift roughly parallel to main drift
 - Moisture only along vein/wet joint on left, right rib is dry

Looking in just past flume #1.
Note wet joint on left rib and dry
rib right.

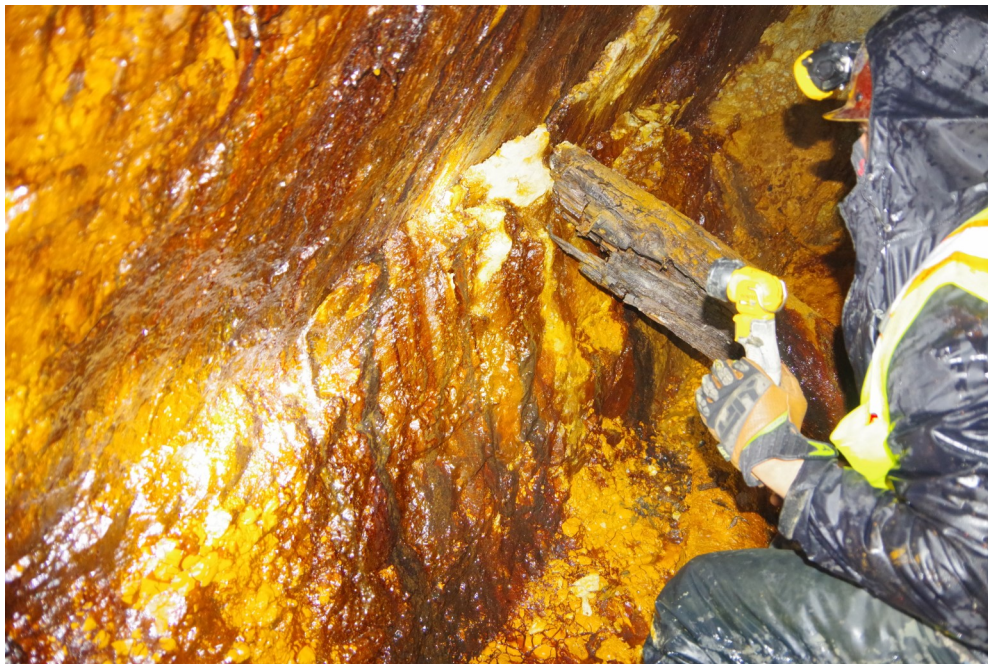
PHOTO 24

- 1 area of noticeable seepage but no major inflow
- Flows through Flume 1 side drift are measuring between 1.4 gpm and 1.7 gpm (Figure 5).
- Flows from Flume 2 in the main adit near station 2+30 stayed relatively stable around 6.8 gpm (Figure 5). This is within the expected range.

Area of seepage along joint in side drift; this is the area closest to the bulkhead

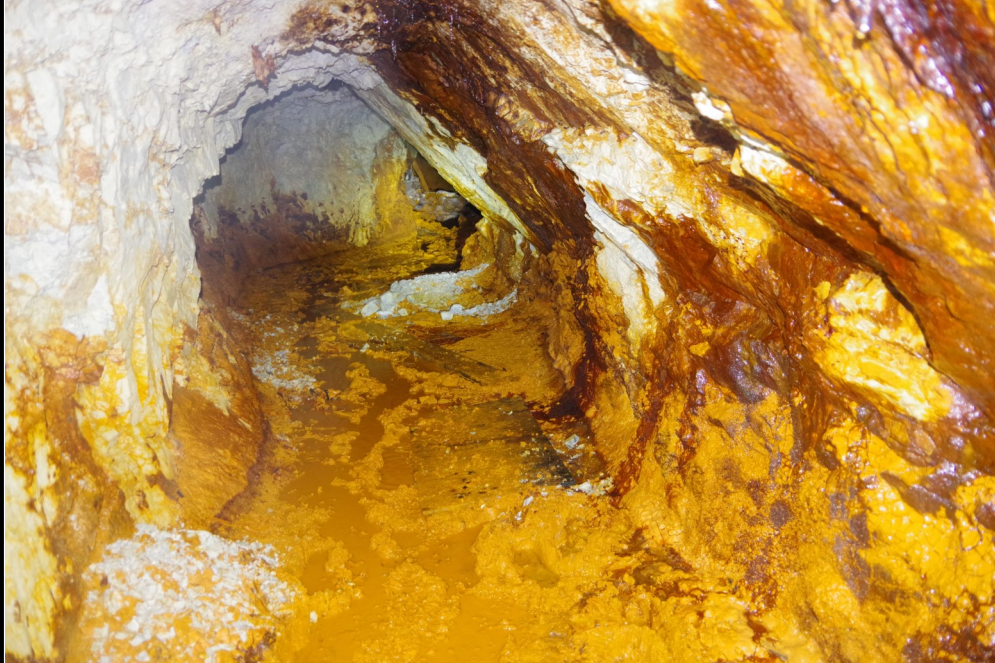
PHOTO 23

Looking back towards main drift; note dry rib
