# WEEKLY REPORT – RED & BONITA BULKHEAD TEST

DATE: October 1- 7, 2020	REPORT NO: 13
TEST PHASE: Phase 4, Drain Down	TO: Kerry Guy, James Hou
PREPARED BY: Christoph Goss, PhD, PE,	FROM: Deere & Ault, Mountain Studies Institute, U.S.
Morley Beckman, PE, and Erinn Johnson	Environmental Protection Agency, Environmental
	Restoration, and Weston Solutions

Environmental Protection Agency Red & Bonita Bulkhead Test – Weekly Report No. 13 October 1-7, 2020

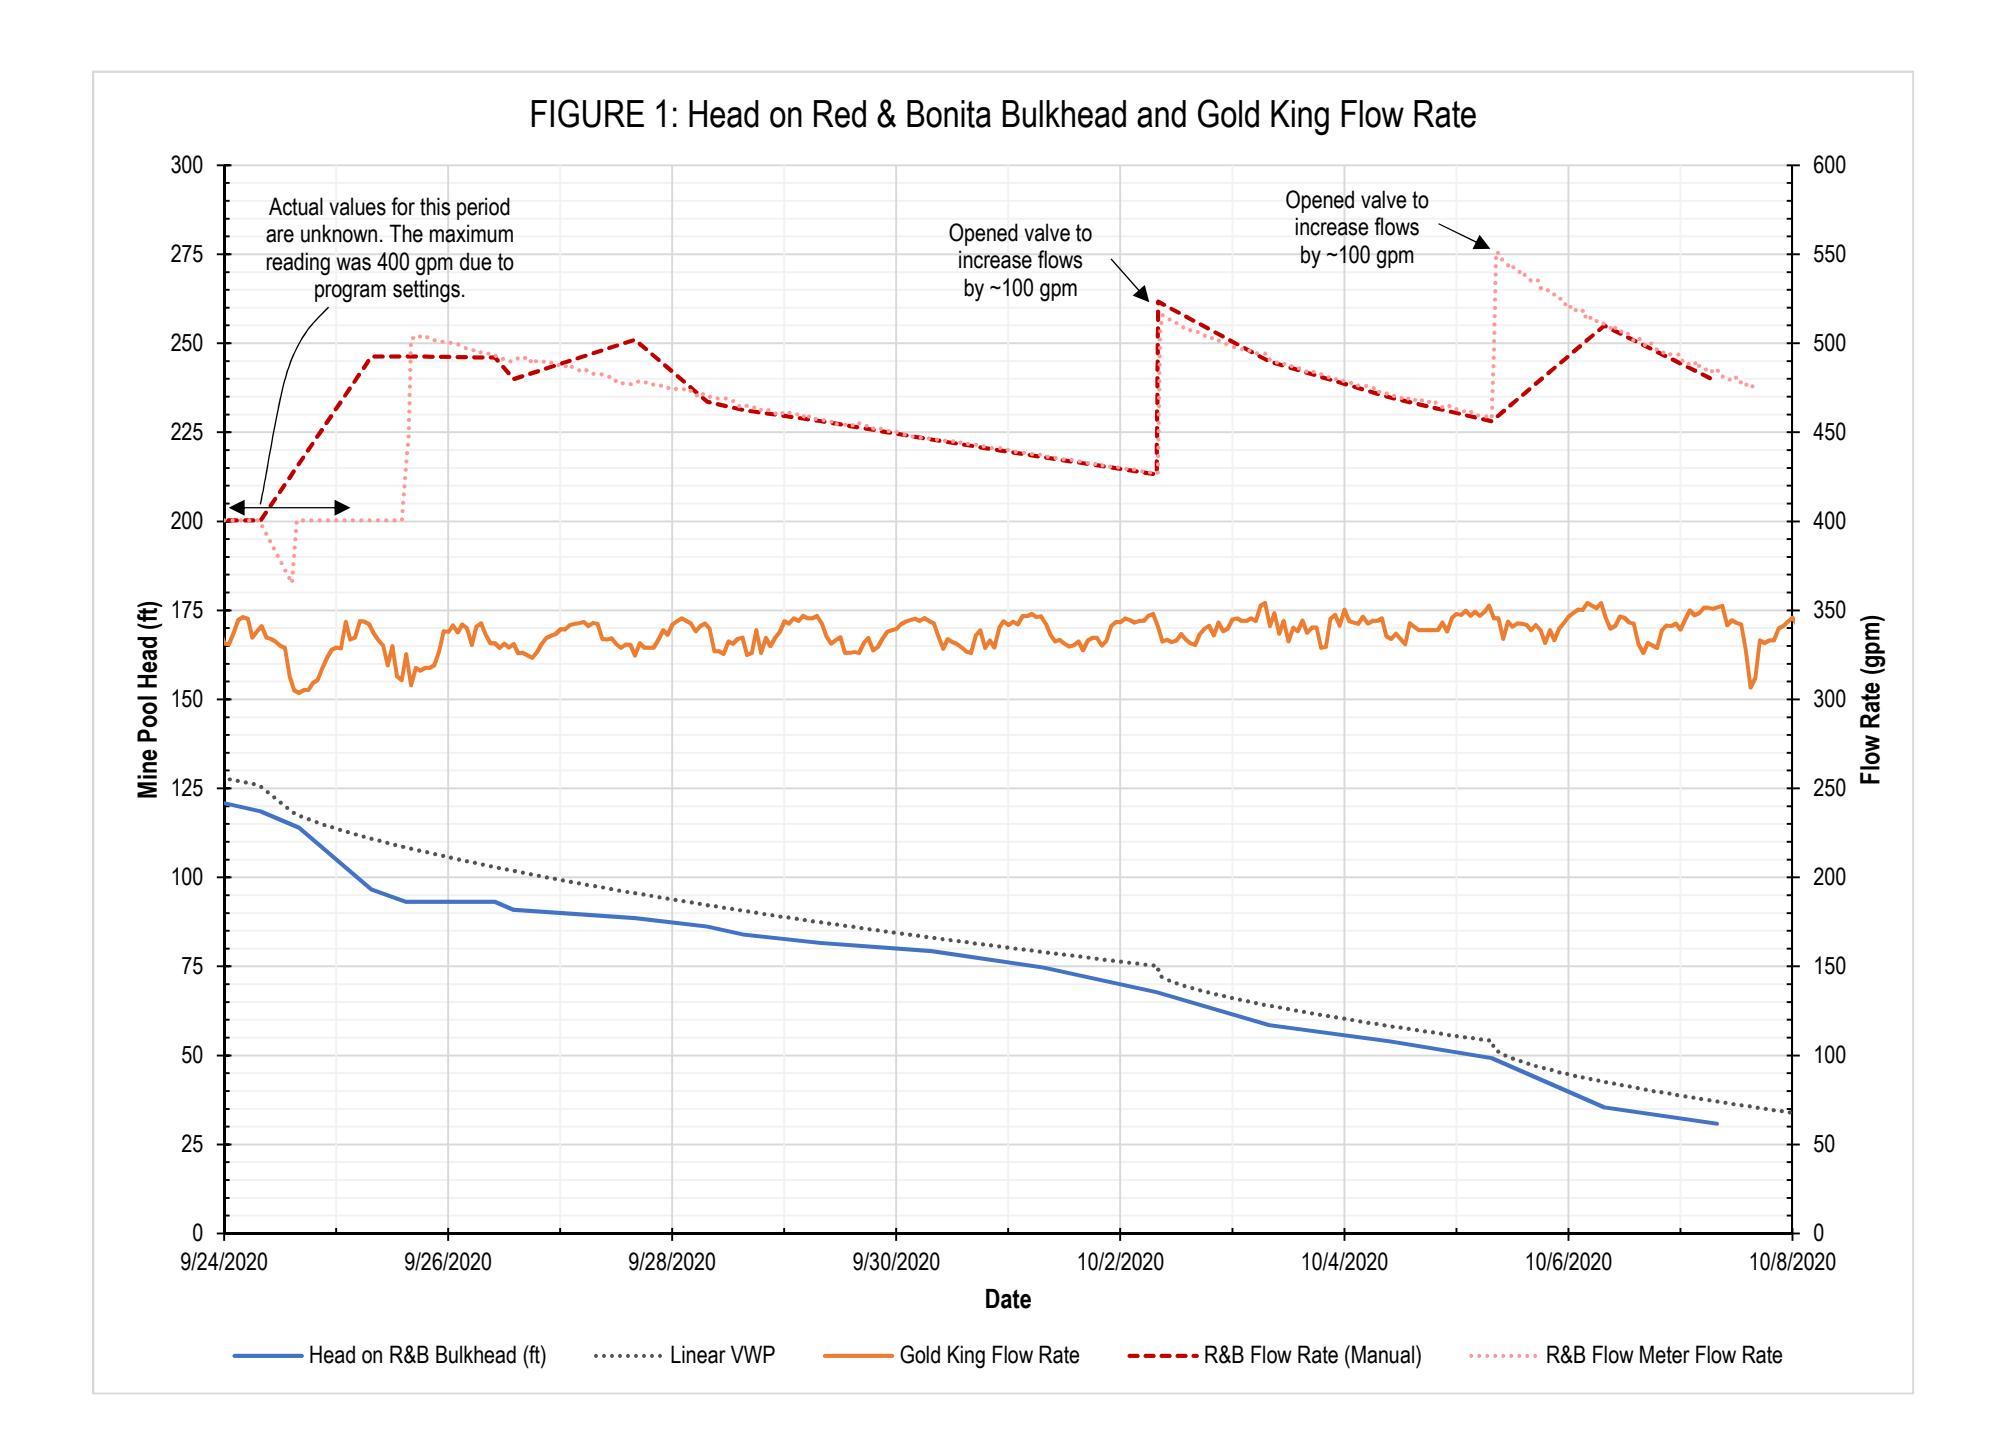
Figure 1: Head Behind Red & Bonita Bulkhead and Gold King Flows vs. Time (Current Testing Period)

- Flows from R&B were increased by 100 gpm on 10/2/20 and again on 10/5/20 by opening the globe valve further. As the mine pool dropped, the flows decreased. (See Figure 1).

- The discharge out of Red & Bonita varied from 426-523 gpm this week (Figures 1 and 2). The discharge, as recorded manually by ER and automatically every 30 minutes by the data logger attached to the ultrasonic flow meter, has been added to the figures. The readings generally correlate well.

- The head behind the bulkhead dropped this week from 80 feet to 31 feet. Aside from small bumps each time the globe valve was opened further, the drop has been relatively steady at approximately 5 feet per day. Based on this, we estimate reaching the elevation of the stopes in the mine (22') on October 9 or 10. On or about October 12 is when the mine pool should reach approximately 10'. At that point flows should be decreased to limit the water velocity and the amount of sludge/debris that it carries. If the particulate content and water quality are compatible with the plant, the flows can remain higher.

- Flow rates at Gold King continue with daily fluctuation cycles between approximately 305 to 350 gpm (Figures 1 and 2). Average daily flow rates continue to be less volatile than prior to 9/9/20 and are generally fluctuating less than 50 gpm daily. The flow rates generally correspond with flow rates measured at the treatment plant.

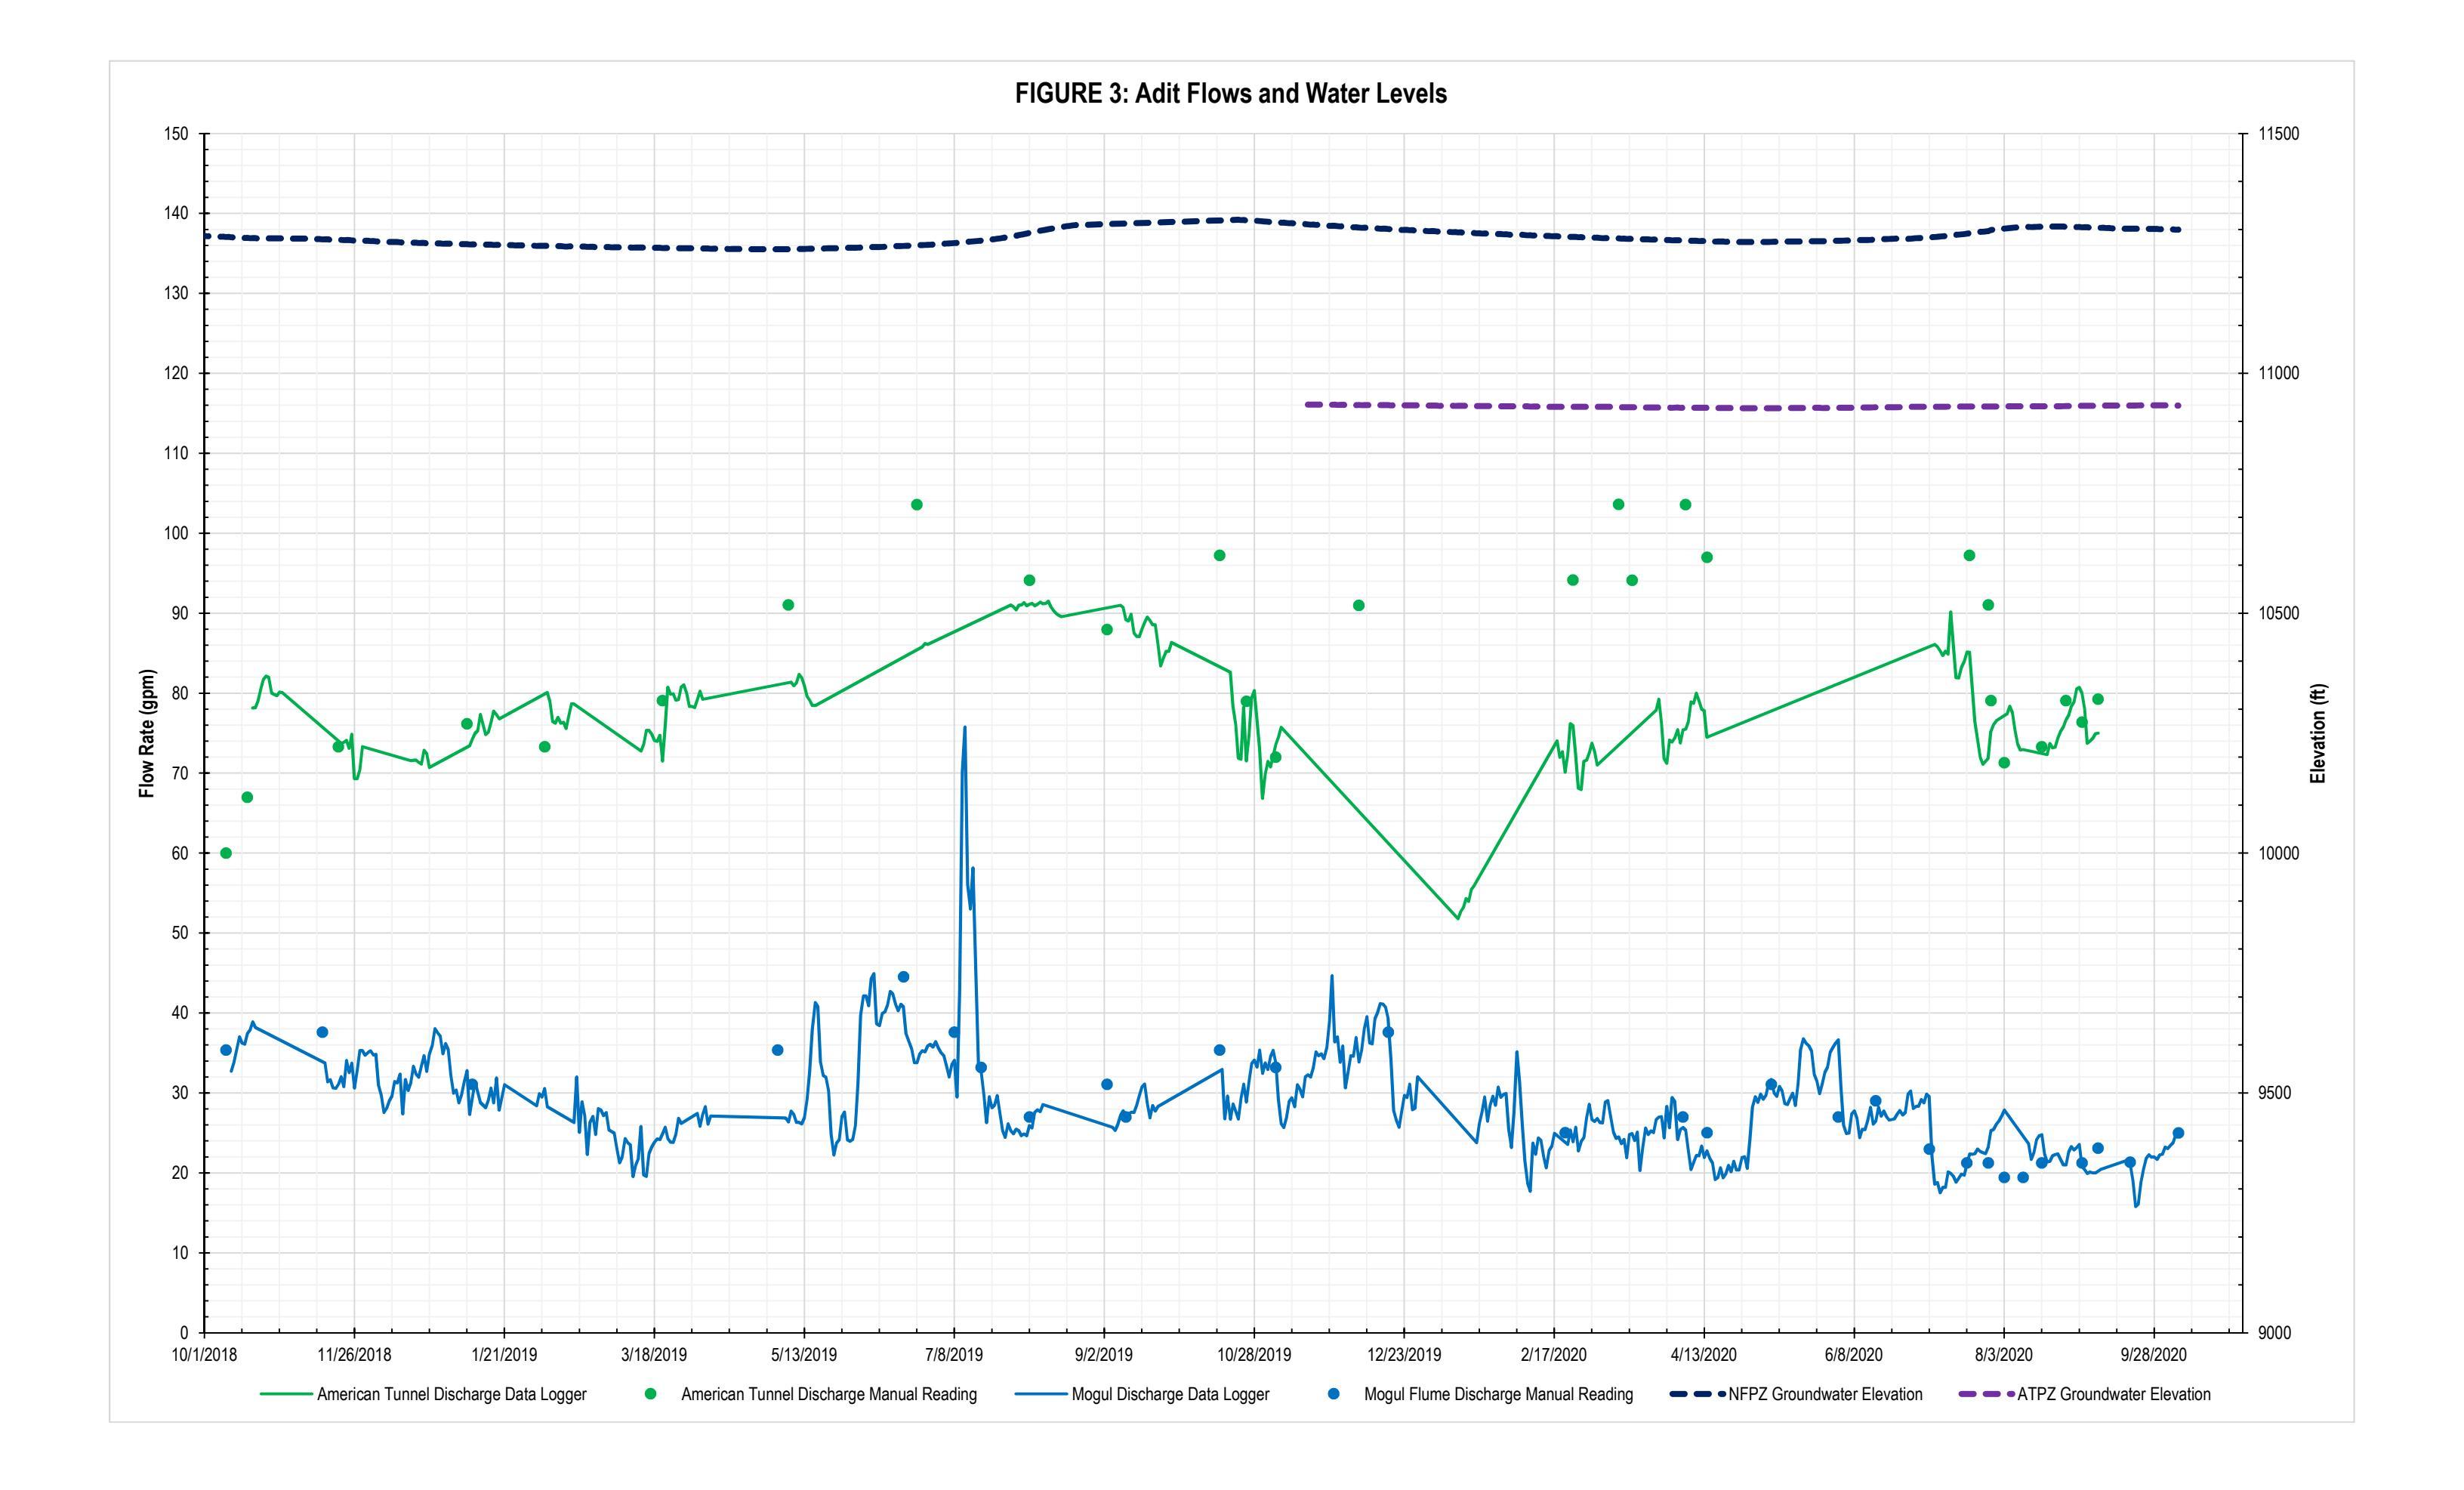
Figure 3: Adit Flows and Piezometers vs. Time

- The data from American Tunnel will not be updated this week due to a problem with the data connection pin. Figure 3 is shows the existing data for reference.

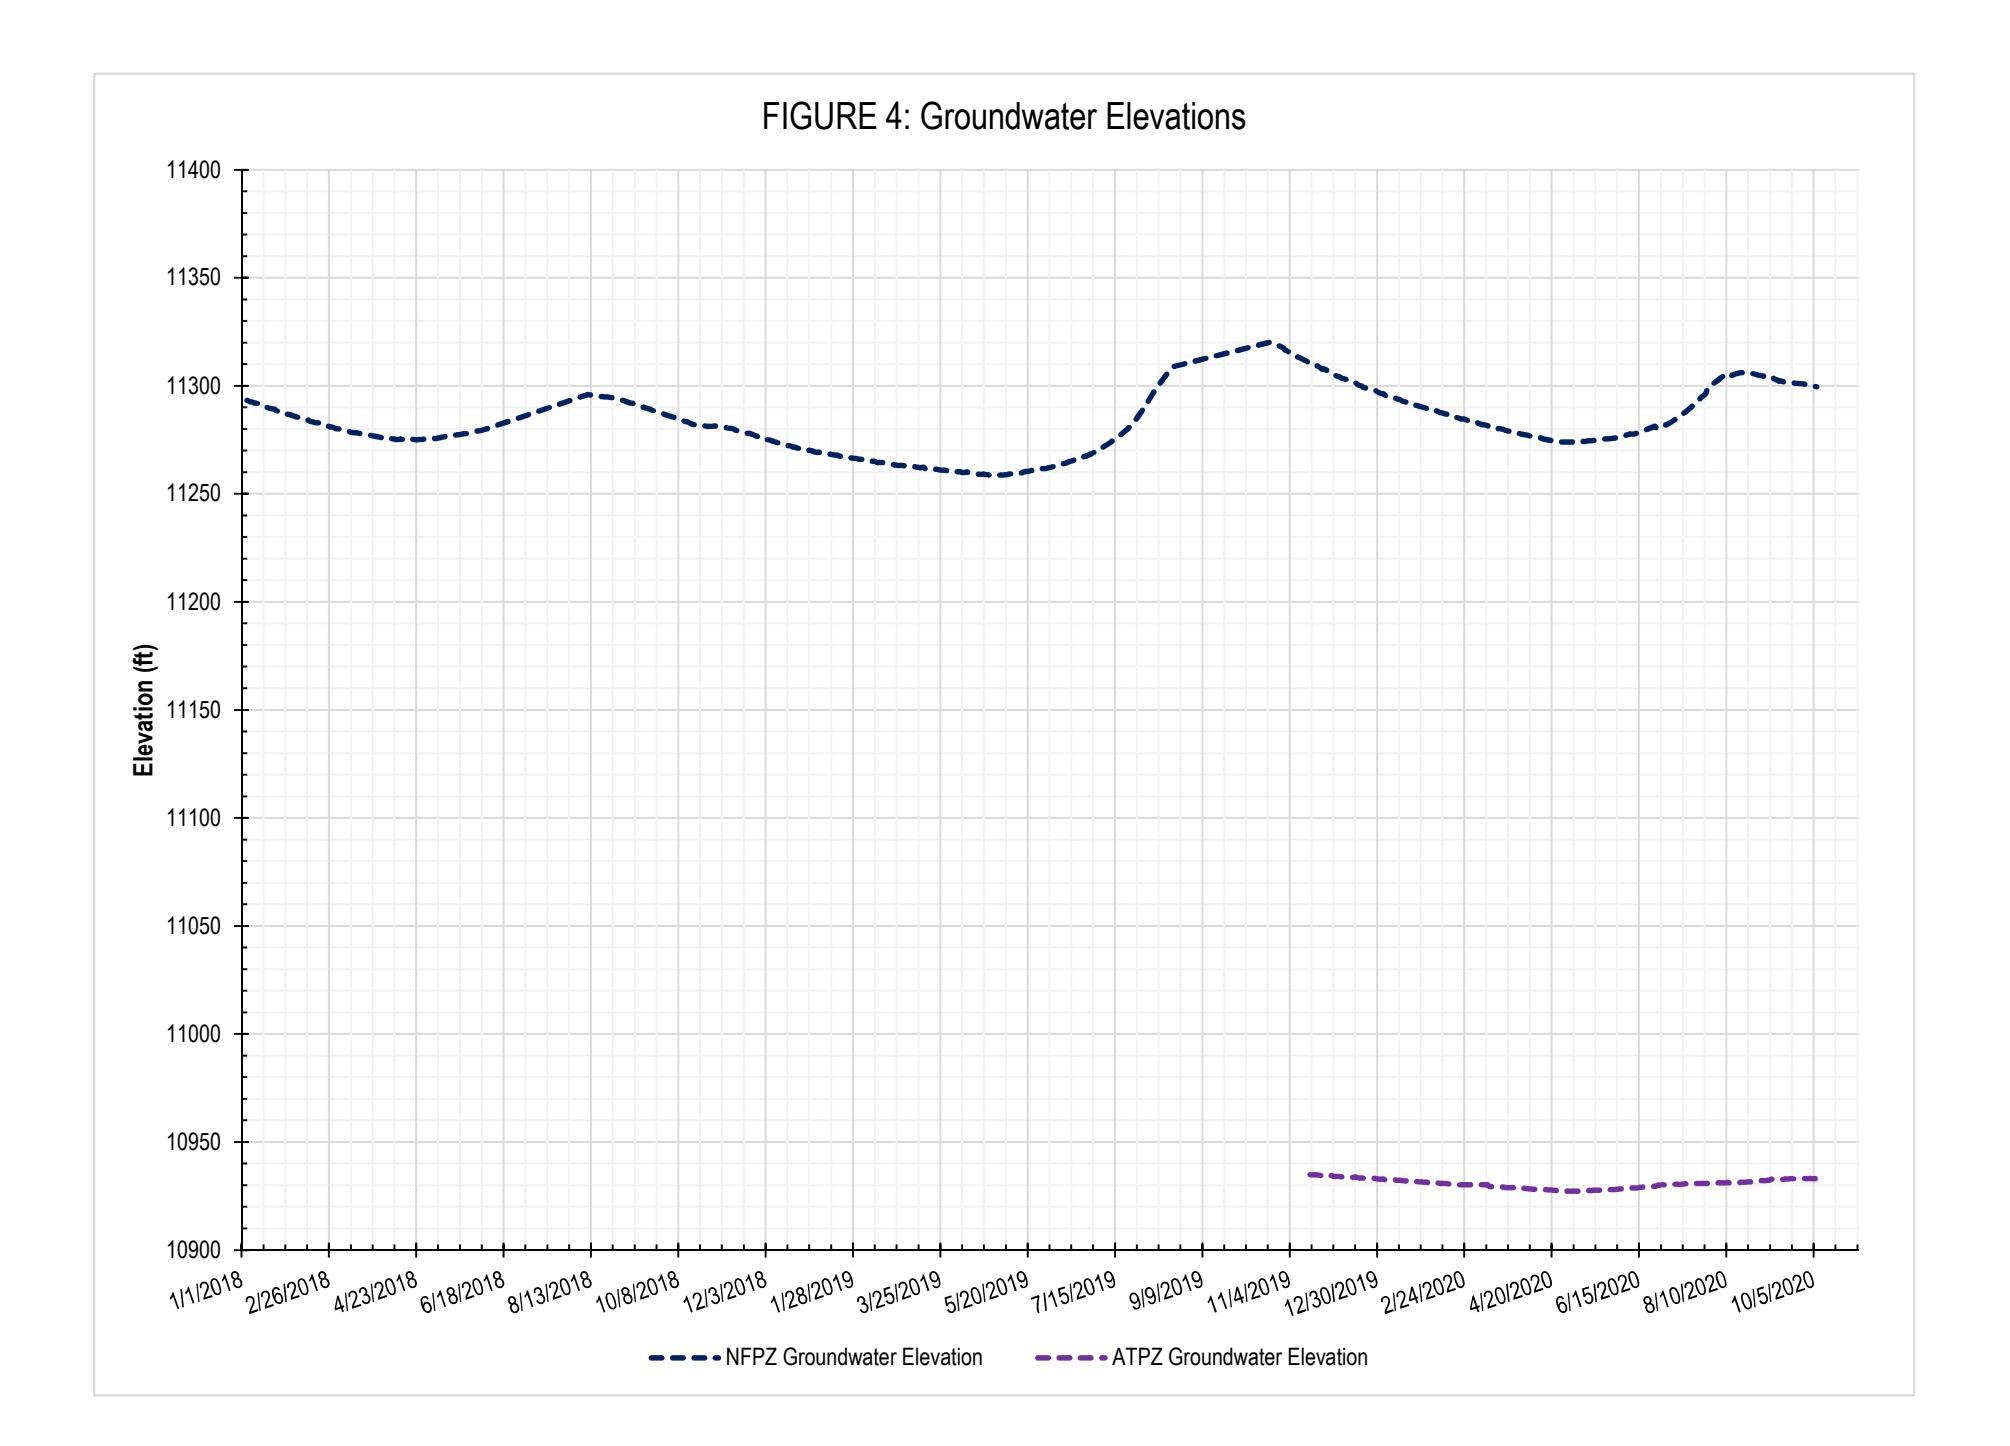
Figure 4: NFPZ-1 and ATPZ-2 vs. Time

- Water levels in NFPZ-1 following typical seasonal cycle (Figure 4). Level in NFPZ-1 peaked in mid-August and is
  dropping as part of the typical cycle. The somewhat flatter curve coming down suggests a possible influence from
  either the Red & Bonita bulkhead test or possibly from senescence. Senescence is when there is cell death in
  plants, usually associated with the change in color of the leaves, which causes plants to no longer take up water
  thereby leaving more water in the ground.

- ATPZ-2 (water level behind American Tunnel Bulkhead 3) remained fairly steady (Figure 4).
- In Red & Bonita, flows through Flume 1, Flume 2 and Flume 3 have significantly decreased since reopening the globe valve and lowering the mine pool elevation behind the bulkhead. Flume 1 has continued to decrease to about 0.05 gpm. Flume 2 decreased to about 0.7 gpm. Flume 3 has decreased to about 0.11 gpm (Figure 5). The relationship between the flume flows (groundwater inflow into the adit) is direct and with little lag.

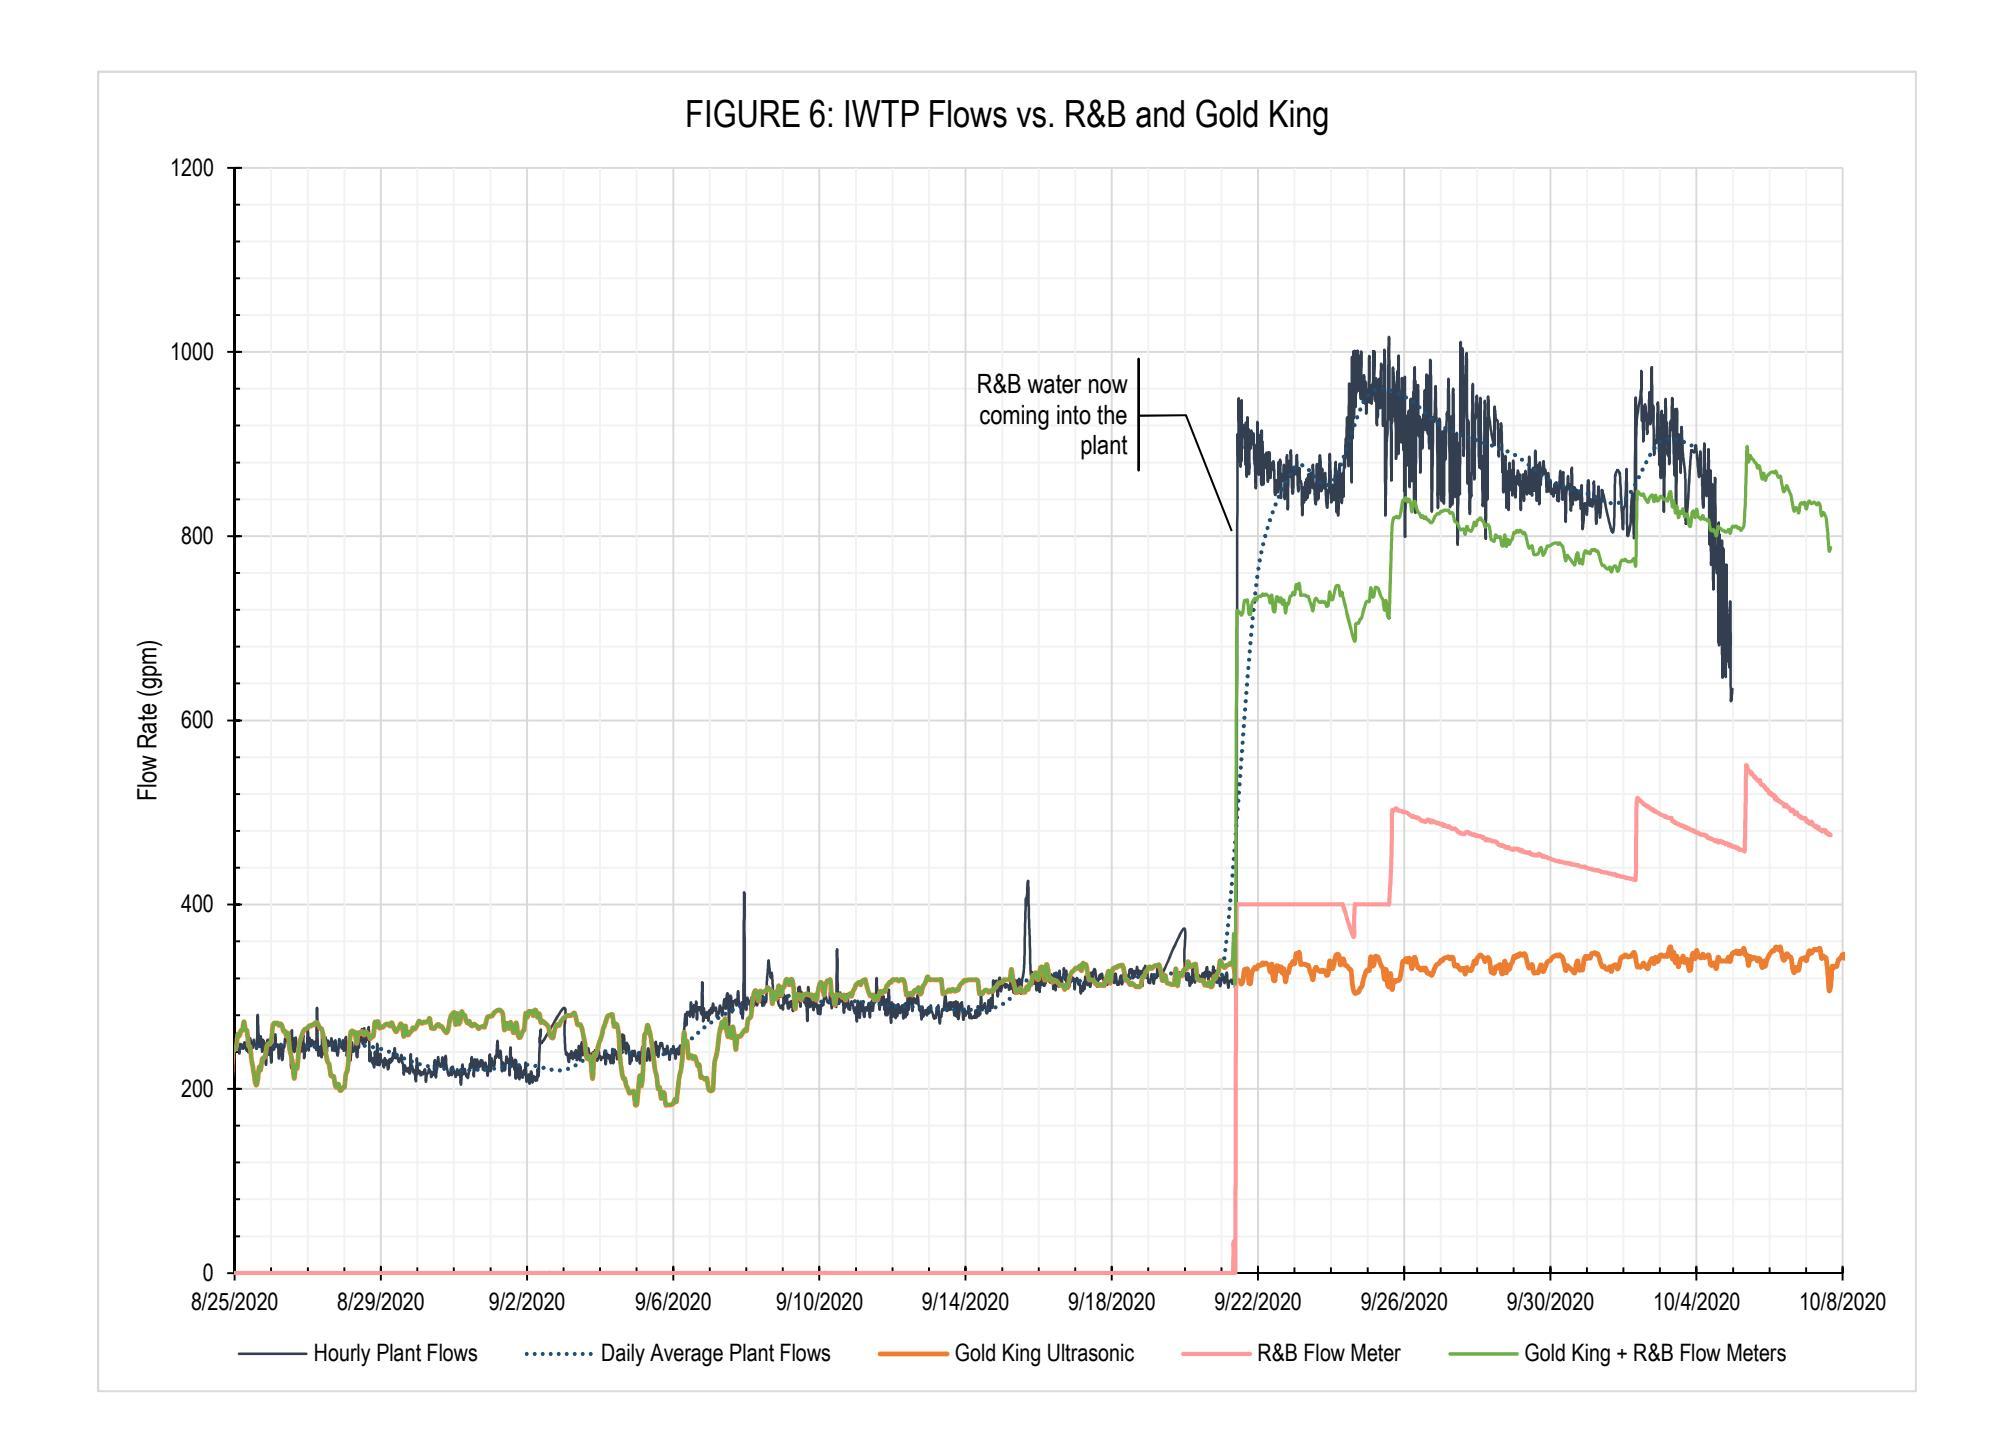
Figure 6: IWTP Flows vs R&B and Gold King Flows

- IWTP flows have been plotted against the Gold King and R&B flows in Figure 6. This figure shows the relationship between the flows measured at the plant and the flows measured at Red & Bonita and Gold King. The flows should be identical. Prior to treating R&B water, the measured flow rates at Gold King and the plant were very close. Once the R&B water was added, the difference in readings increased to 80-120 gpm.

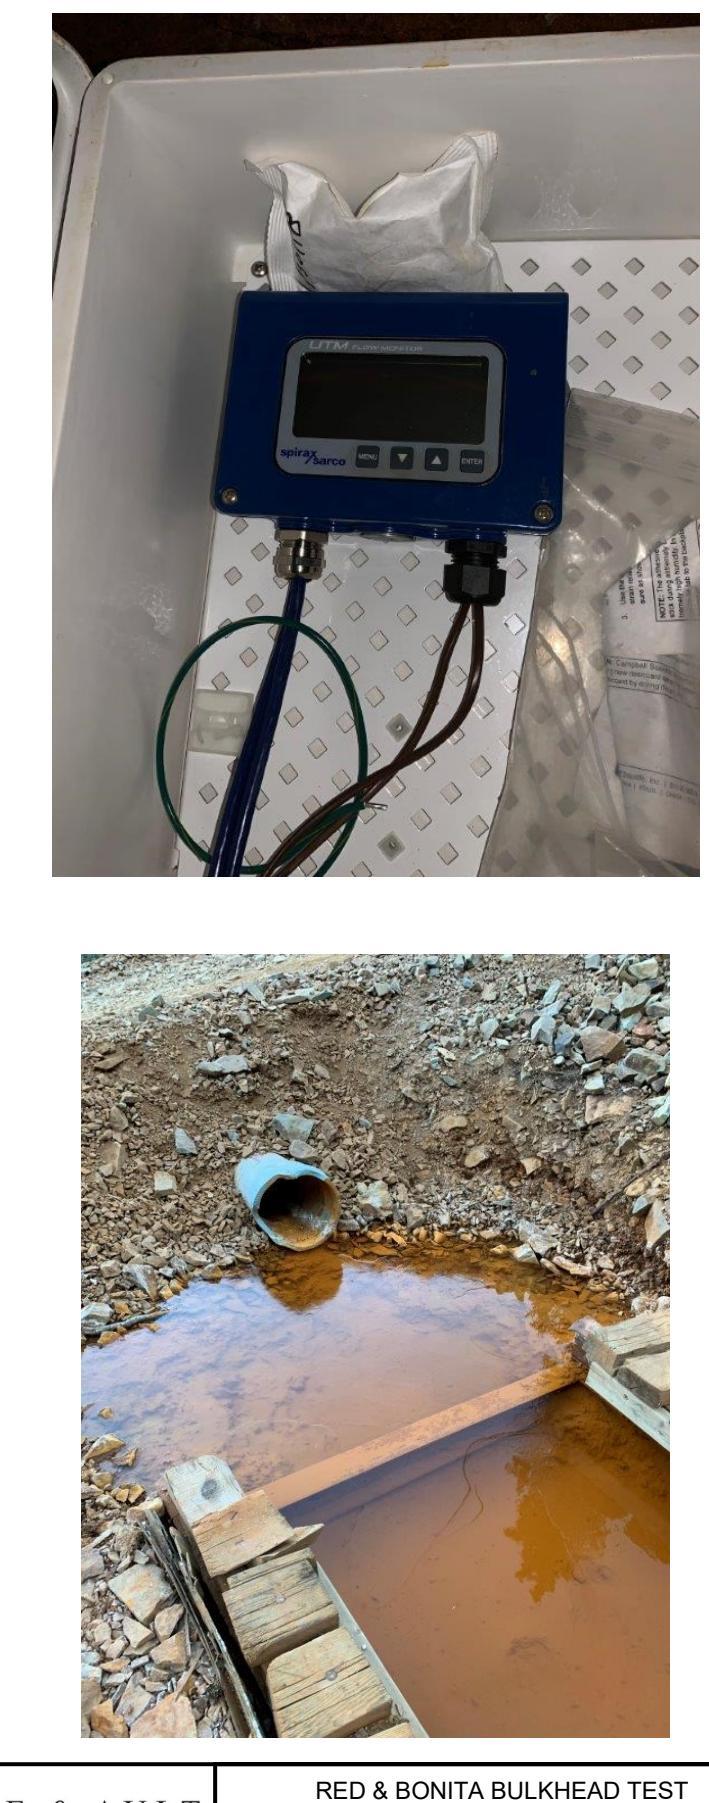
#### PHOTO 1

Flow meter in casing. Reading was about 510 gpm.

Portal sump pond below overflow pipe

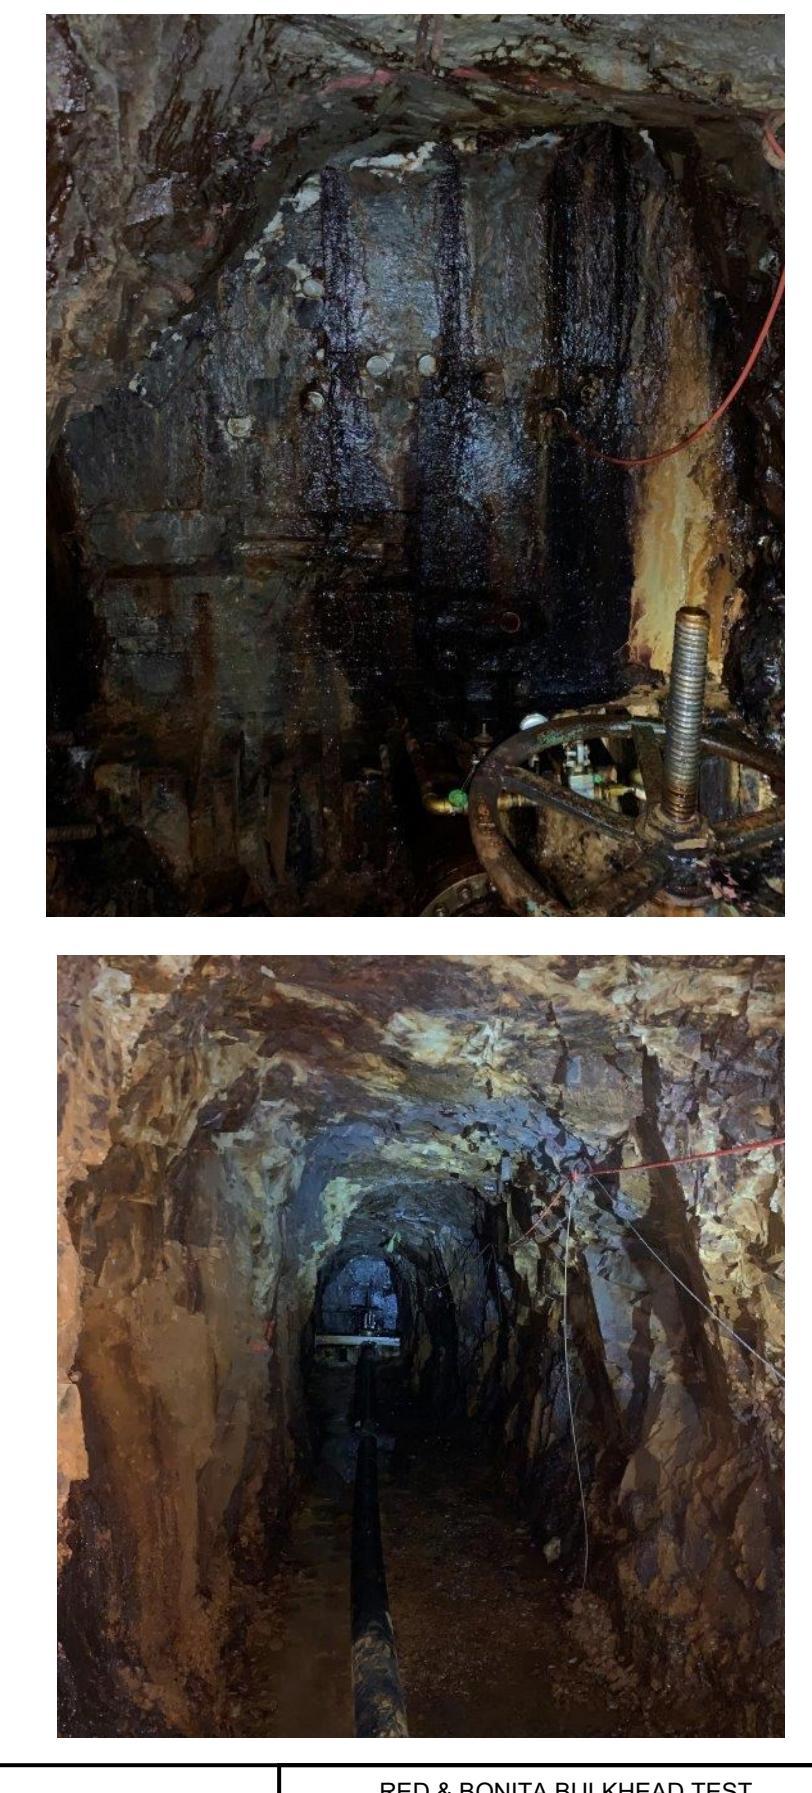
### PHOTO 3

Less seepage around the bulkhead. Note light precipitate on right vs darker precipitate on left and center.

Less wet and dripping since opening the valve.

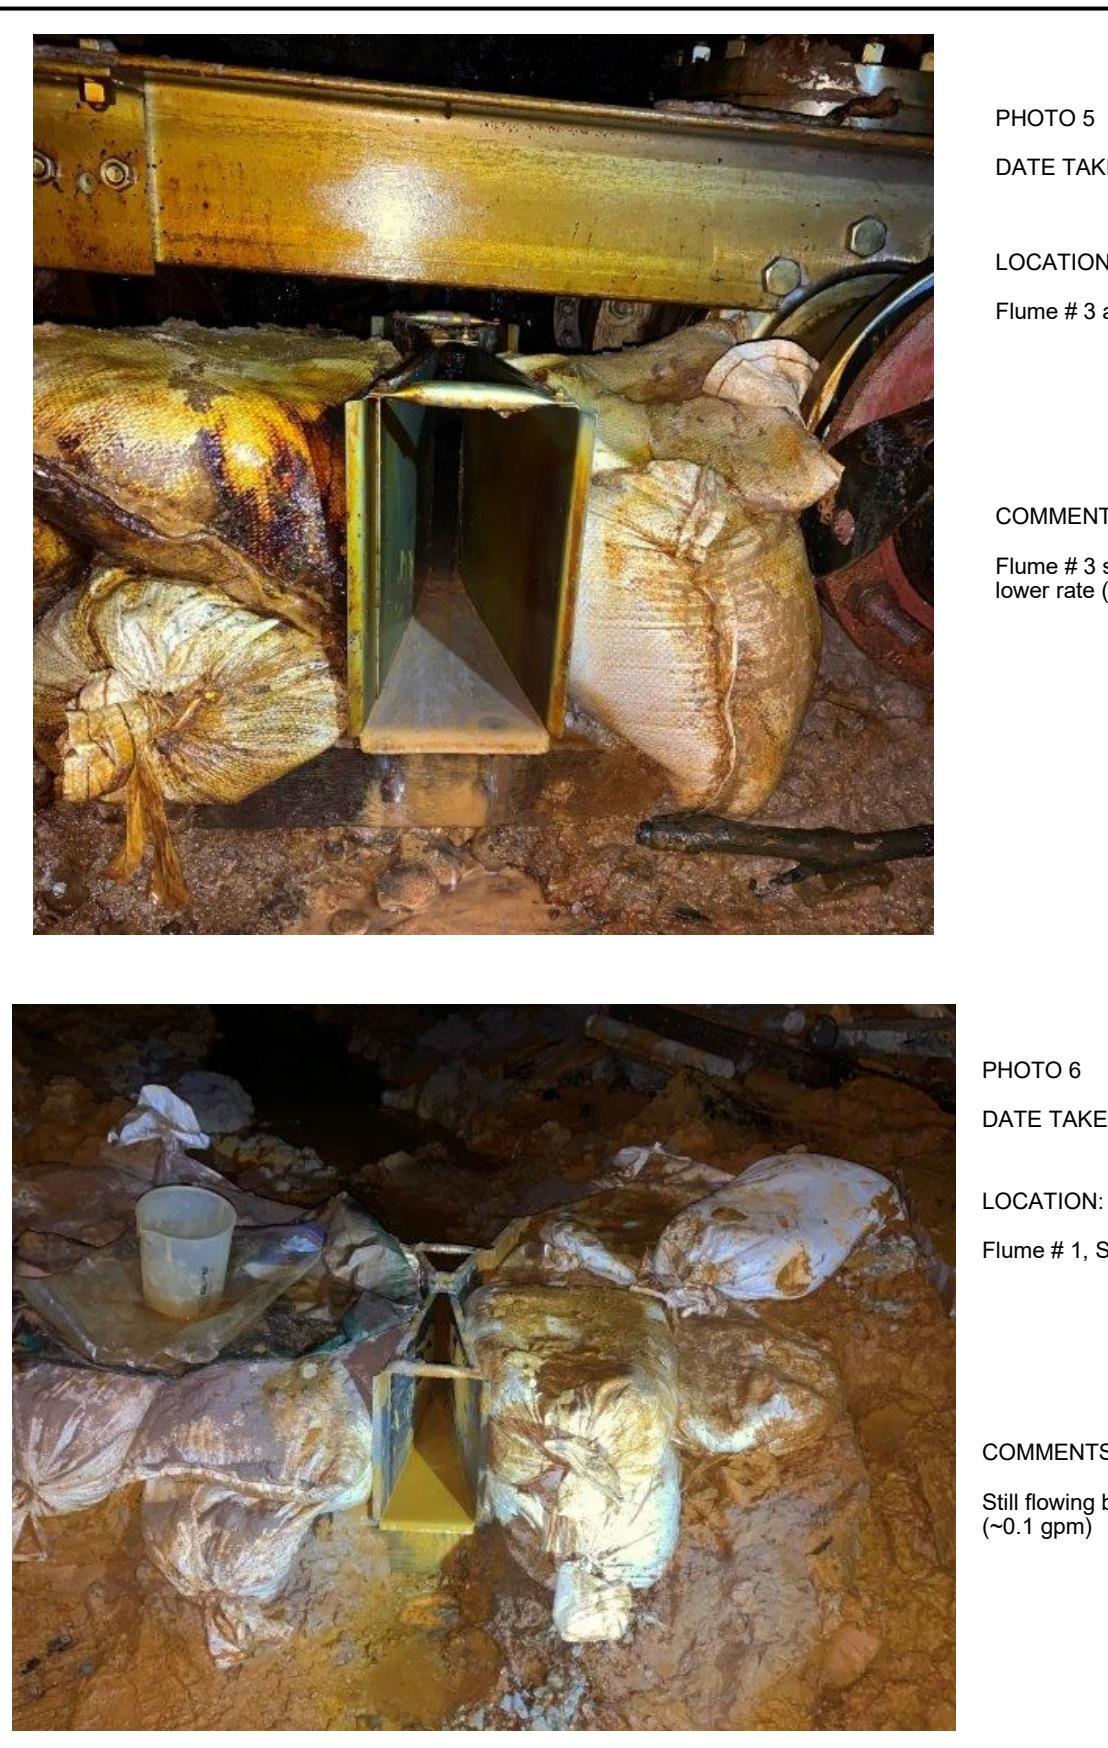
PHOTO 5

Flume # 3 still draining, but at a lower rate (~0.1 gpm).

Still flowing but at a lower rate, (~0.1 gpm)
