WEEKLY REPORT – RED & BONITA BULKHEAD TEST

DATE: September 17-23, 2020

REPORT NO: 11

TEST PHASE: Phase 3, Filling to 200 ft Head
and Phase 4, Drain Down

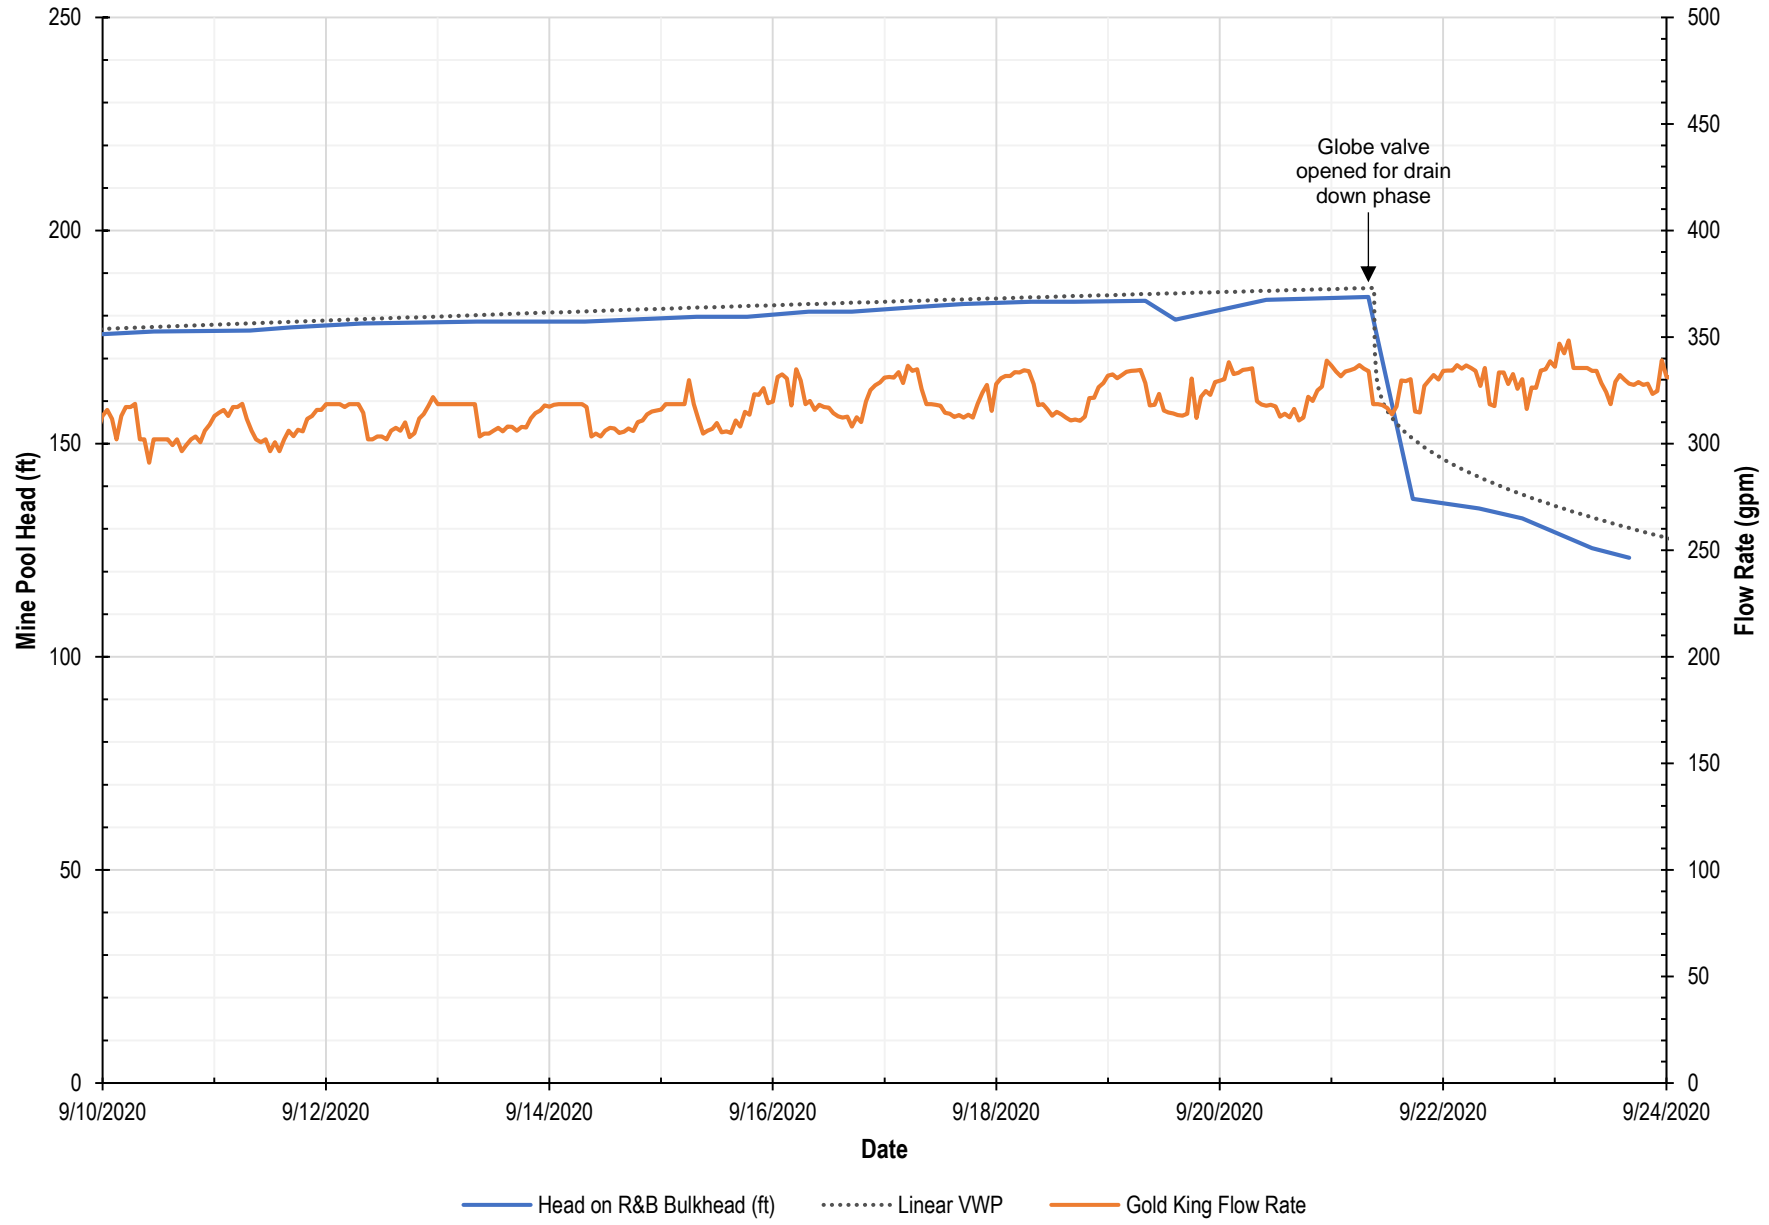
FIGURE 1: Head on Red & Bonita Bulkhead and Gold King Flow Rate

- Flow rates at Gold King continue with daily fluctuation cycles between approximately 305 to 350 gpm (Figure 1). Average daily flow rates continue to be less volatile than prior to 9/9/20, and are generally increasing almost 340 gpm daily. The flow rates generally correspond with flow rates measured at the treatment plant.

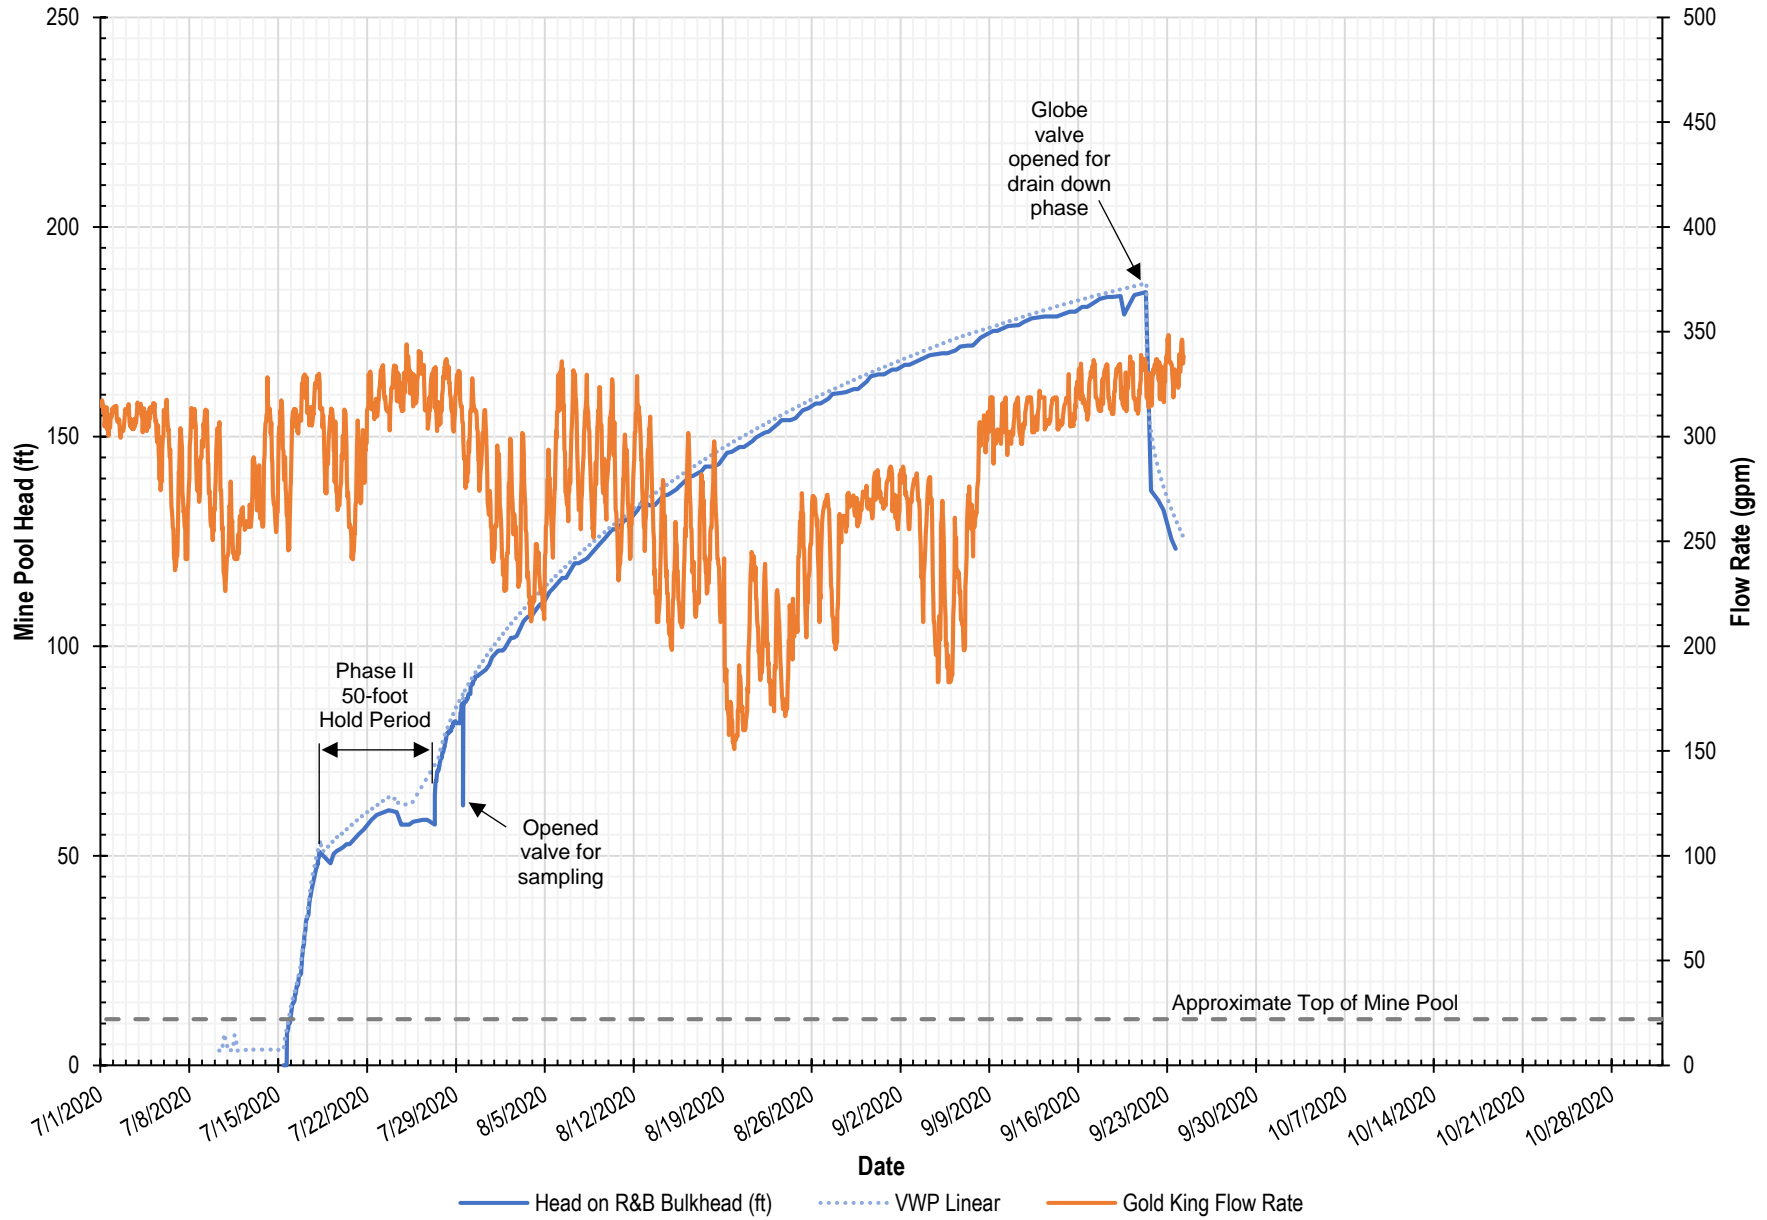
FIGURE 2: Head on Red & Bonita Bulkhead and Gold King Flow Rate - Full Time Period

Figure 2: Gold King Flow and Red & Bonita Head vs. Time (Full Testing Period)

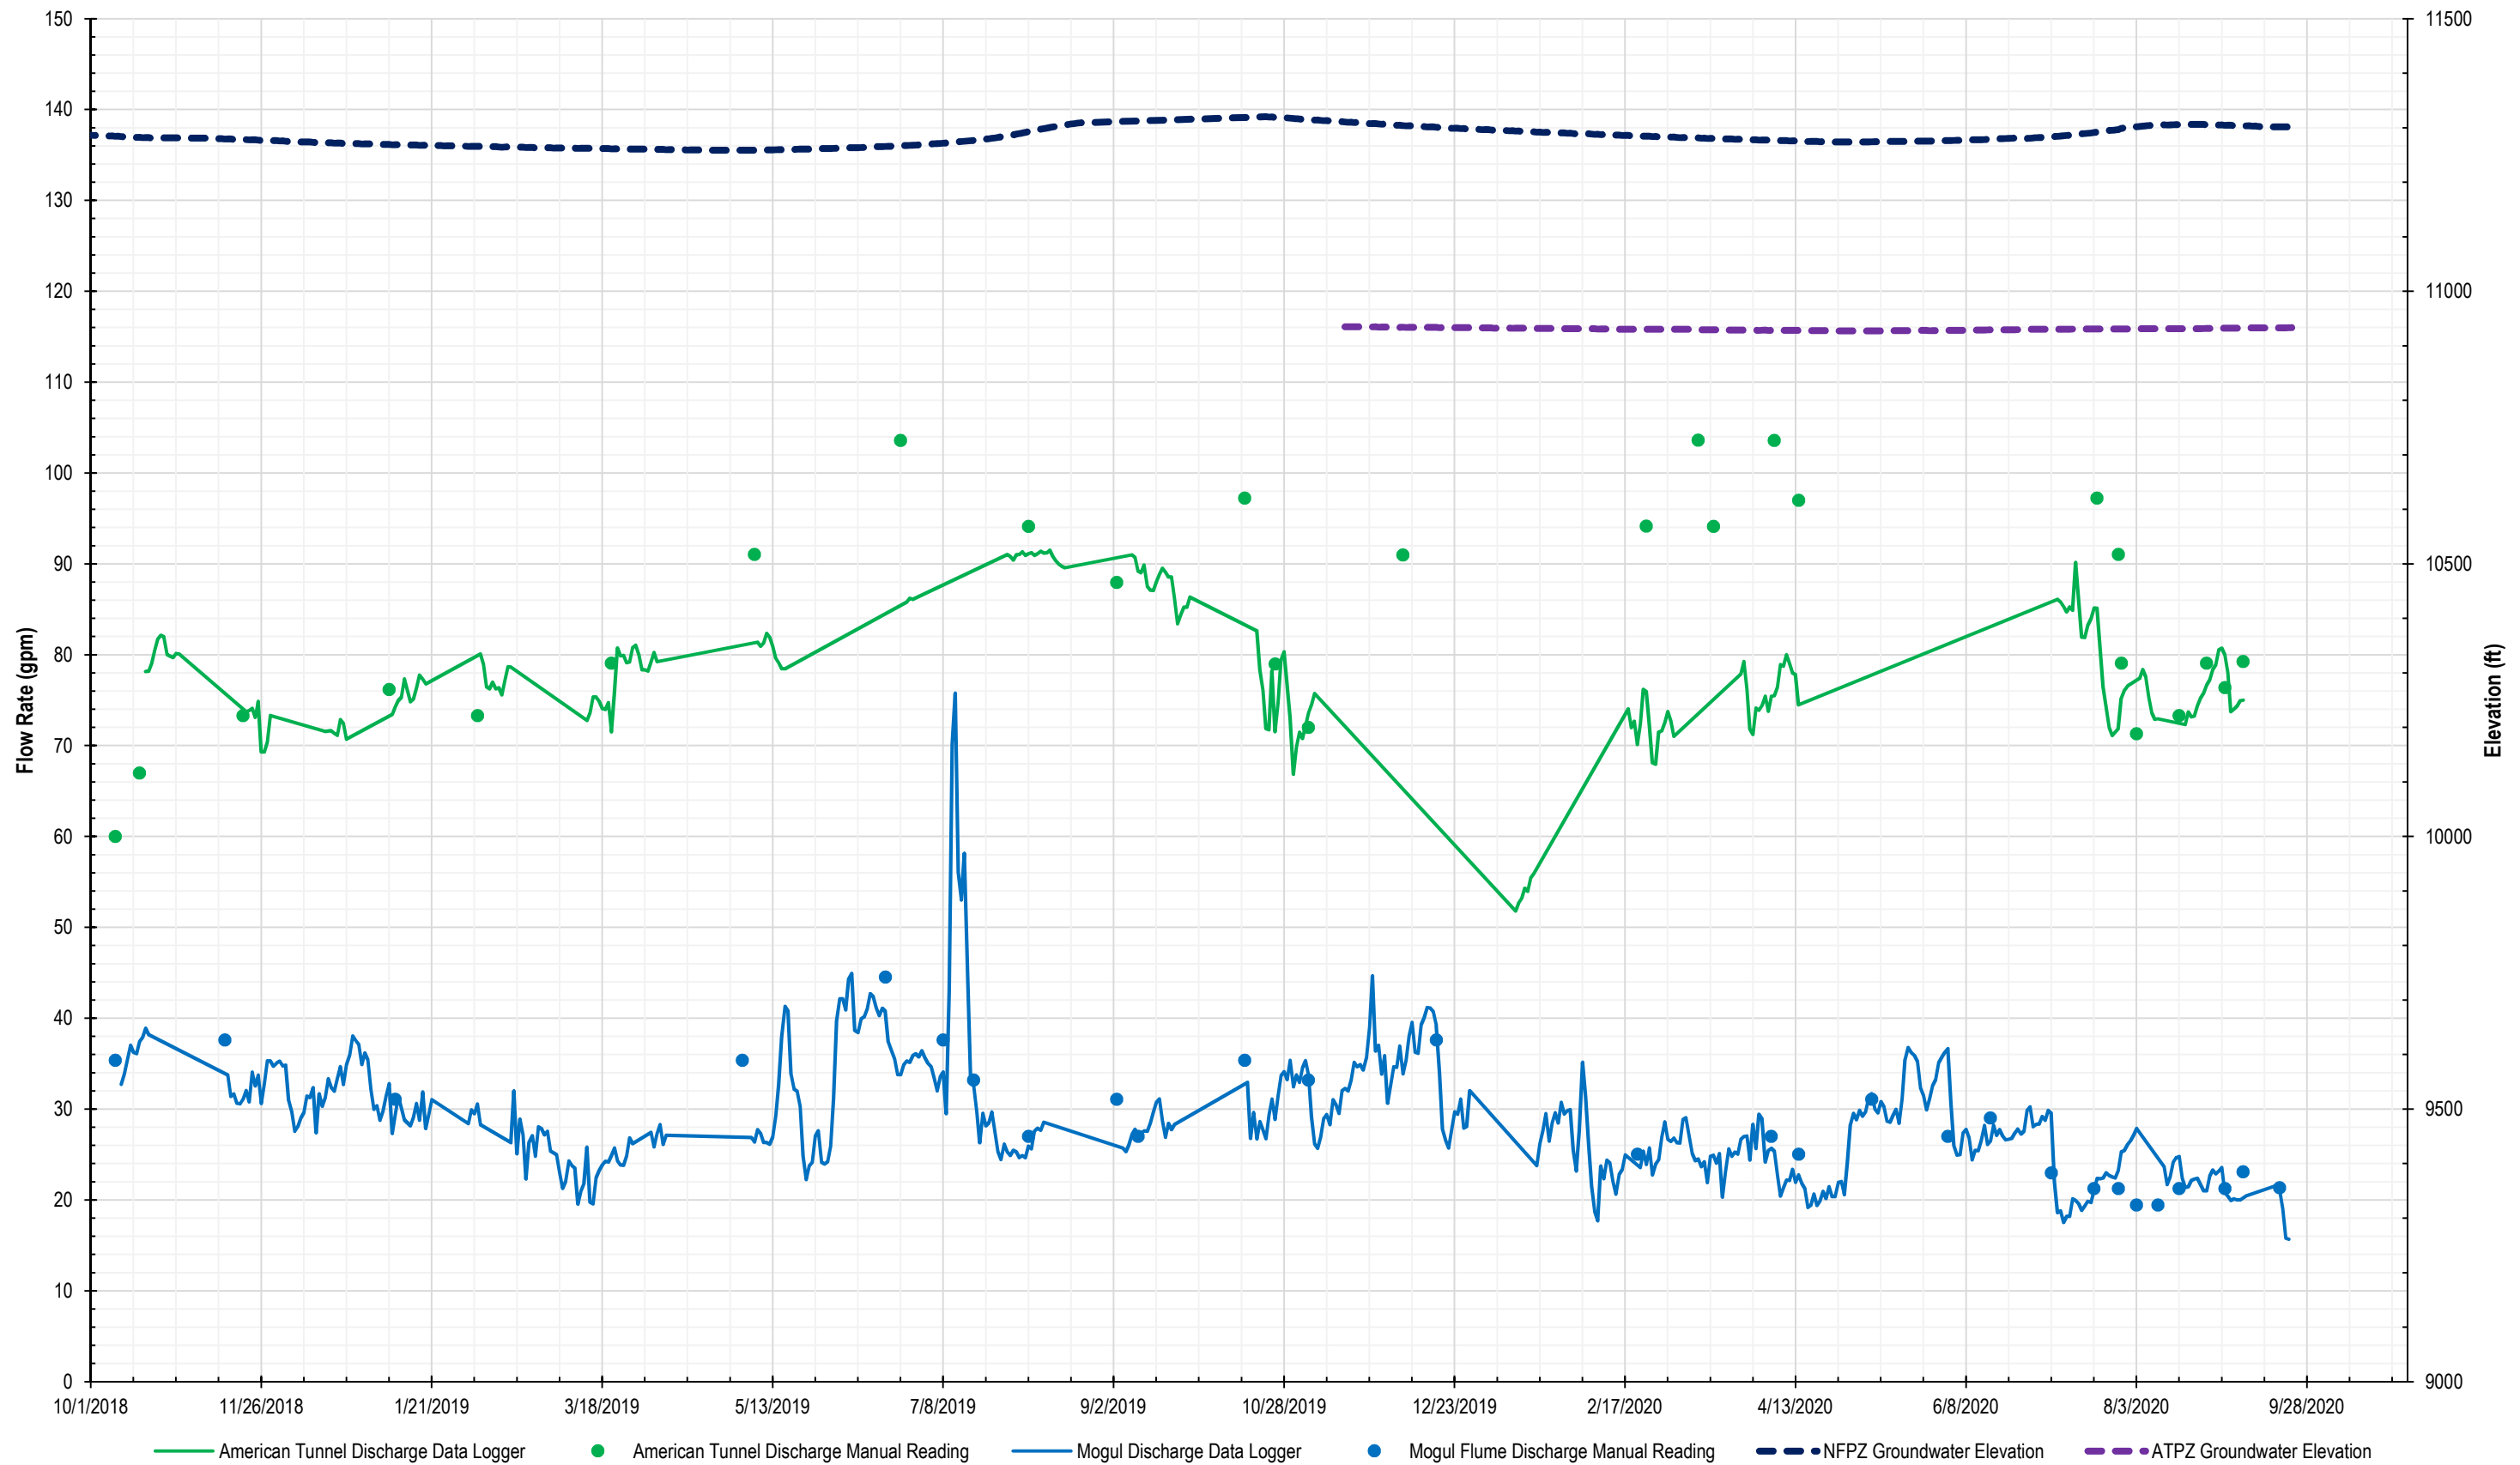
FIGURE 3: Adit Flows and Water Levels

Figure 3: Adit Flows and Piezometers vs. Time

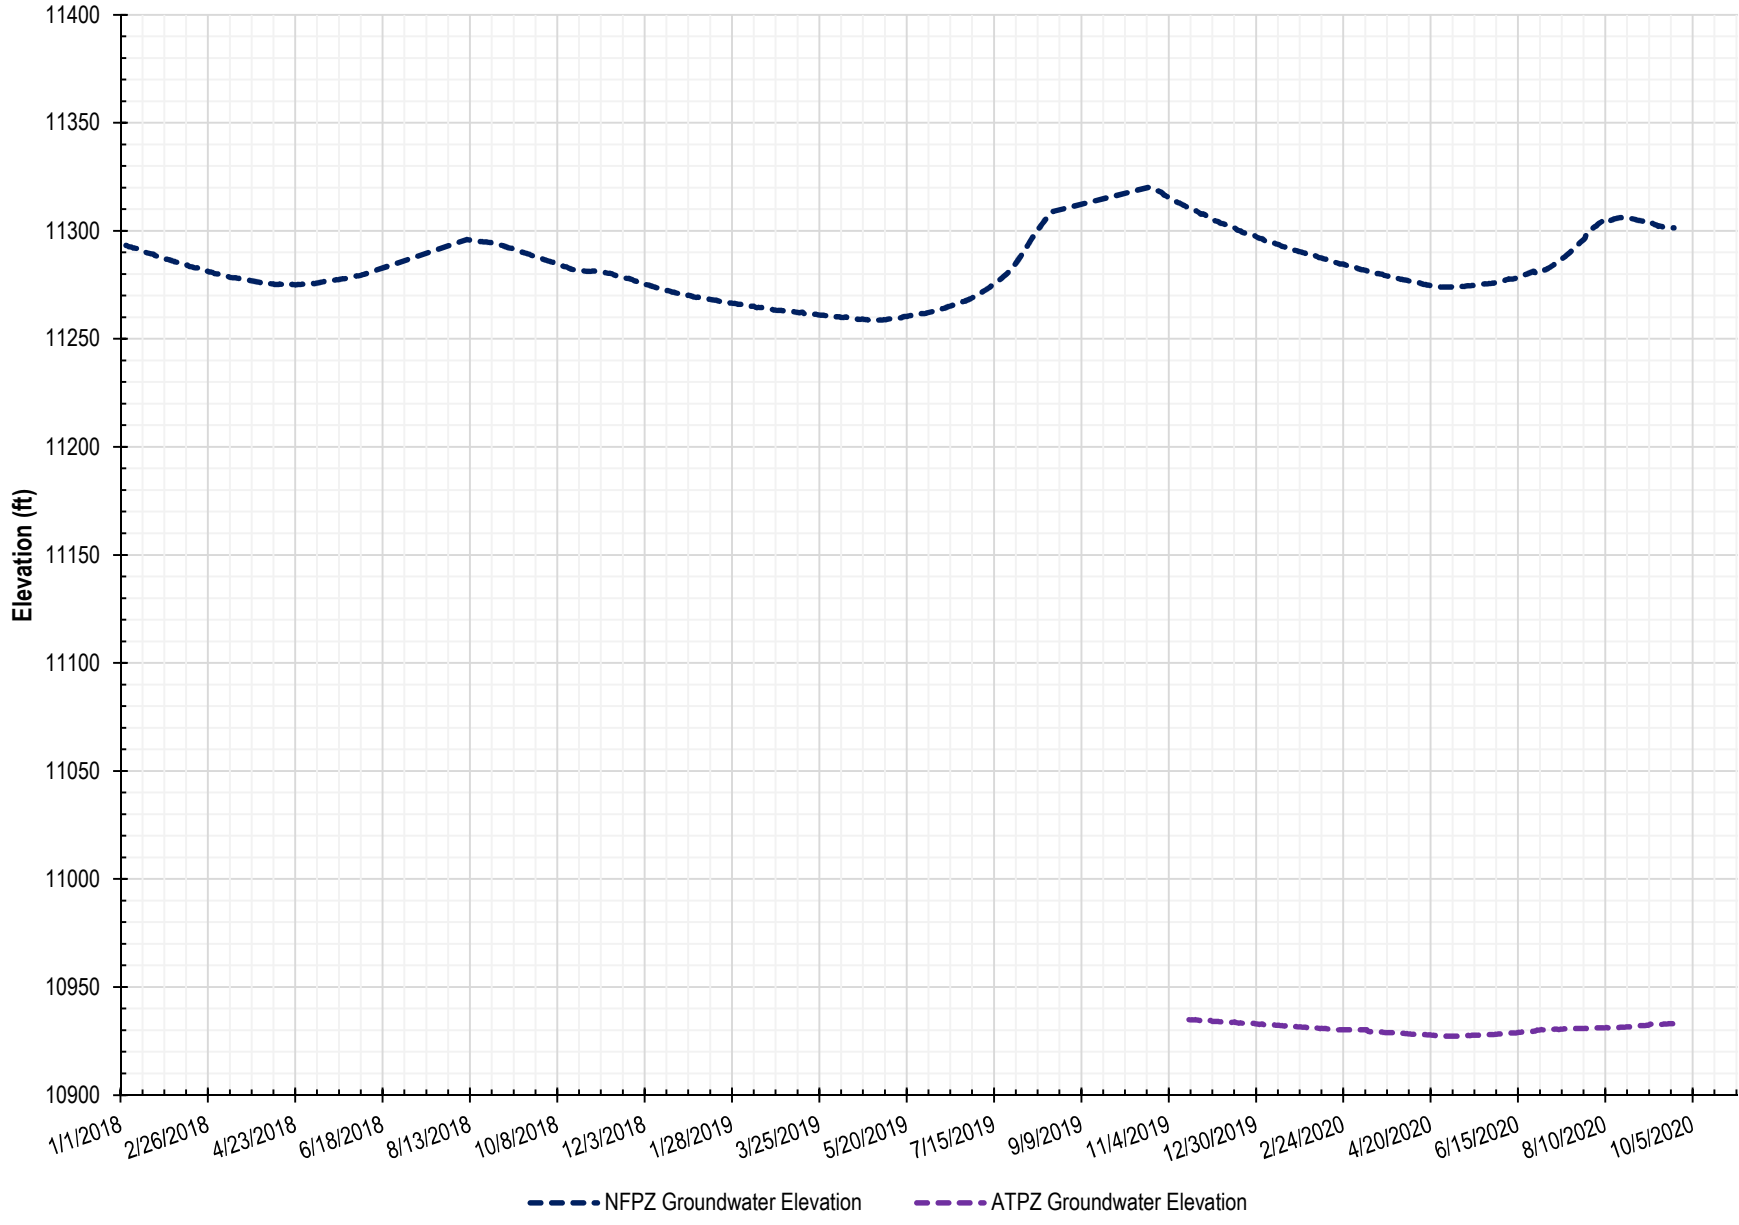
FIGURE 4: Groundwater Elevations

- The Mogul Mine data was collected this week and appears to be following its seasonal downward trend.
- Water levels in NFPZ-1 following typical seasonal cycle (Figure 4). Level in NFPZ-1 peaked in mid-August and is dropping as part of the typical cycle.

- ATPZ-2 (water level behind American Tunnel Bulkhead 3) remaining fairly steady (Figure 4). Slight increase in ATPZ-2 level in the past few weeks – this will continue to be monitored in future weeks.

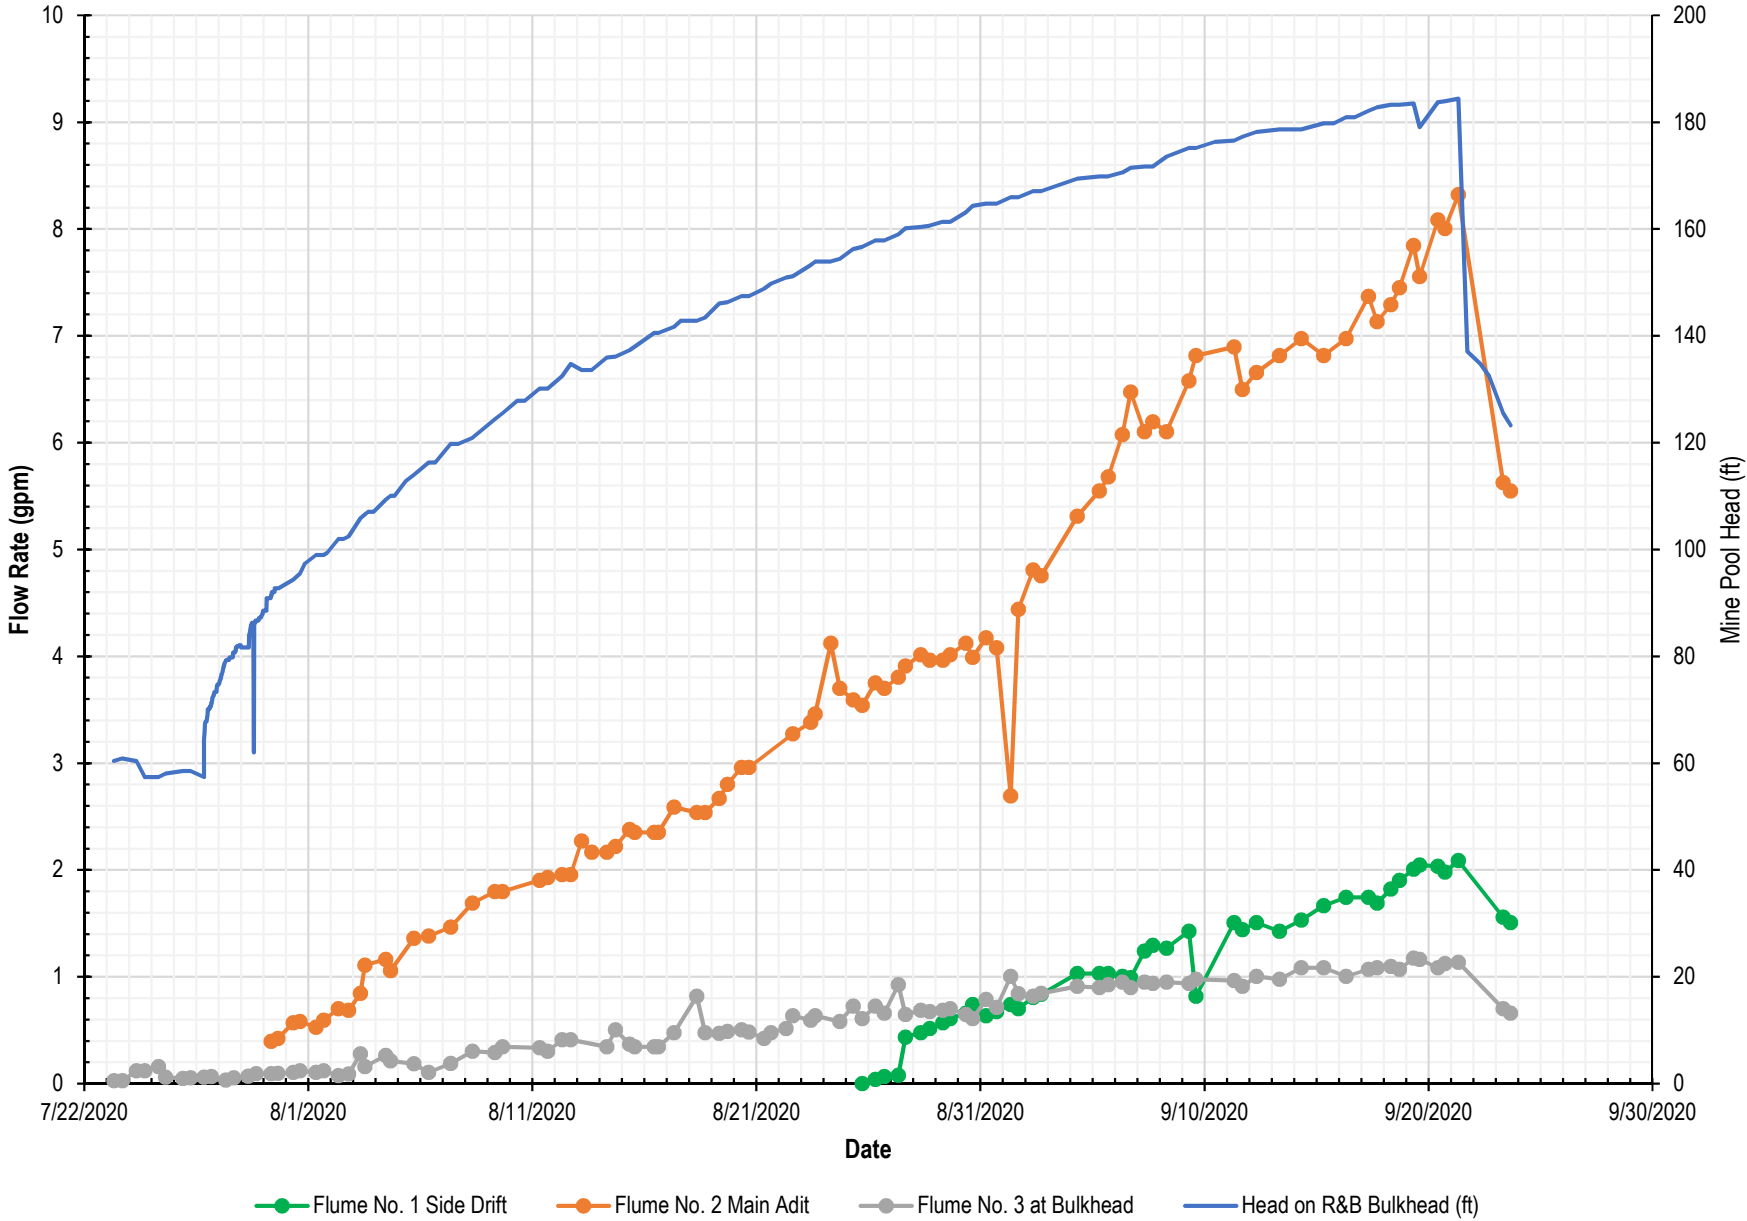
FIGURE 5: Red & Bonita Adit Flume Flow Rates

- Good agreement between pressure gauges at R&B portal and bulkhead.
- Flows through Flume 1 side drift were measuring between 1.7 gpm and 2.1 gpm prior to the opening of the Globe valve. The flows have decreased to approximately 1.5 gpm after opening (Figure 5).

- Flows from Flume 2 in the main adit near station 2+30 increased from 1.7 to 8.3 gpm prior to opening they have now decreased to about 5.5 gpm (Figure 5).

- Flows from Flume 3 at the bulkhead remained around 1 gpm (Figure 5), relatively unchanged from last week. Until the globe valve was opened. The flows have decreased to about 0.7 gpm.

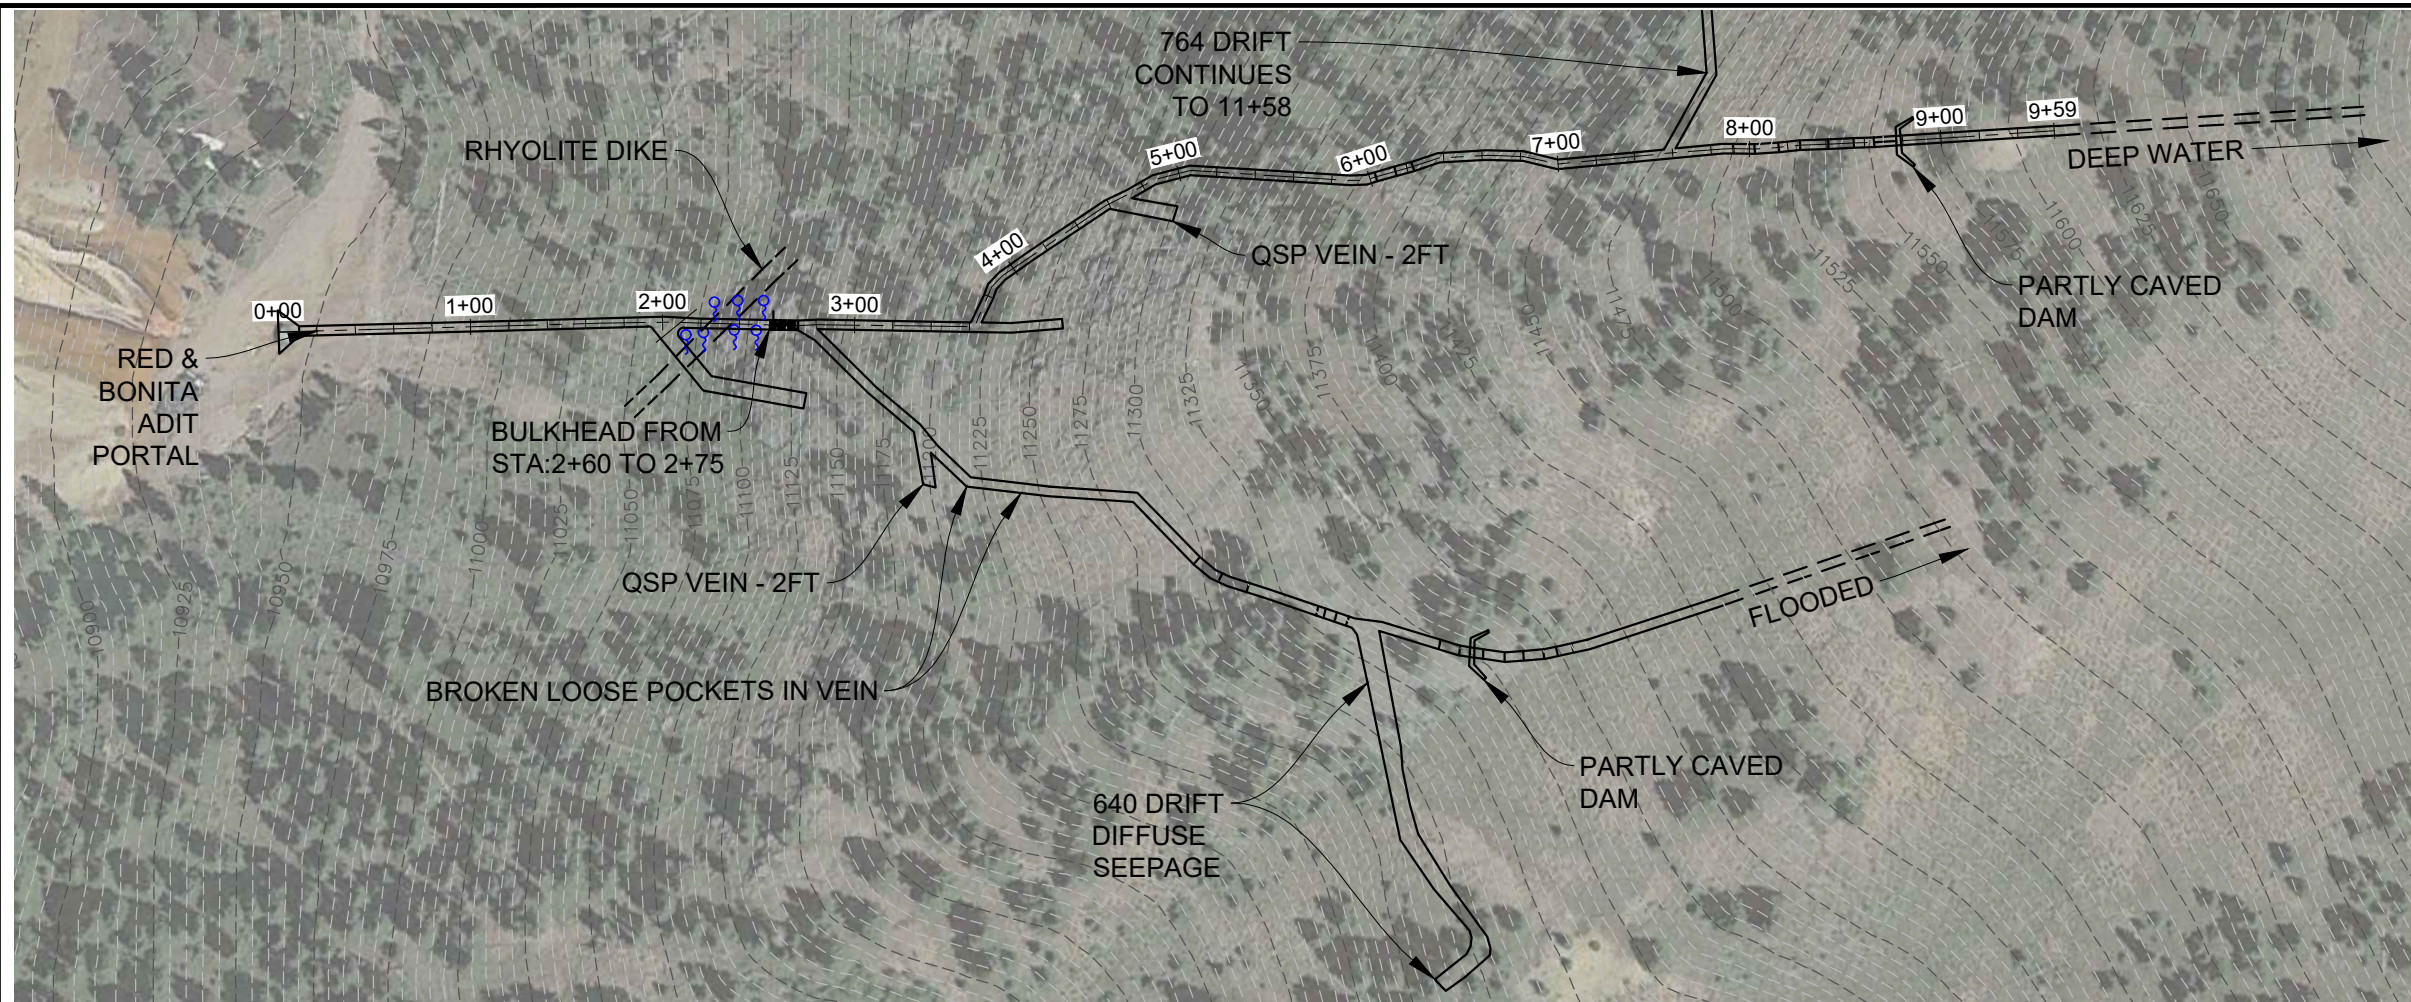
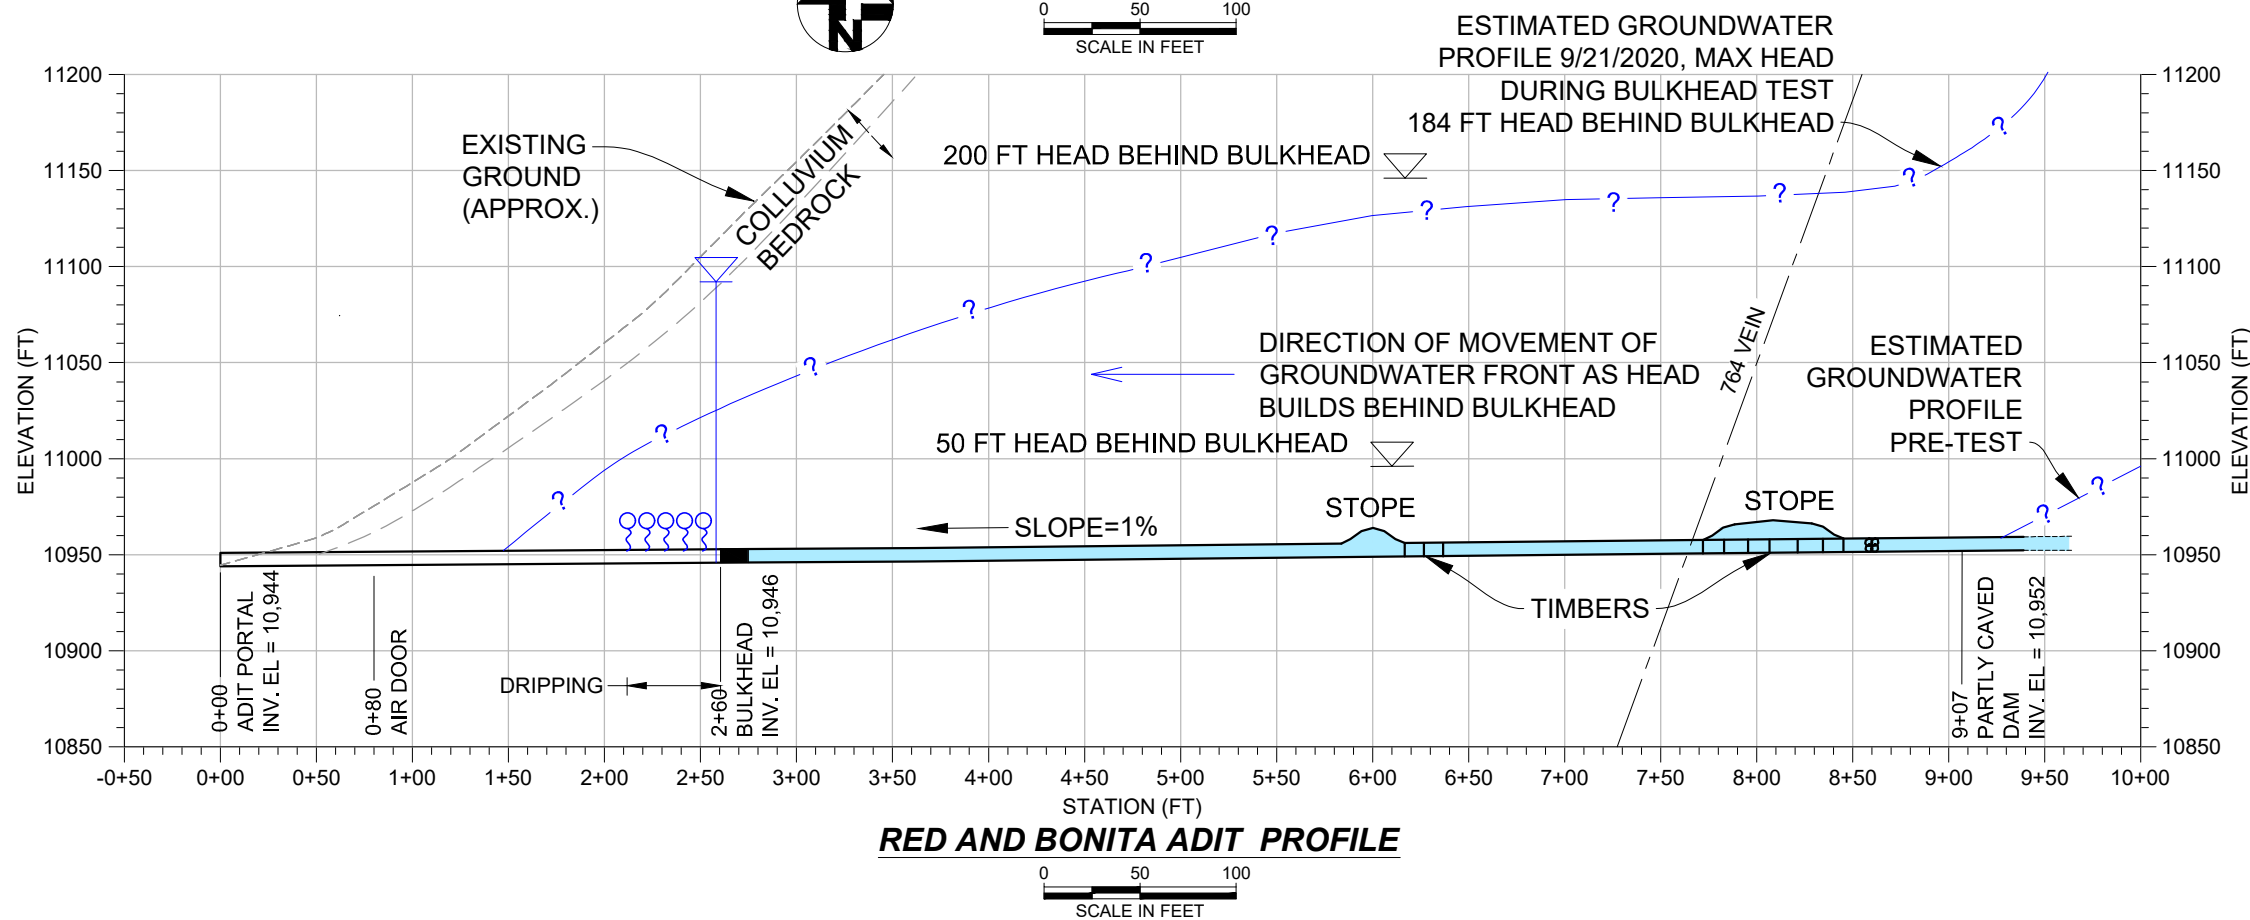
RED & BONITA ADIT	
PLAN & PROFILE	
DEERE & AULT <small>A SCHNABEL ENGINEERING COMPANY</small>	FIGURE NO. 6
DATE: SEPT 24, 2020	SCALE: AS NOTED

Figure 6: Red & Bonita Plan & Profile with Estimated Groundwater Table

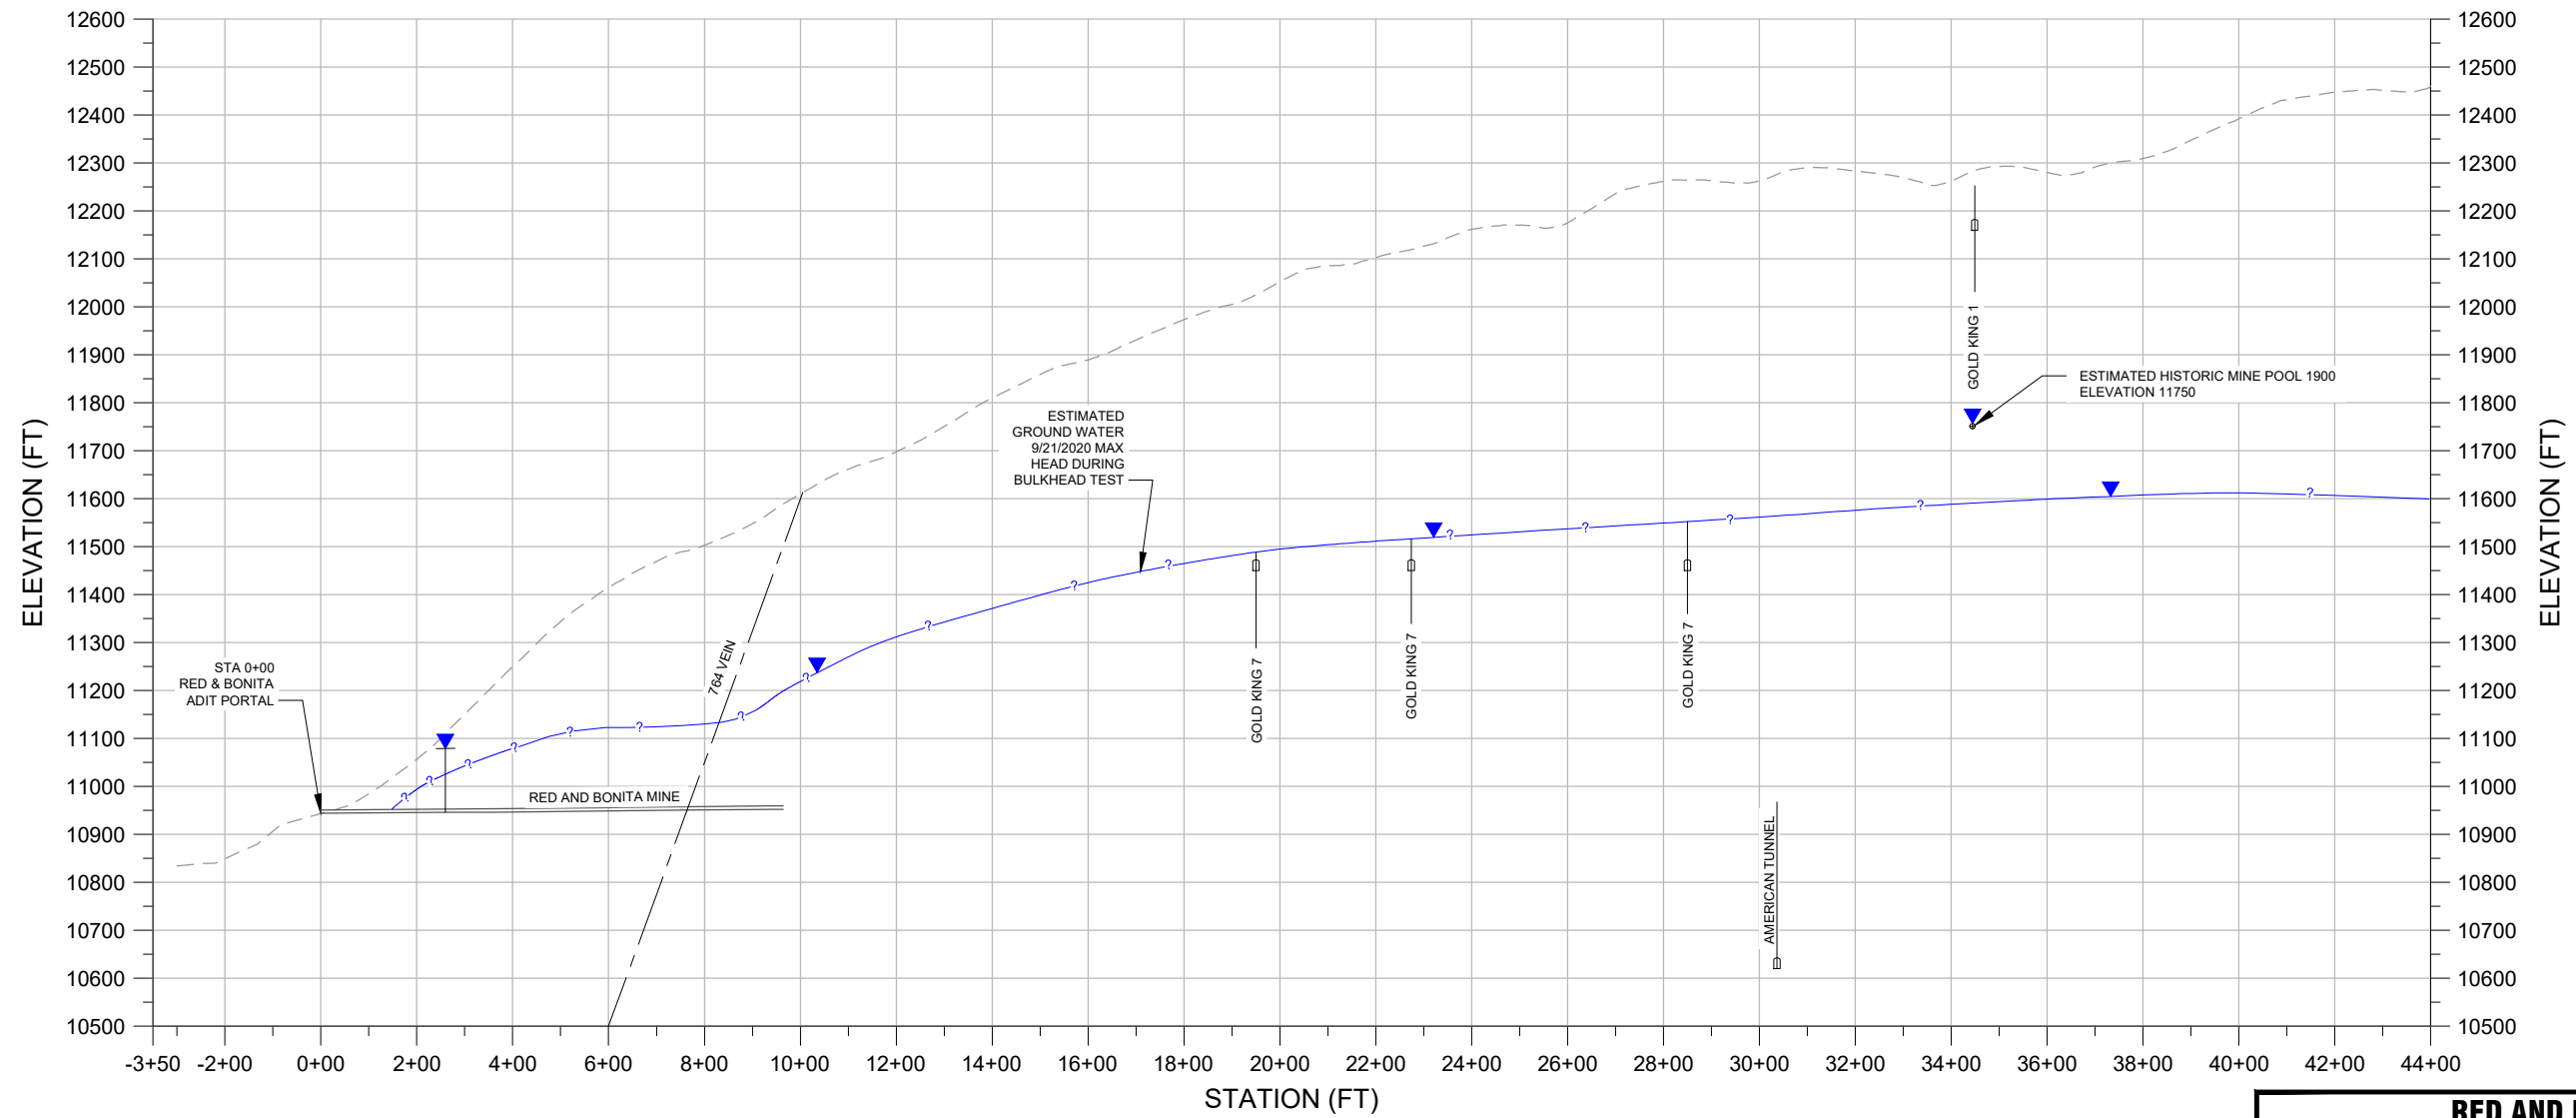
RED AND BONITA ADIT	
CROSS-SECTION	
DEERE & AULT <small>A SCHNABEL ENGINEERING COMPANY</small>	FIGURE NO. 7
DATE: SEPT 24, 2020	SCALE: AS NOTED

Figure 7: Red & Bonita Extended Plan & Profile with Estimated Groundwater Table

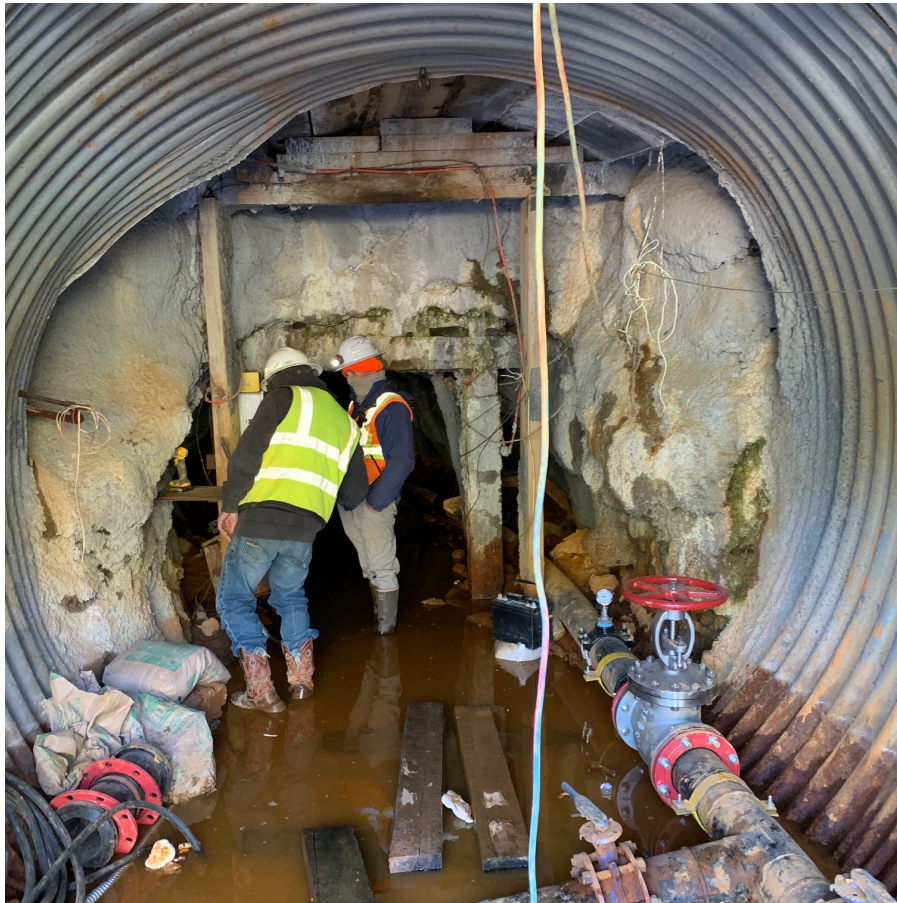
PHOTO 1

Globe Valve, Red & Bonita portal.

Crew from ER onsite to open the globe valve. Globe valve is the large red and silver valve on the right. This photo was taken shortly before the valve was opened to begin drain down.

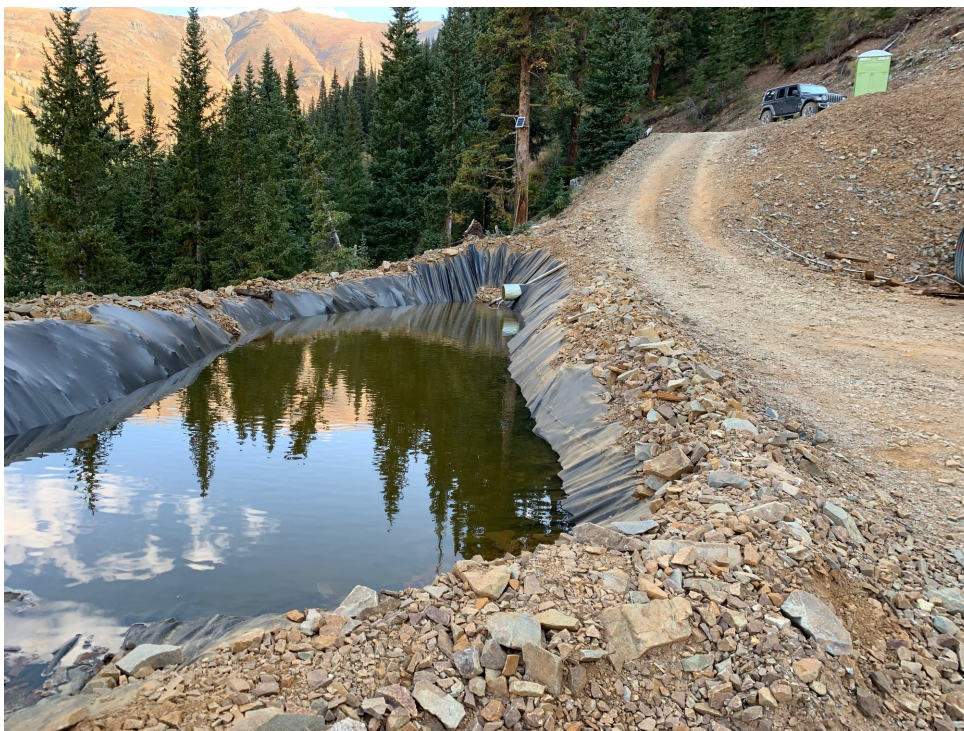
PHOTO 2

Overflow pond by the Red & Bonita portal, taking overflow from the adit.

Pond filling at 3.7 gpm on 9/21/20

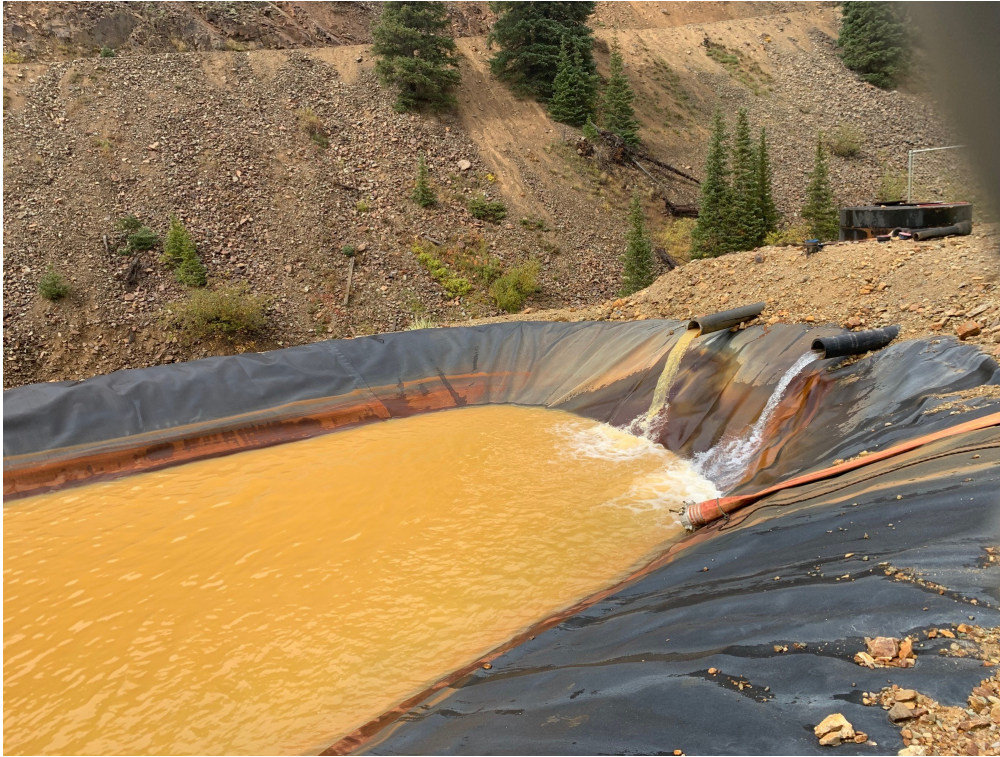
PHOTO 3

WTP pond at Gladstone

Gladstone IWTP pond the day after opening the R&B bulkhead. R&B water coming from the right pipe. Gold King water coming from the left pipe.
