WEEKLY REPORT – RED & BONITA BULKHEAD TEST

DATE: September 17-23, 2020

REPORT NO: 11

TEST PHASE: Phase 3, Filling to 200 ft Head
and Phase 4, Drain Down

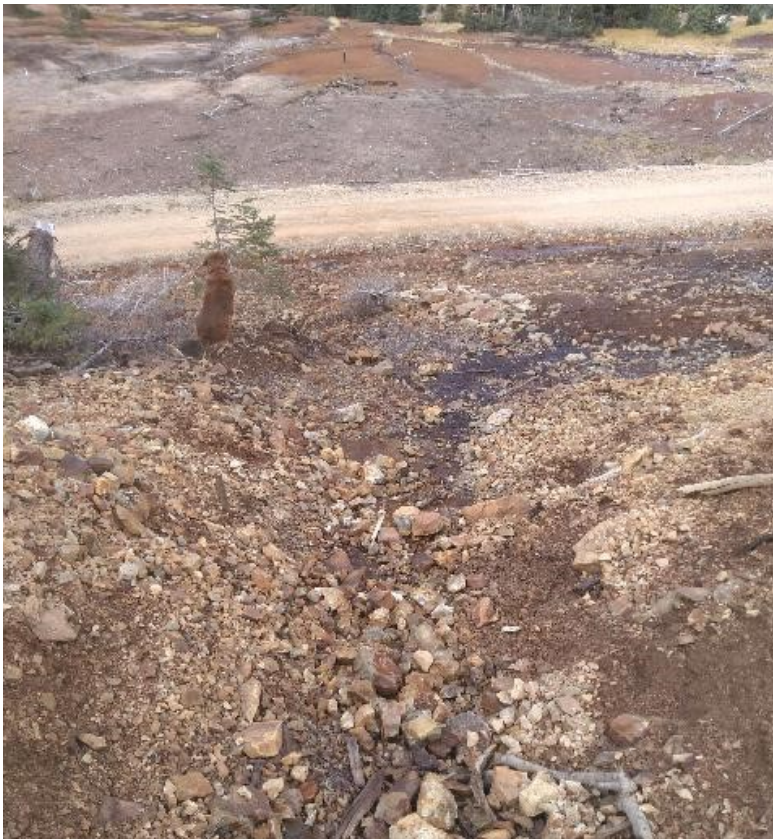
PHOTO 4

SS408 at the base of Red & Bonita mine dump

Seepage location SS408 at the base of the Red & Bonita mine waste pile. Similar flow to last week, about 1.1 gpm.

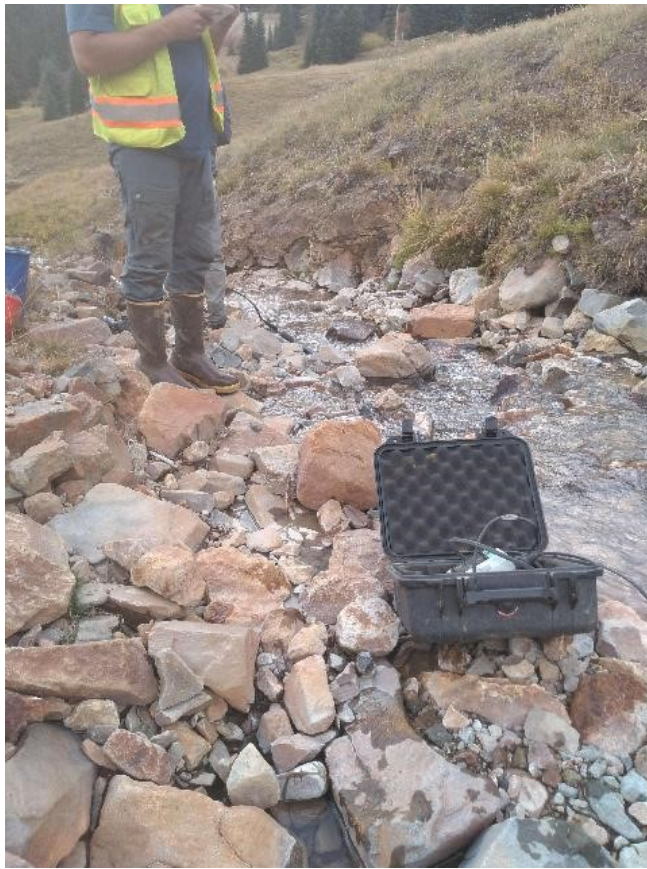
PHOTO 5

Cement Creek upstream from Mogul wetland (UC-1331)

Performing the slug test with USGS and MSI at site UC-1331

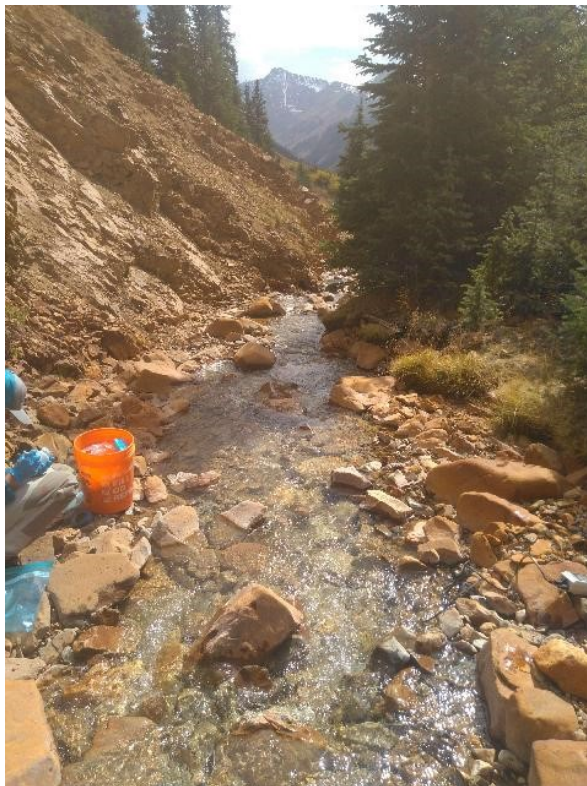
PHOTO 6

Cement Creek between Mogul and Red & Bonita (UC-1827)

Performing the slug test with USGS and MSI at site UC-1827

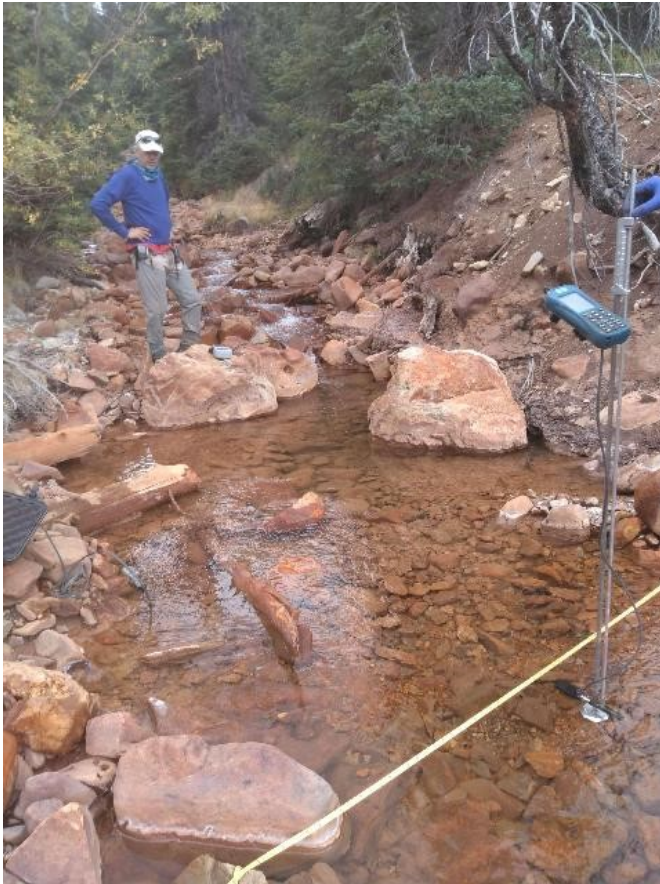
PHOTO 7

Cement Creek South of the Red 7 Bonita flows (UC-2934)

Performing the slug test with USGS and MSI at site UC-2934

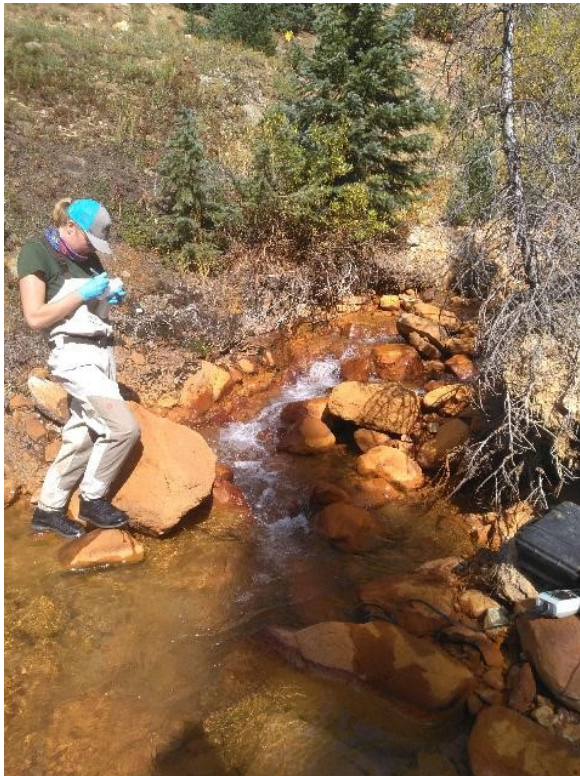
PHOTO 8

Cement Creek South of the North Fork confluence (UC-3337)

Performing the slug test with USGS and MSI at site UC-3337

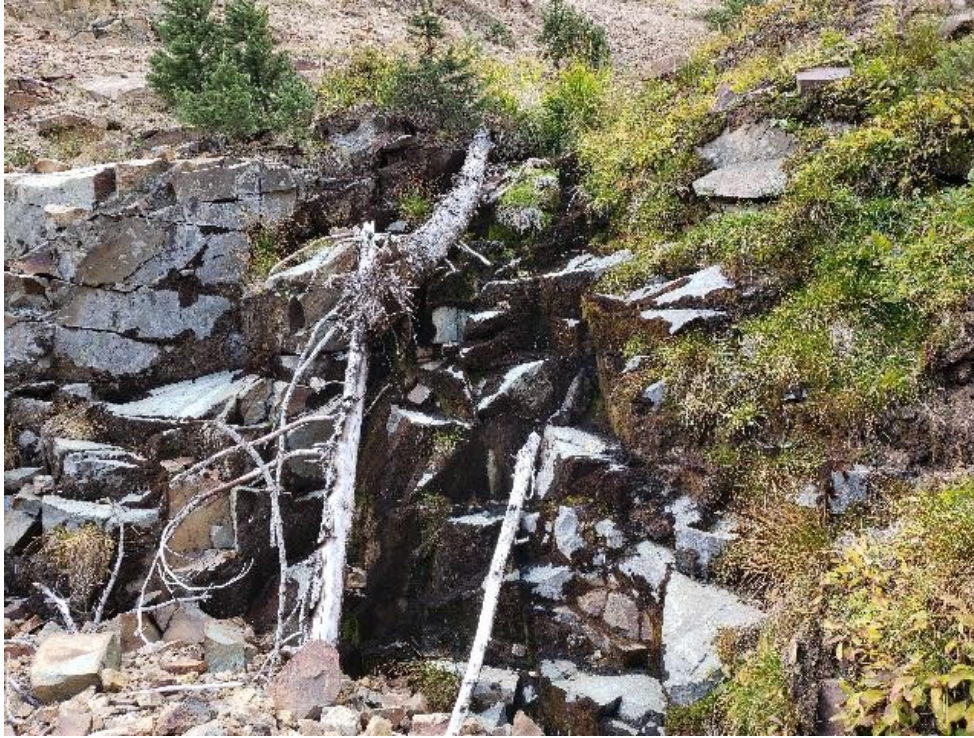
PHOTO 9

Adams Mine Drainage (SS421)	Dripping at approximately once per 15 seconds.

Adams Mine Drainage, Seepage location SS421

New seepage location SS421, in the drainage valley below the Adams mine portal.

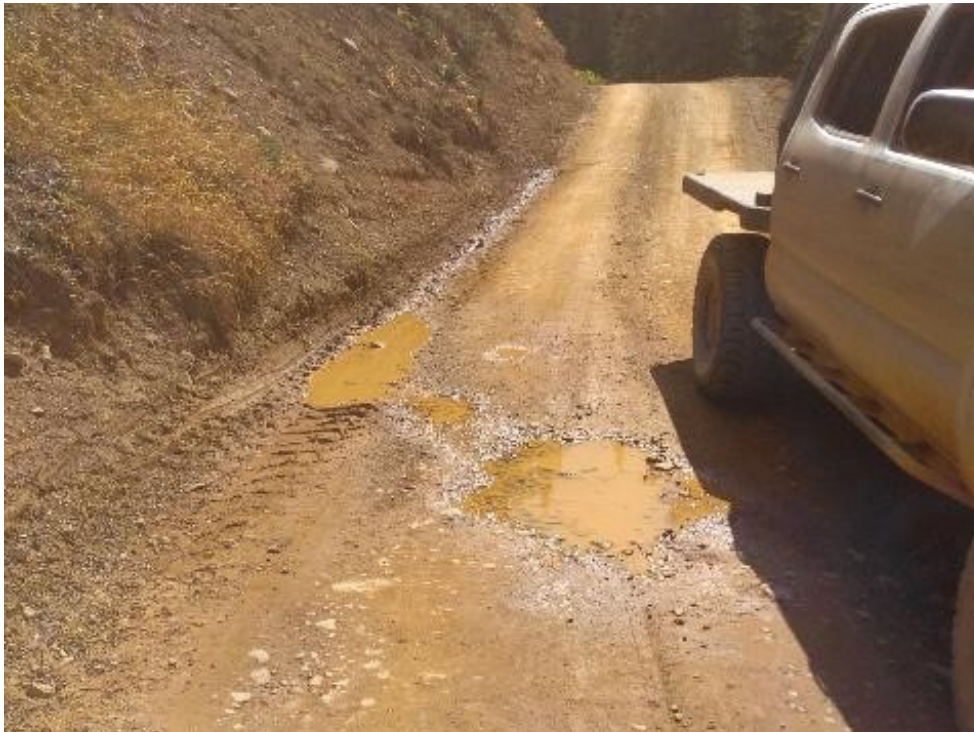
PHOTO 10

Along CR-52, seepage location SS422

New seepage location SS422, along the road to Natalie Occidental (CR-52) between SS016 & SS017.

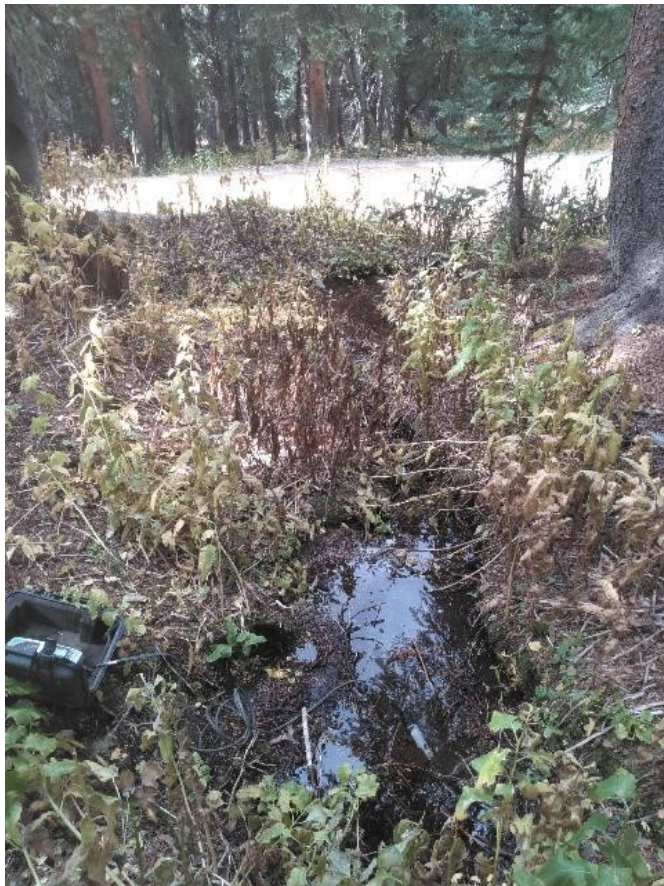
PHOTO 11

Along CR-52, seepage location SS423

New seepage location SS423, along the road to Natalie Occidental (CR-52) South of house on CR 52.

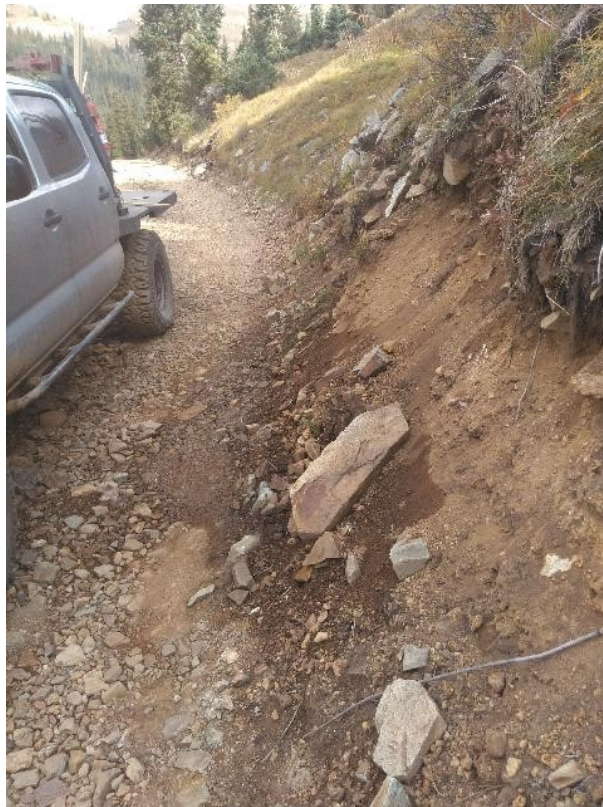
PHOTO 12

Upslope side of R&B access road, seepage location SS424

New seepage location SS424
